30% DESIGN REPORT

# **St. Vrain Creek Restoration Highway 36 to Crane Hollow Road Boulder County, Colorado**

Project No. 110666

REVISED December 2016

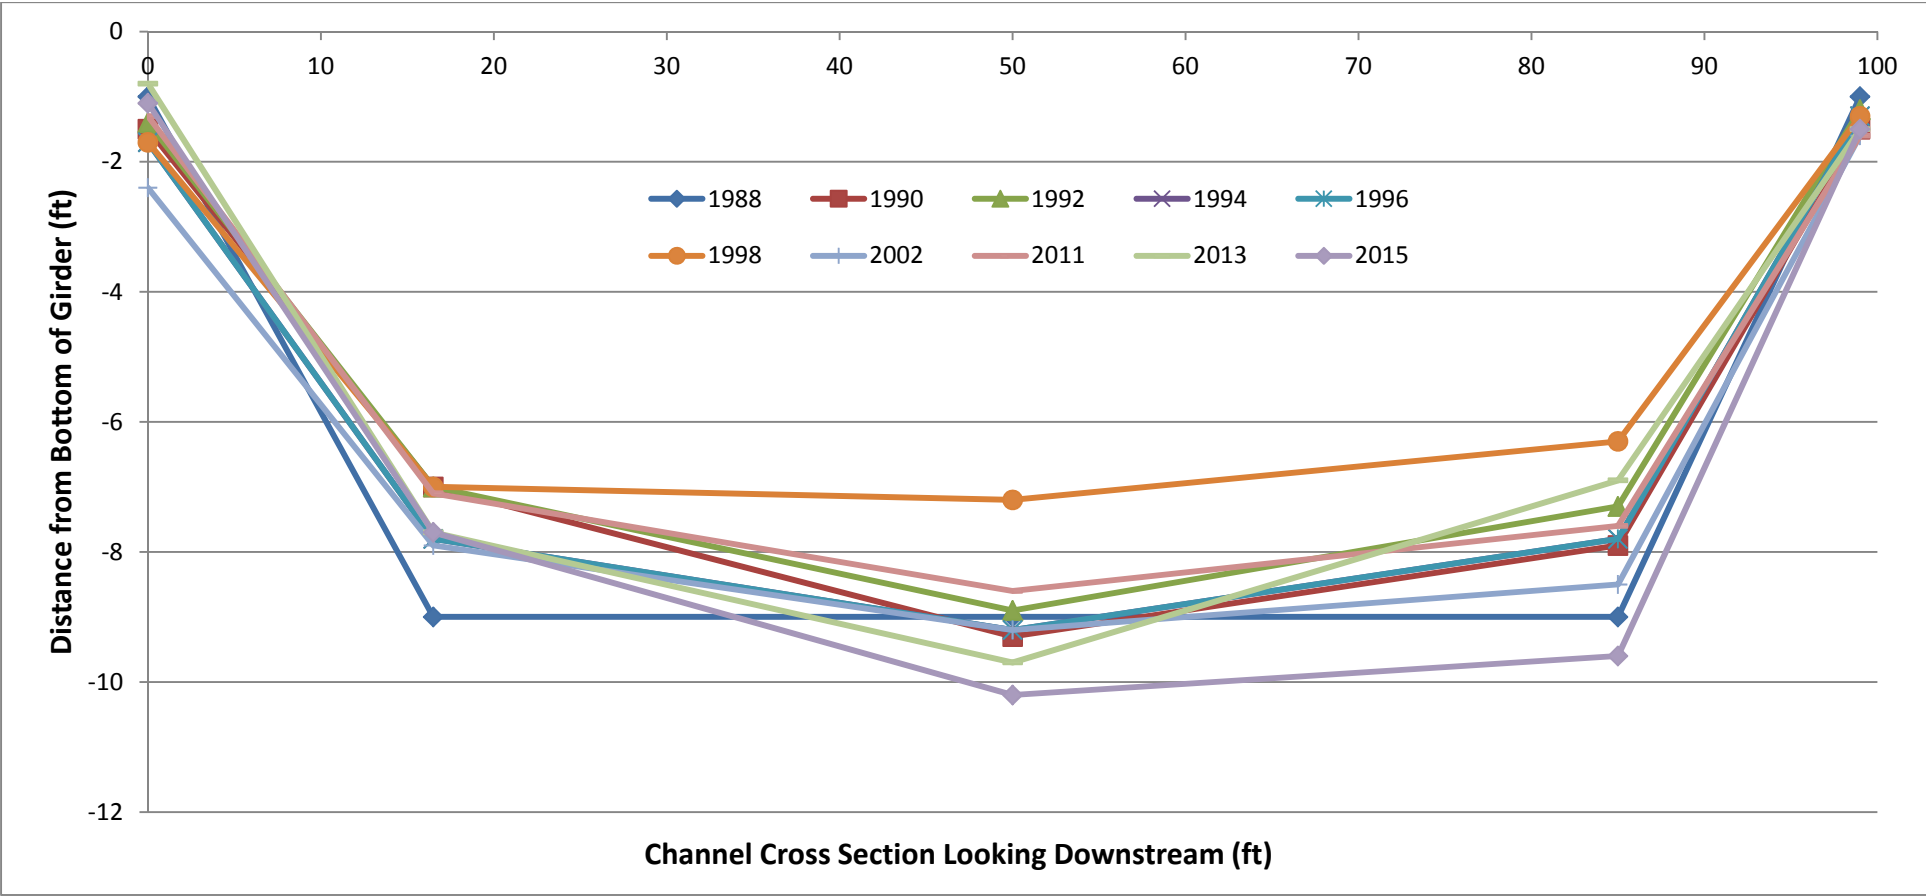
Figure 6. Hygiene Road Bridge

Year	Distance to Top of Left Bank (ft)	Distance to Left Bank Toe (ft)	Depth to Thalweg (ft)	Distance to Right Bank Toe (ft)	Distance to Top of Right Bank (ft)	Change in Channel Invert Elevation (at Thalweg) (ft)	Erosional Description
1988	1.0	9.0	9.0	9.0	1.0	--	--
1990	1.5	7.0	9.3	7.9	1.5	-0.3	Degradation
1992	1.4	7.0	8.9	7.3	1.2	0.4	Aggradation
1994	1.7	7.8	9.2	7.8	1.3	-0.3	Degradation
1996	1.7	7.8	9.2	7.8	1.3	0.0	--
1998	1.7	7.0	7.2	6.3	1.3	2.0	Aggradation
2002	2.4	7.9	9.2	8.5	1.6	-2.0	Degradation
2011	1.3	7.1	8.6	7.6	1.6	0.6	Aggradation
2013 (Pre-Flood)	0.8	7.7	9.7	6.9	1.5	-1.1	Degradation
2015	1.1	7.7	10.2	9.6	1.5	-0.5	Degradation

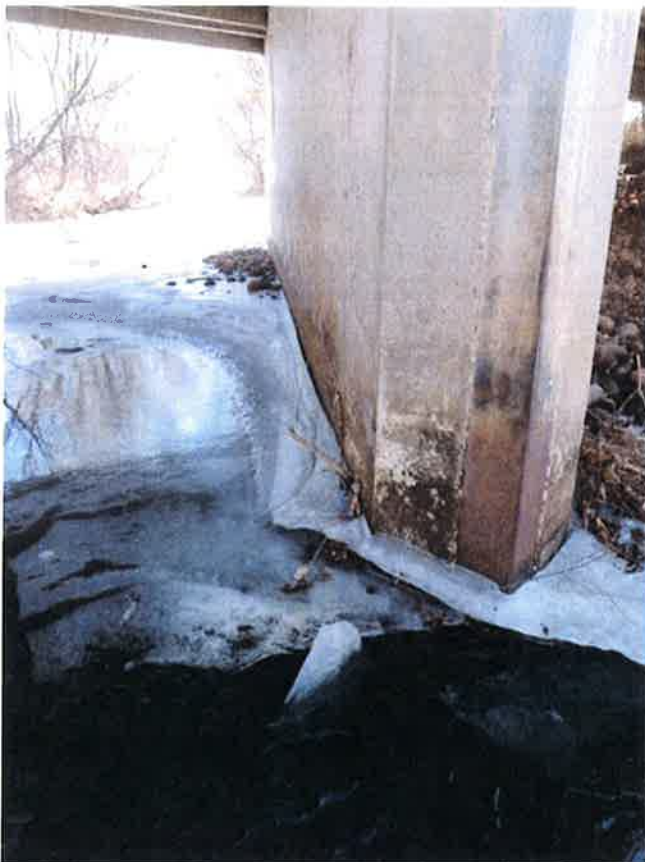
**SMALL HOLE ON WEST SIDE OF FLEX BEAM**

**P2 CONDITION (AT NORTH FACE (±2 FEET  
LOCAL SCOUR HOLE IN FRONT OF P2  
UPSTREAM SIDE)**

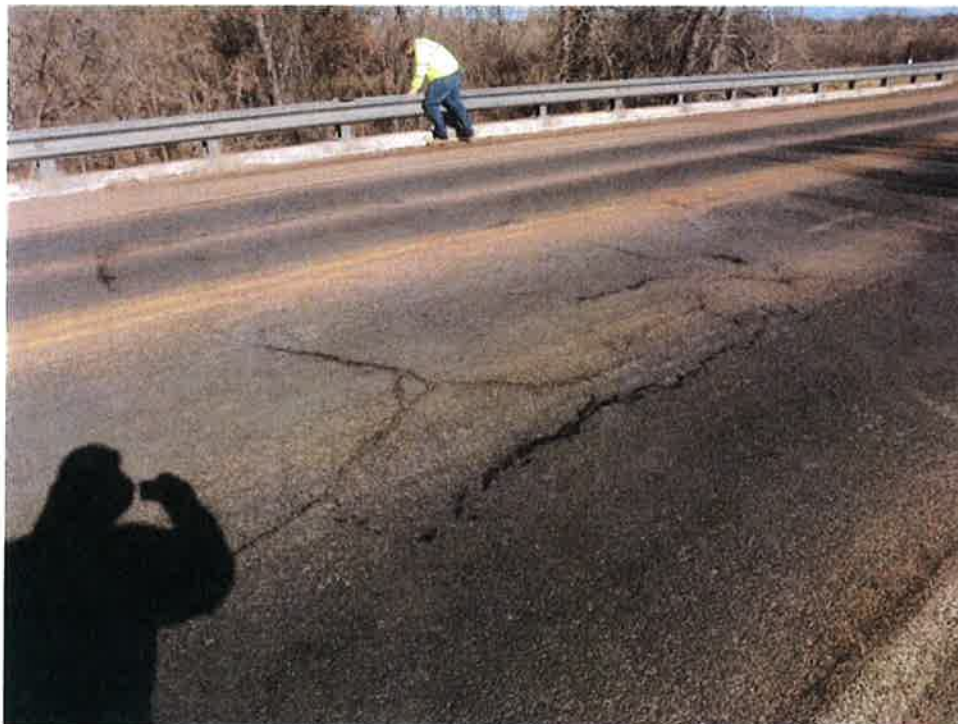
**LIGHT ASPHALT CRACKING ON DECK**

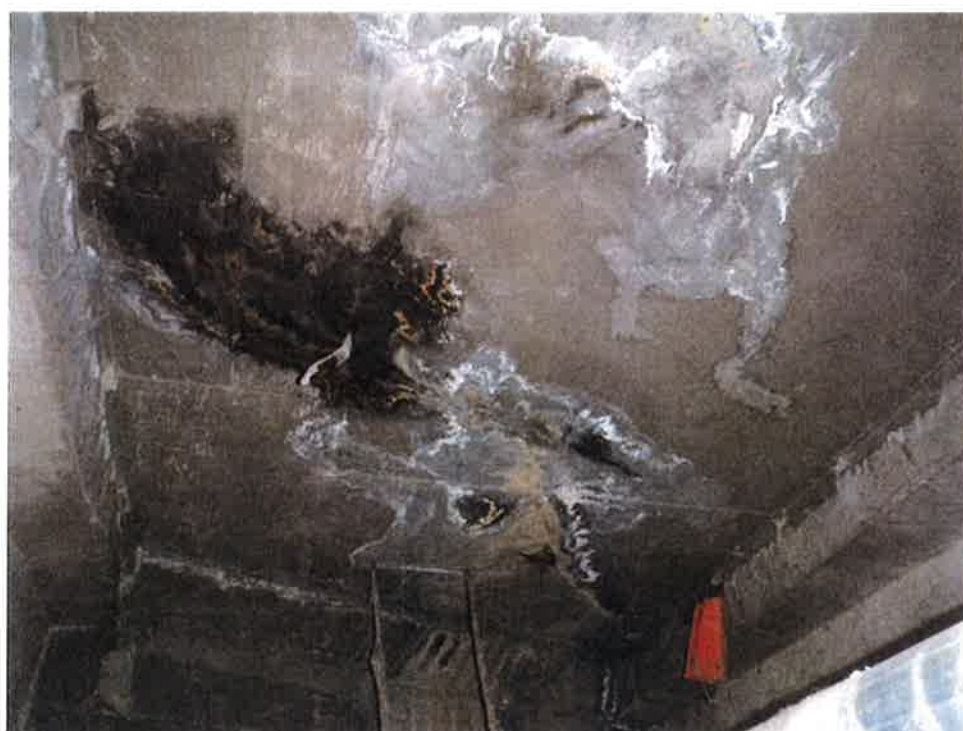
**TYPICAL CRACKING WITH LIGHT EFFLORESCENCE AND RUST  
STAIN IN SOFFIT**
