Reach 4b SSV1 and SSV2

Weekly Construction updates

Date: 10/5/2017

Location: South St. Vrain, West of Lyons, CO

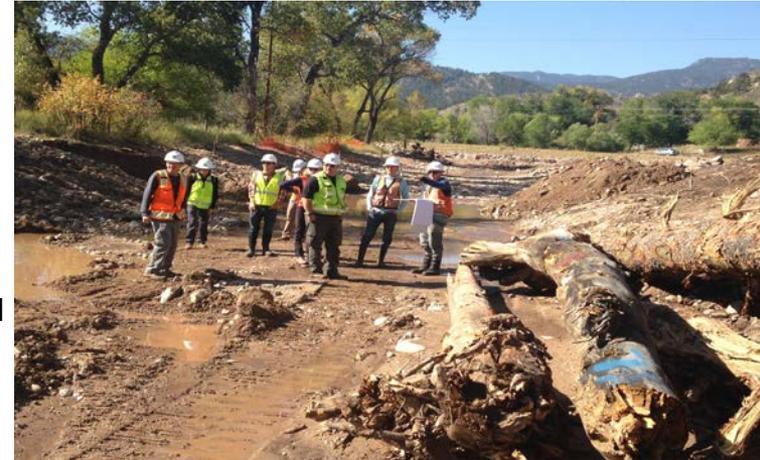
Upstream View: EWP QA team's site visit at main channel St. 90+50

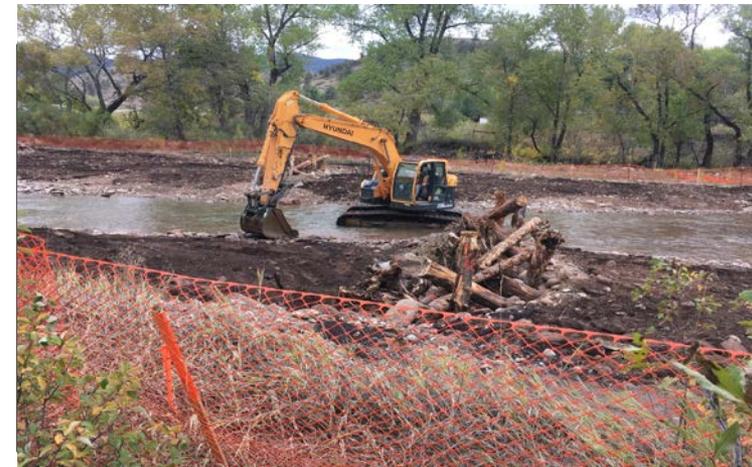
Floodplain soil conditioning between main channel St. 94+75 to 99+80

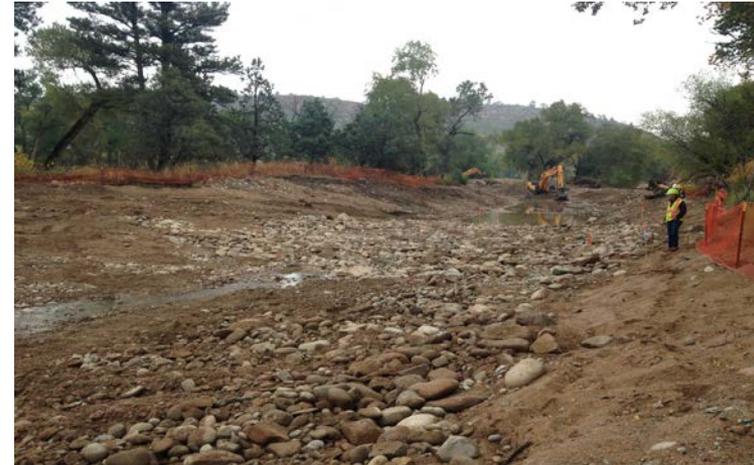
Downstream view: Construction of riffle structure at main channel St.91+43 .

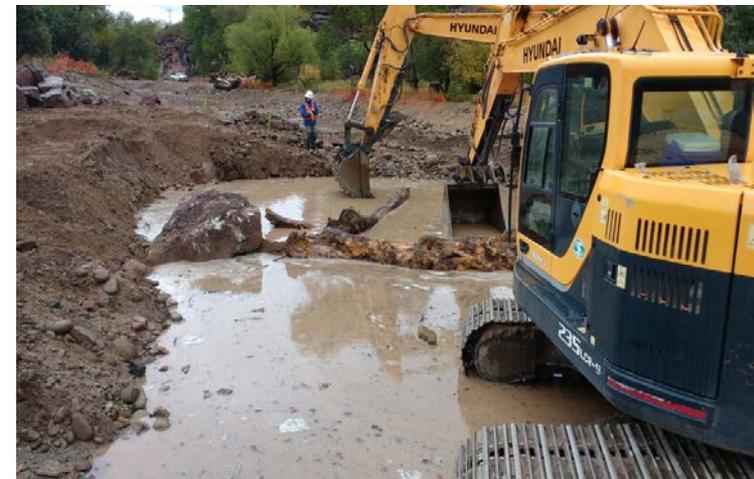
Downstream View: installation of instream Type 1 large woody structure (priority 1) at main channel St. 92+50 left bank

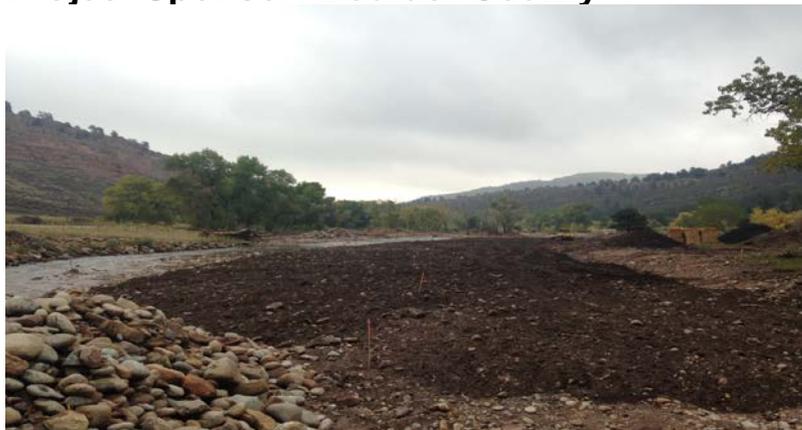
Downstream View: Floodplain benching, fine grading and soil conditioning between main St. 73+50 to 82+00 in progress.

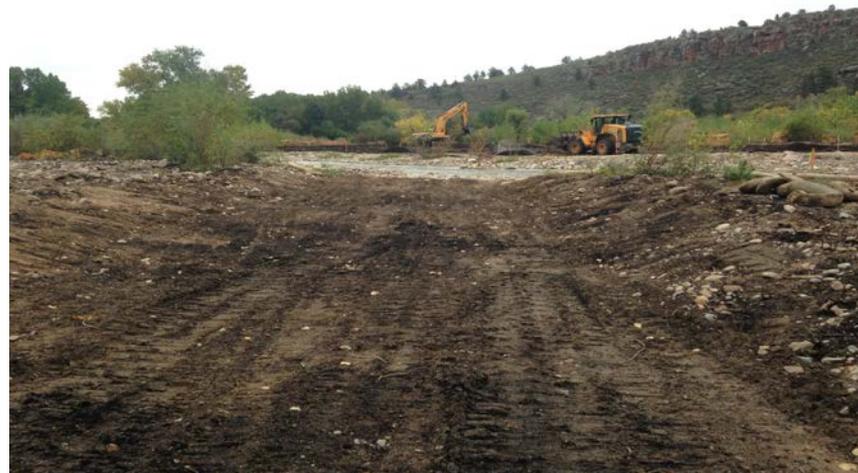
Downstream View: Completed fine grading and soil conditioning of revised overflow channel C profile.

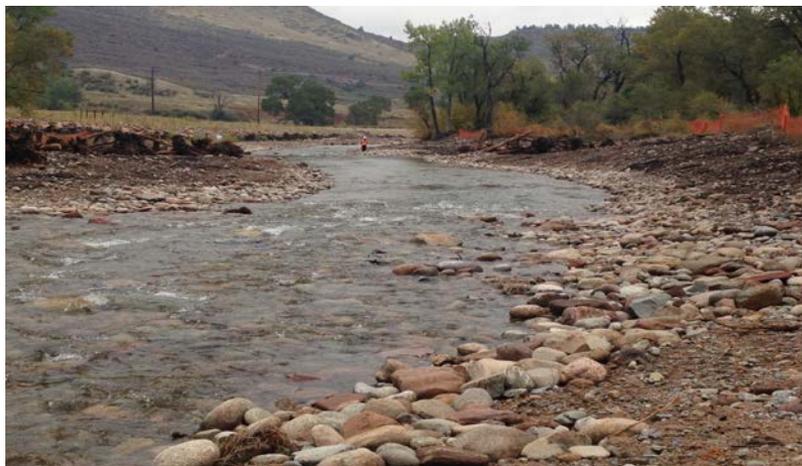
Downstream View: Fine grading of main channel profile between St 94+50 to 99+00.

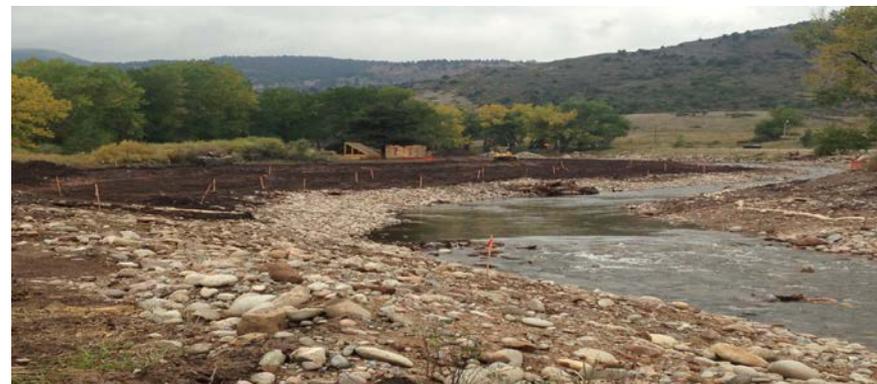
Upstream View Floodplain benching, fine grading and soil conditioning between main St. 73+50 to 81+75.
