Reach 4b SSV1 and SSV2

Weekly Construction updates

Date: 10/12/2017

Location: South St. Vrain, West of Lyons, CO

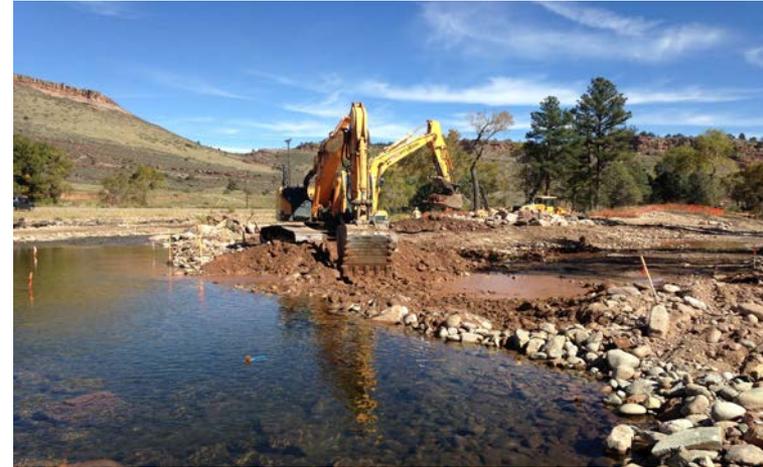
Downstream View: Flipping main channel to design alignment at St .93+20

1. Flipped main channel to design alignment at St 93+20 at upstream confluence with over channel A.
2. Boulder toe bank stabilization with cobble as filler and face material completed between main channel St. 66+50 to 68+70 right bank.

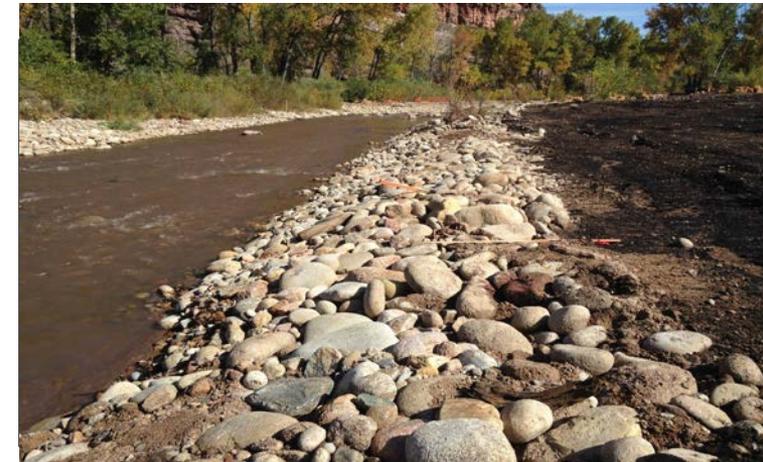
Downstream View: Corrected right bank boulder toe bank stabilization between main channel St. 66+50 to 68+70 and adjacent floodplain.

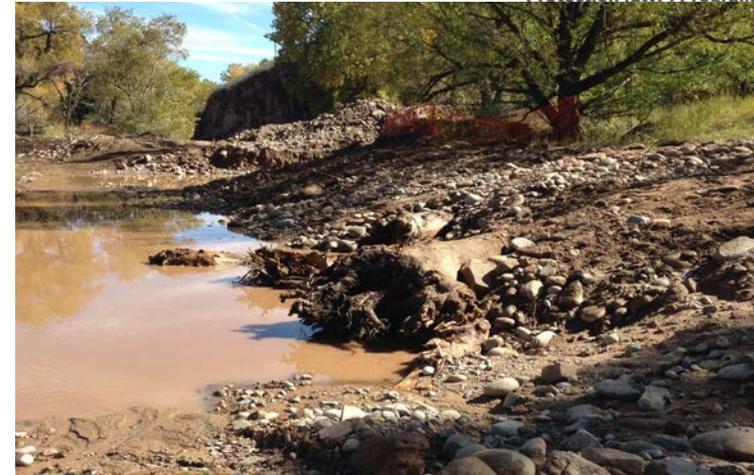
Downstream view: Type 2 large woody structure at main channel St. 90+40 right bank .

5. Completed Installation of instream Type 2 large woody structure (priority 1) at main channel St. 90+40 right bank.
6. Completed Installation of Type 5 large woody structure (priority 2) adjacent to main channel St. 79+10 left floodplain.

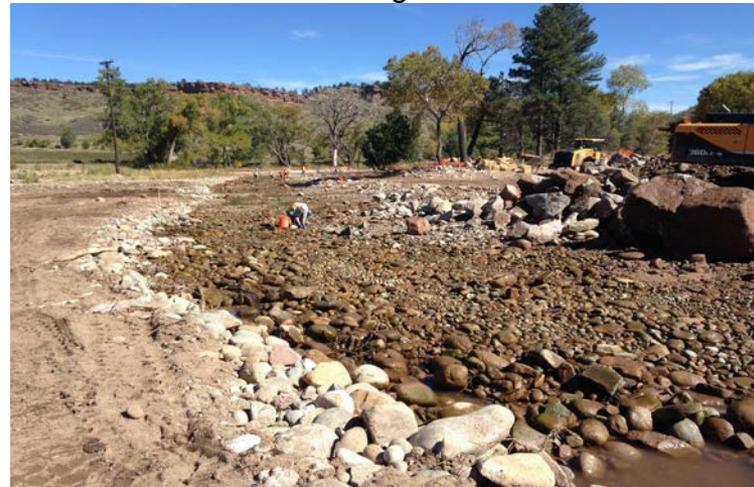
Downstream View: overflow channel A bedform (previous main channel) after main channel realignment .

7. Construction of riffle crest , face and pool at main channel St.91+43 and 88+02 in progress.
8. Fine grading of overflow channel A after main channel realignment in progress.

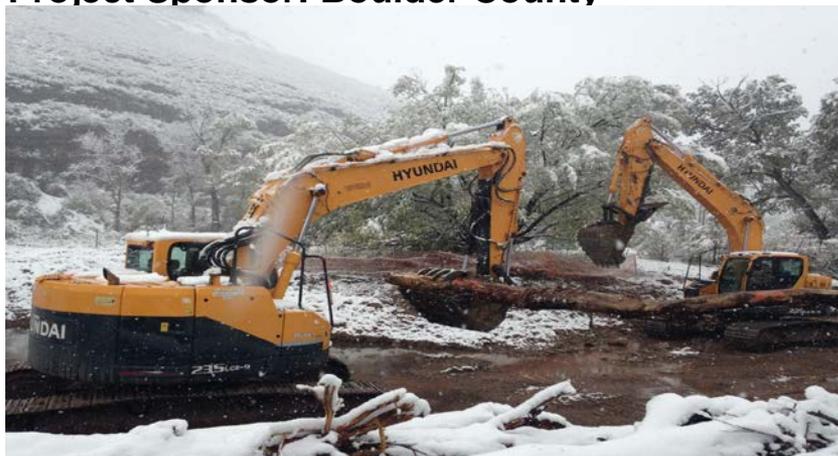
Downstream View: Type 2 large woody structure at main channel St. 90+40 right bank in progress

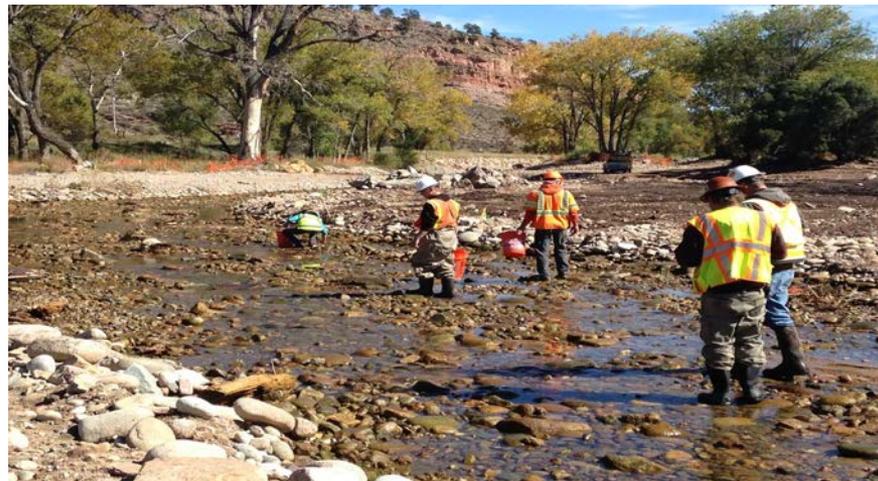
Downstream View: Crew saving fish in overflow channel A (previous main channel) after main channel realignment..

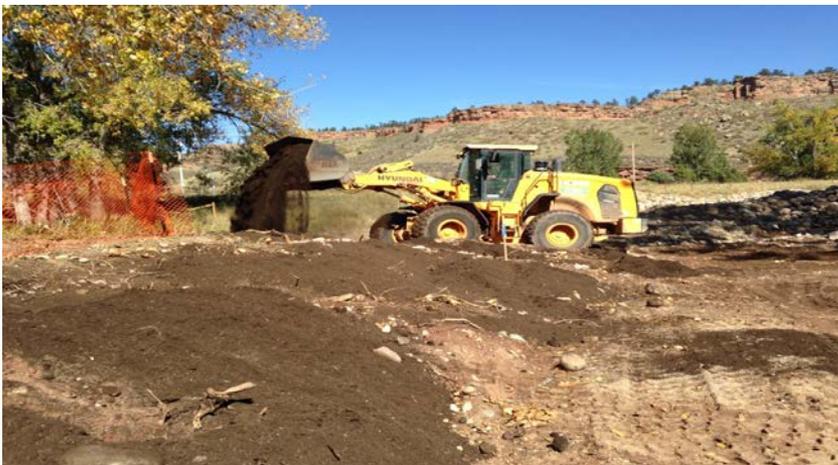
Downstream View: Soil Conditioning in progress in right floodplain adjacent to main channel St. 83+50.

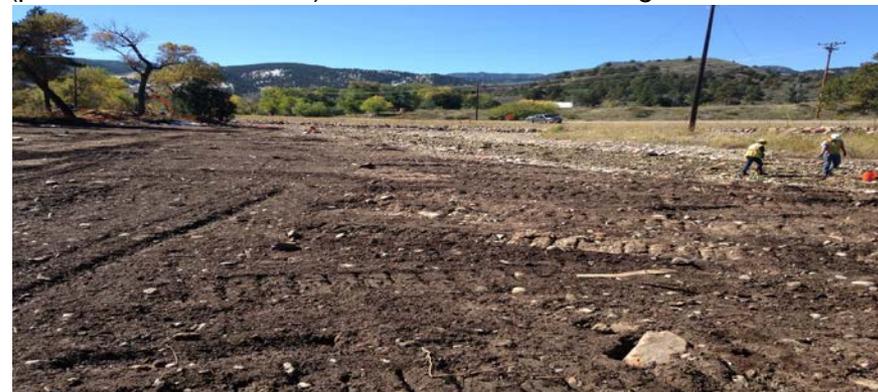
Upstream View: Completed Floodplain benching, fine grading and soil conditioning between main St. 86+00 to 90+50.
