SVR3 EWP Stream Restoration

Project Weekly Construction Notes: 1/8 to 1/12/2018

Date: 1/15/2018

Location: St. Vrain Reach 3 – multiple work sites

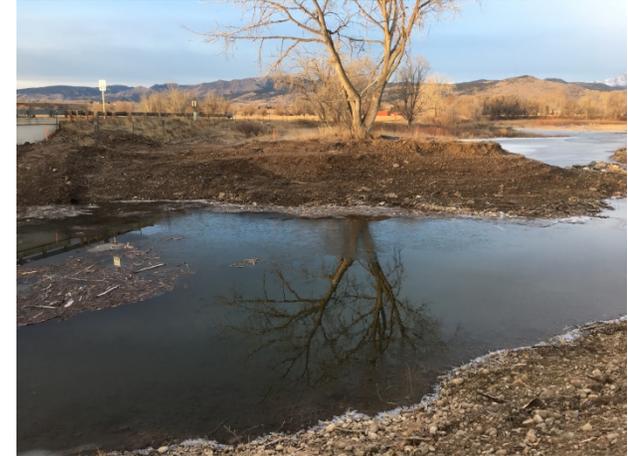
1-8-18: Rough grading of soil filled riprap area north of the Hygiene Road bridge on the west side of the stream.

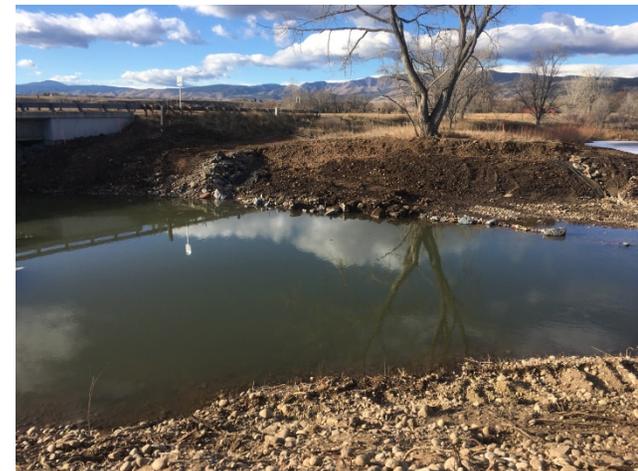
1-9-18: Riprap installation underway NW of the Hygiene Road bridge.

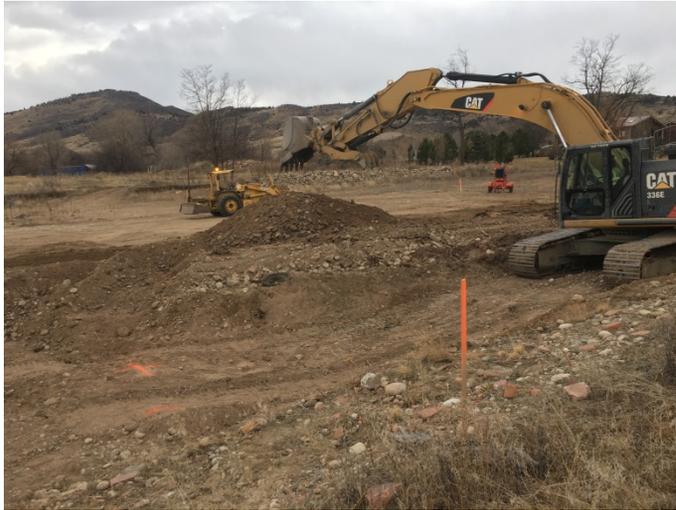
1-10-18: Clay core excavation starts for Breach 1.

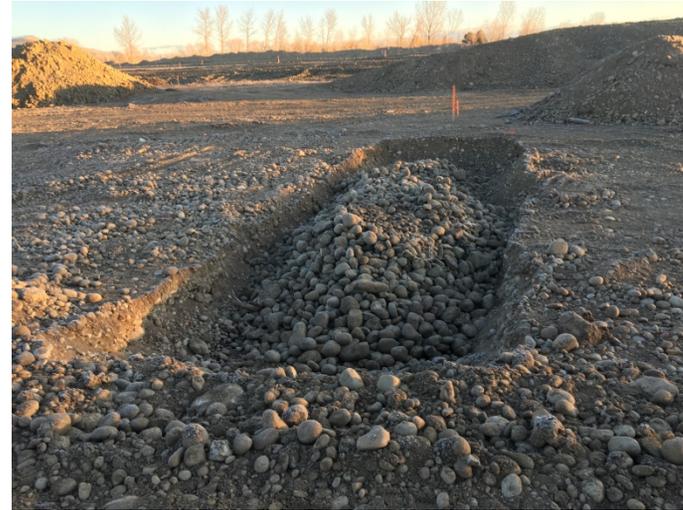
1-11-18: Installation of in-stream feature riffle head.

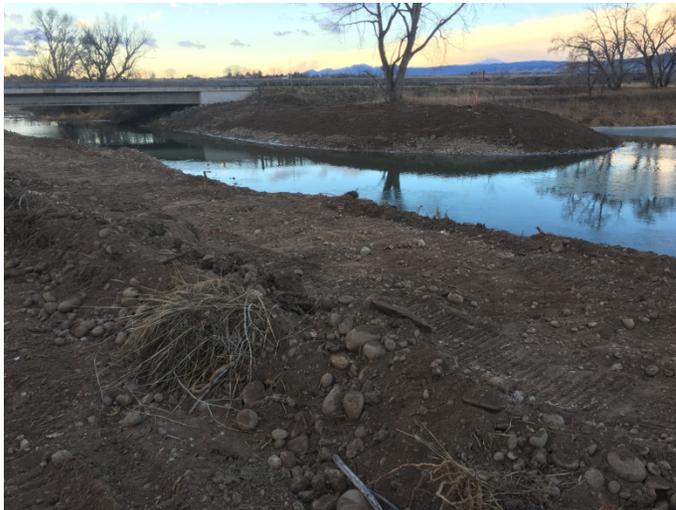
1-12-18: Soil filled riprap complete NW of the Hygiene Road bridge, grading starts on NE side of the bridge for riprap installation.

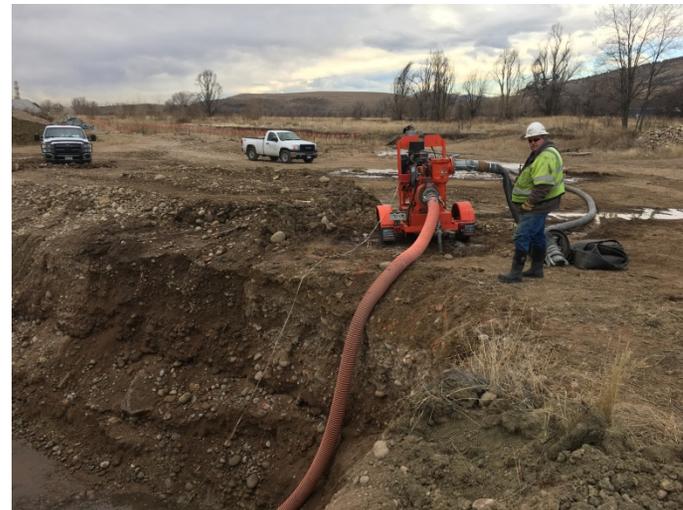
1-12-18: Test dewatering of clay core in conjunction with survey and engineering inspection, however dewatering location inappropriate and pump shut down until new dewatering plan developed.
