Hall Ranch II Access Road Repair and Hazard Mitigation Weekly Construction updates

Date: 04/09/2018

By: Prashant KC

Location: South St. Vrain, West of Lyons, CO

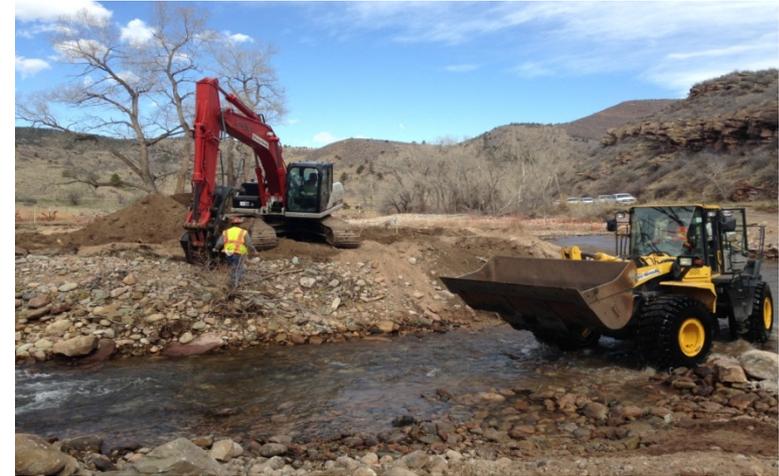
Looking Downstream: Clearing and grubbing floodplain and creek profile

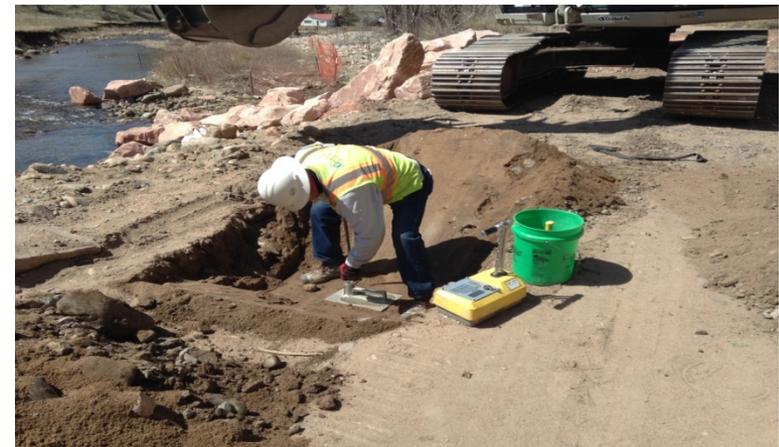
Field density testing of existing temporary low water crossing for structural verification.

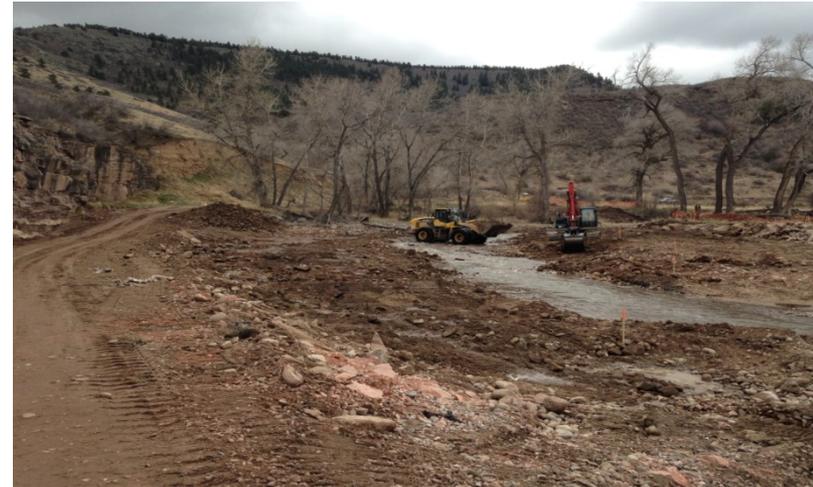
Looking Upstream: Creation of pilot channel for construction of boulder toe bank stabilization and strong substrate for permanent road repairs

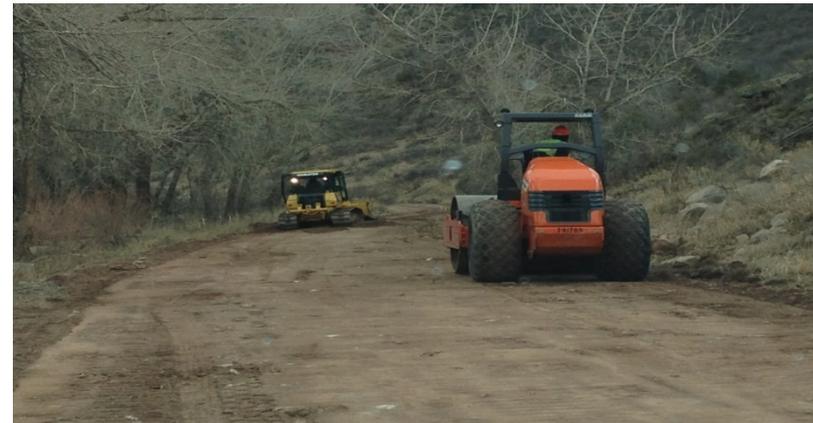
Construction of internal haul and access routes
