Hall Ranch II Access Road Repair and Hazard Mitigation Weekly Construction updates

Date: 04/16/2018

Location: South St. Vrain, West of Lyons, CO

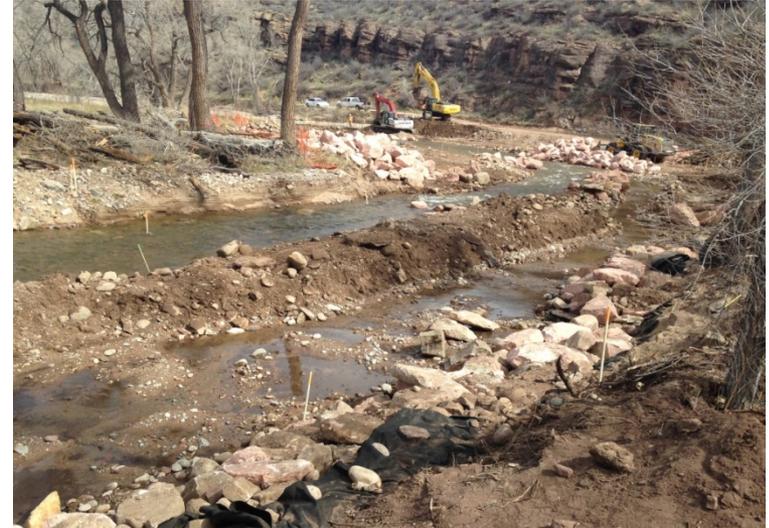
Looking Downstream: Maintenance of pilot channel and native material coffer dam for construction of boulder toe bank stabilization

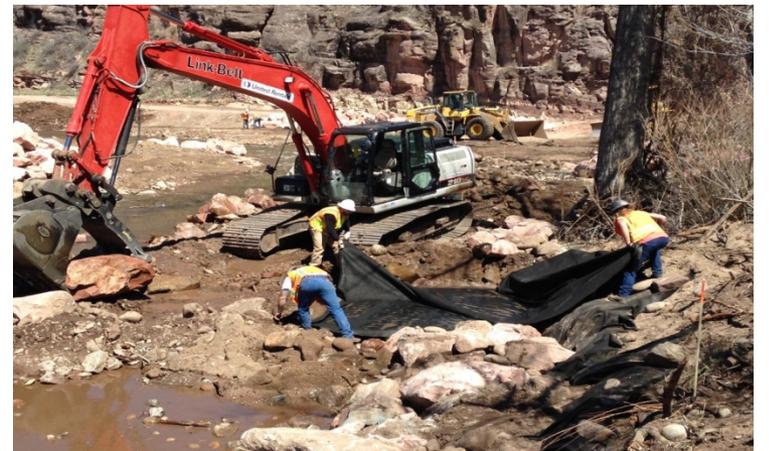
Looking downstream: Installation of class 1 Geotextile for slope stabilization and drainage separation.

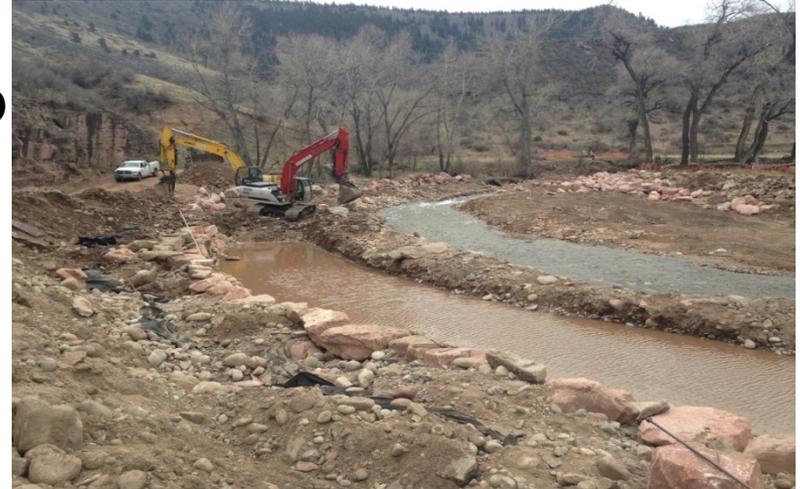
Looking Upstream: Boulder toe bank stabilization construction in progress starting at main channel St 123+85 and moving upstream

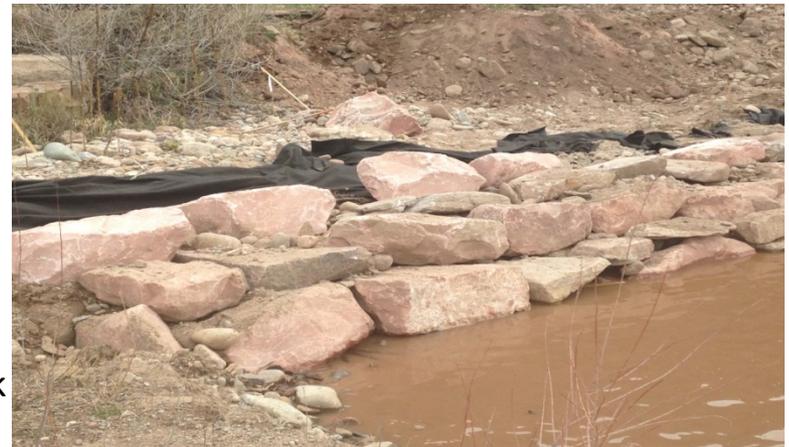
Boulder Toe Construction with 3:1 slope
