# Hall Ranch II Access Road Repair and Hazard Mitigation Weekly Construction updates

**Date: 05/15/2018**

**By: Prashant KC**

**Location: South St. Vrain, West of Lyons, CO**

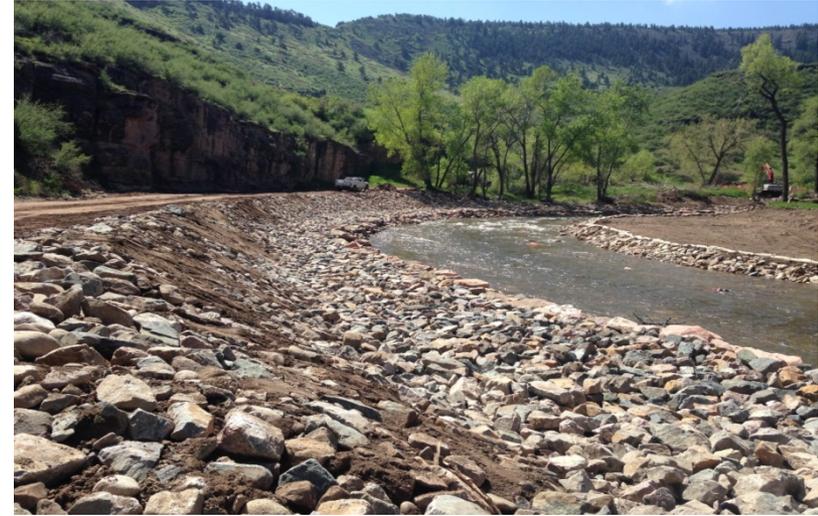
Looking upstream: Completed bank line and slope stabilization .

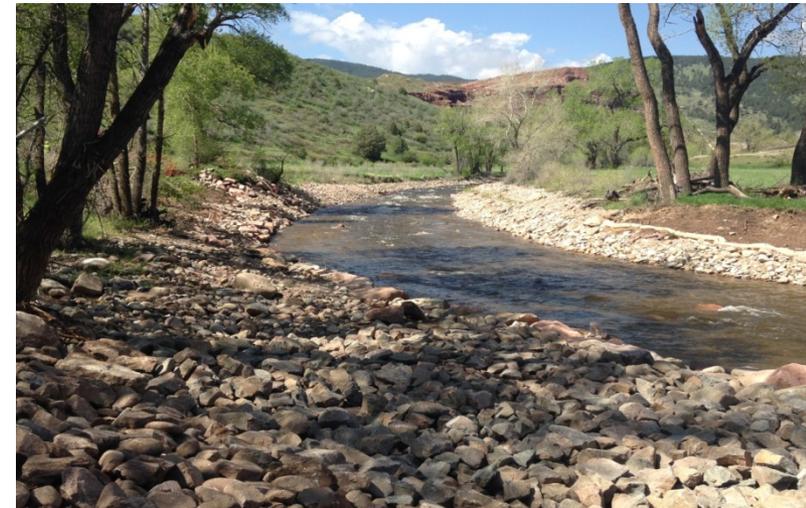
Looking Upstream: Tie -in with upstream low flow transition.

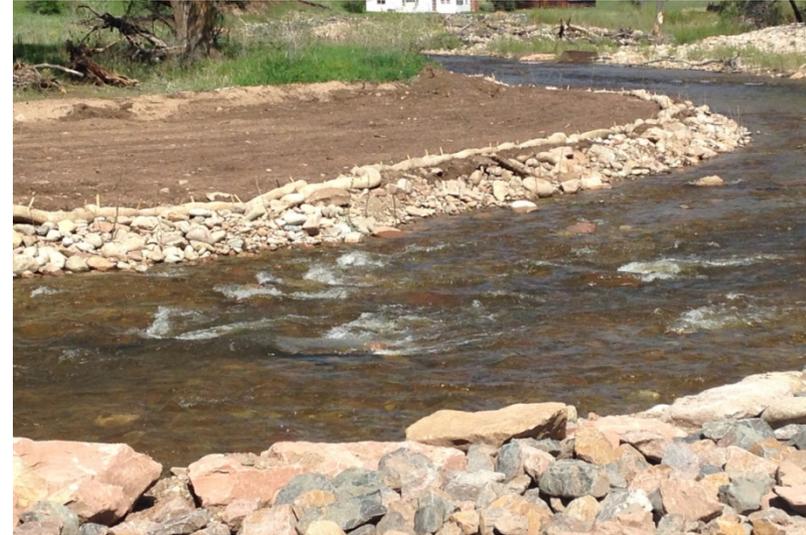
**Looking downstream: Willow installation in river left bank and boulder clusters in low flow channel.**

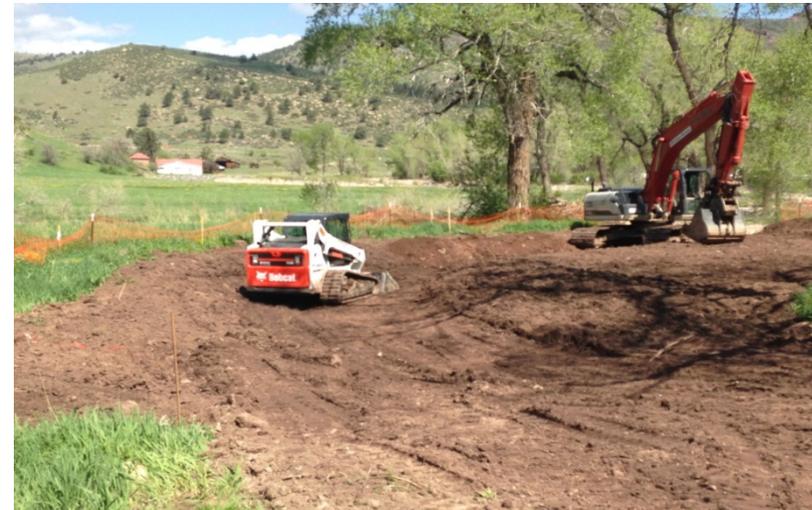
**Looking downstream: fine grading of low water crossing ditch.**

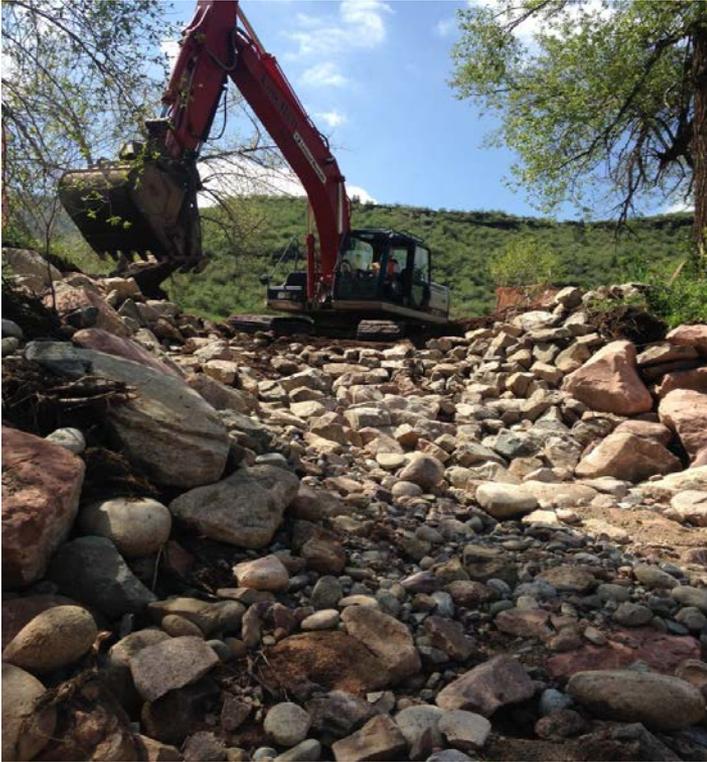
**Looking upstream: Ditch outfall.**

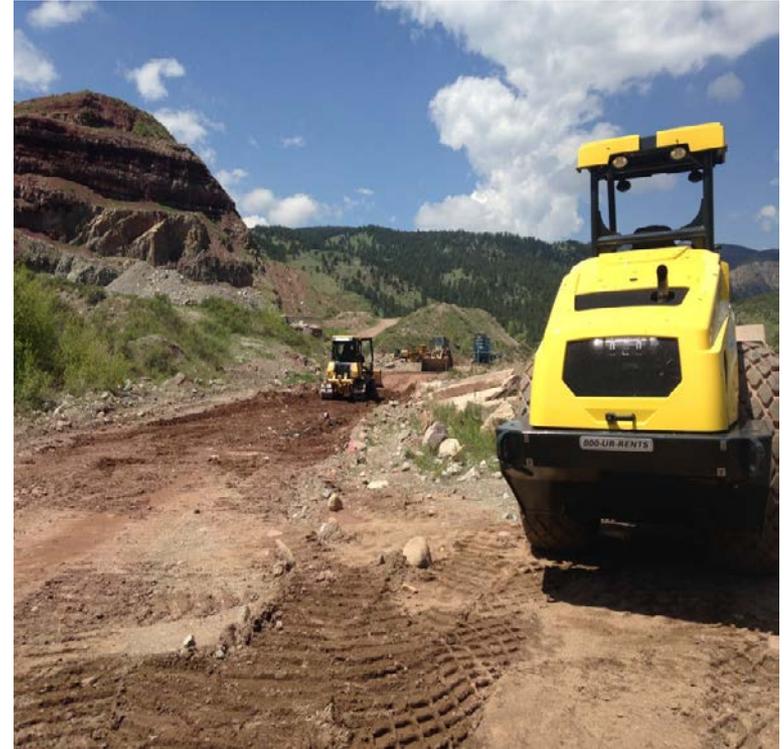
**Subgrade grading of road alignment in progress**
