# Lake 4, West Lake and A-Frame Dam Rehabilitation

## Weekly Construction Update Report

1/13/2020 to 1/17/2020

**Date:** 1/24/2020

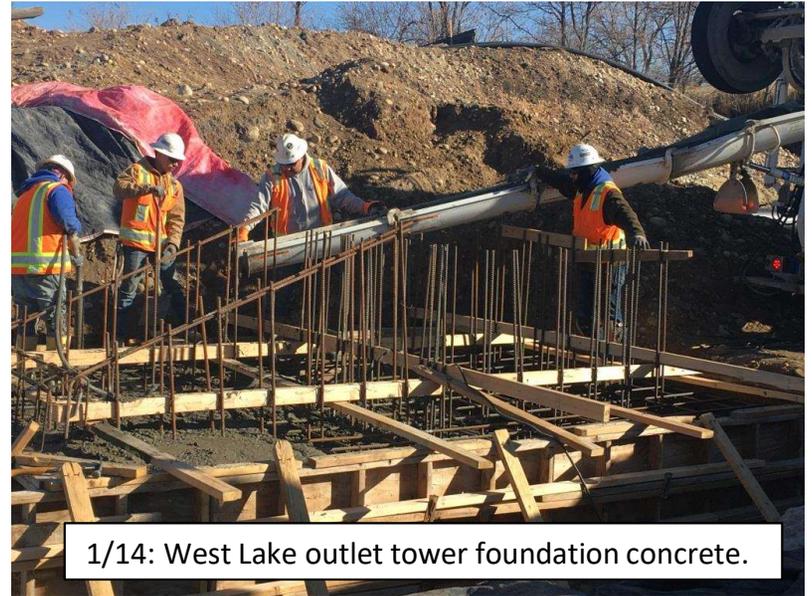
1/14: West Lake outlet tower foundation concrete.

4. The West Lake dam outlet tower foundation concrete pour occurred on Jan. 14; fusing of 20" HDPE outlet pipe started; and the final foundation prep occurred so that outlet pipe form work can start next week.

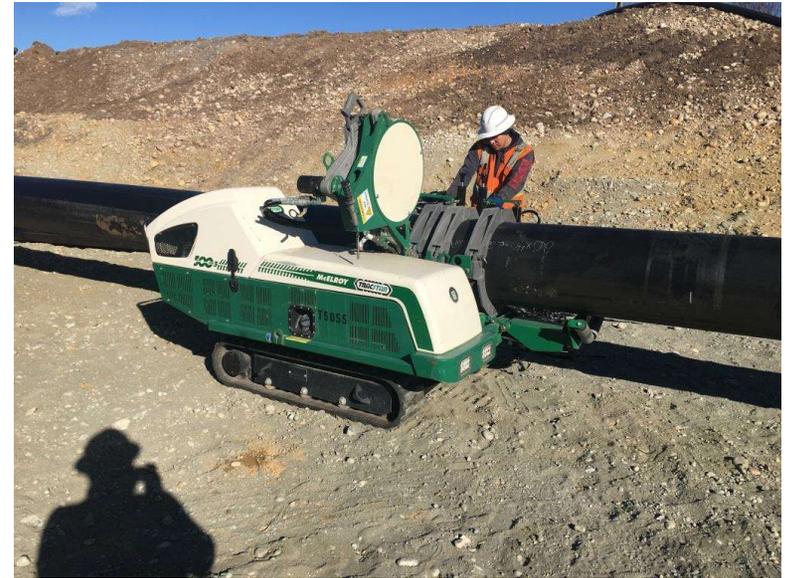
1/14: Fusing 20" HDPE outlet pipe for West Lake

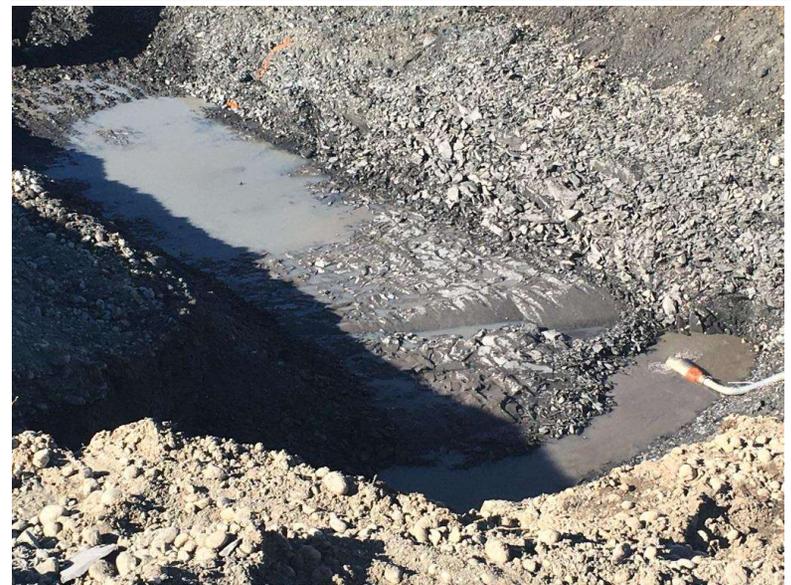
1/14: Cleaned and exposed bedrock in the sub-grade foundation just prior to placement of clay in the core of Lake 3 embankment repair

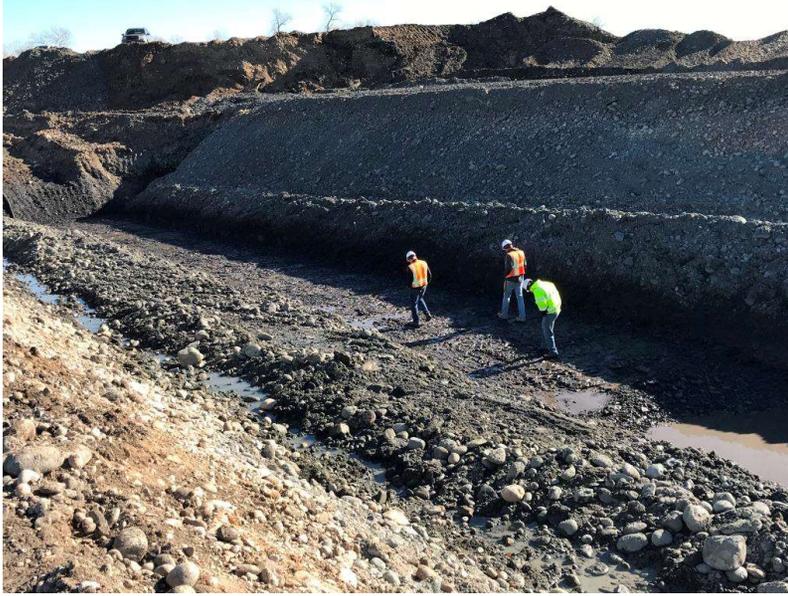
1/15: Lake 4 upstream dam (Lake 3 embankment) - bedrock foundation Inspection

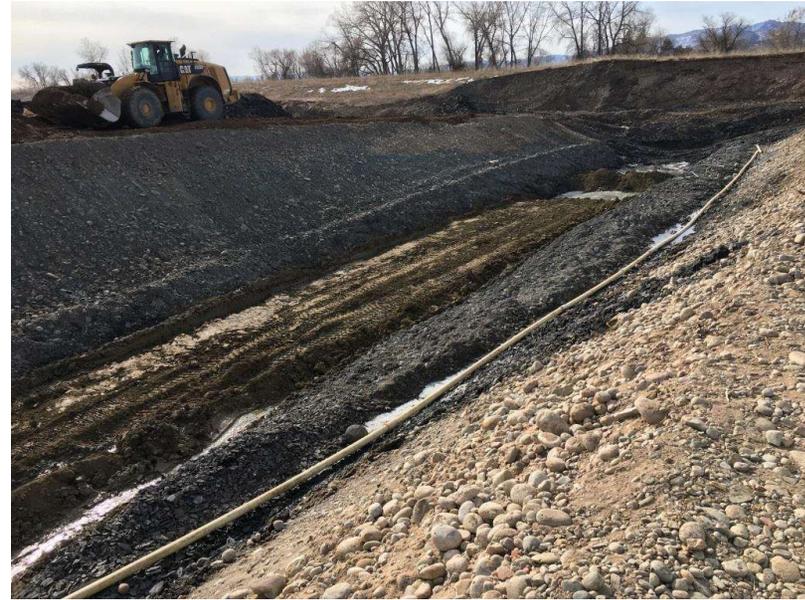
1/16: Lake 4 upstream dam (Lake 3 embankment) - first layer of clay core installation in-process

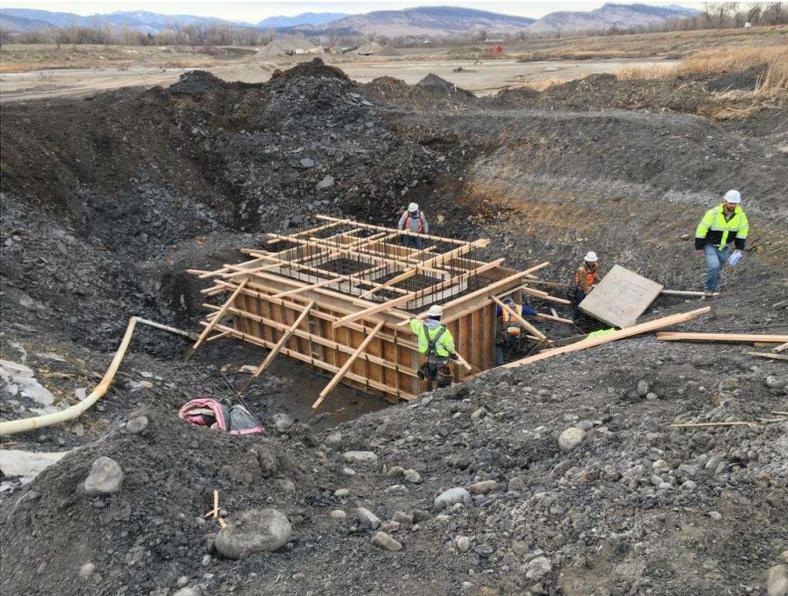
1/16: Lake 4 downstream dam – Tower 1 foundation formwork and rebar installation in-process

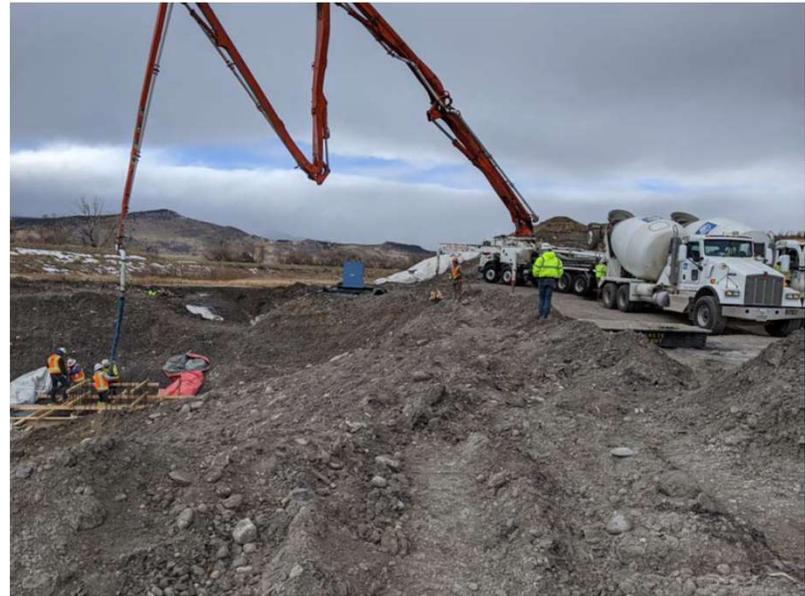
1/17: Lake 4 downstream dam – Tower 2 foundation concrete pour

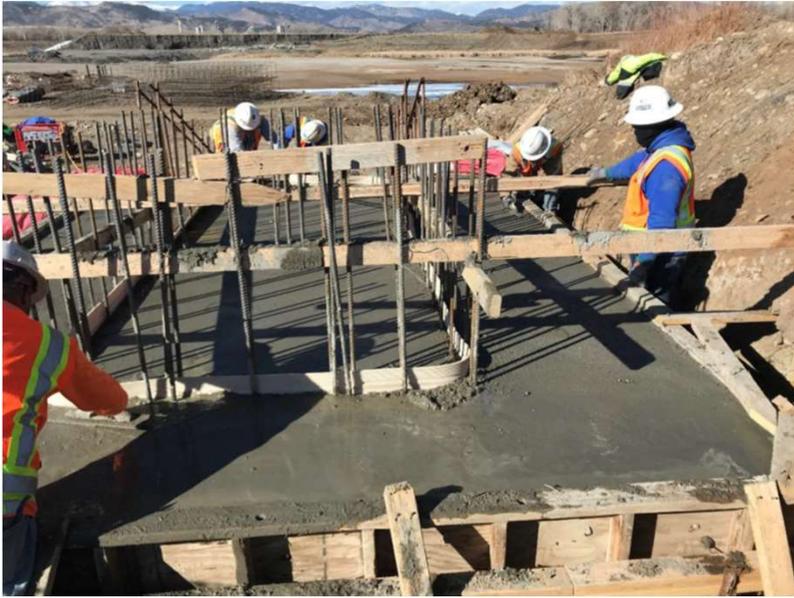
1/14: West Lake dam outlet tower foundation concrete pour - PVC waterstop added to cold joint for tower walls.

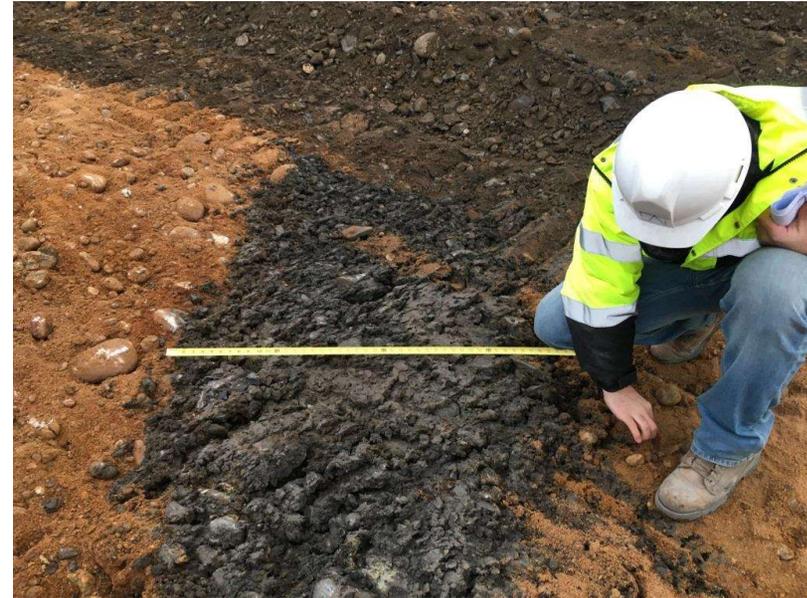
2. Lake 4 downstream embankment/dam – Tower 1 and 2 foundations were formed, tied and poured. Concrete pour occurred on Jan. 17.
3. Lake 4 dam spillway grading started on Jan. 14. Slurry wall was identified by EA.

1/16: Slurry Wall identified with-in excavation limits of Lake 4 Spillway

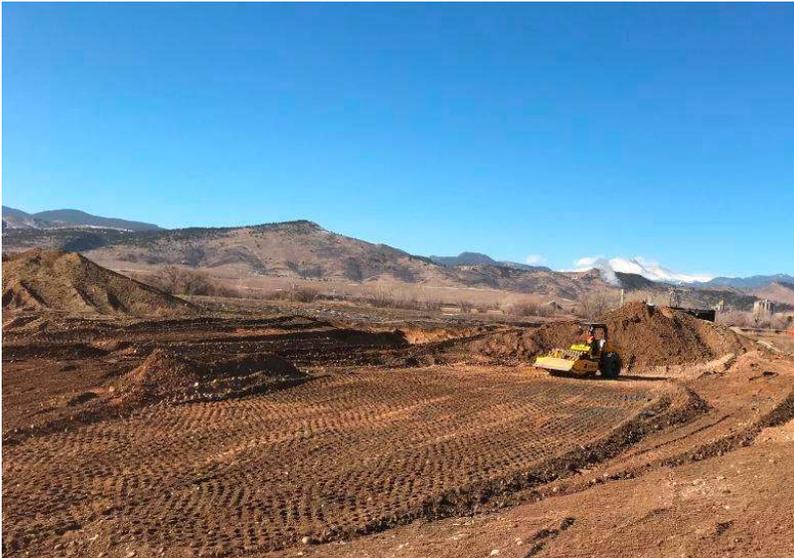
1/16: Lake 4 spillway subgrade preparation

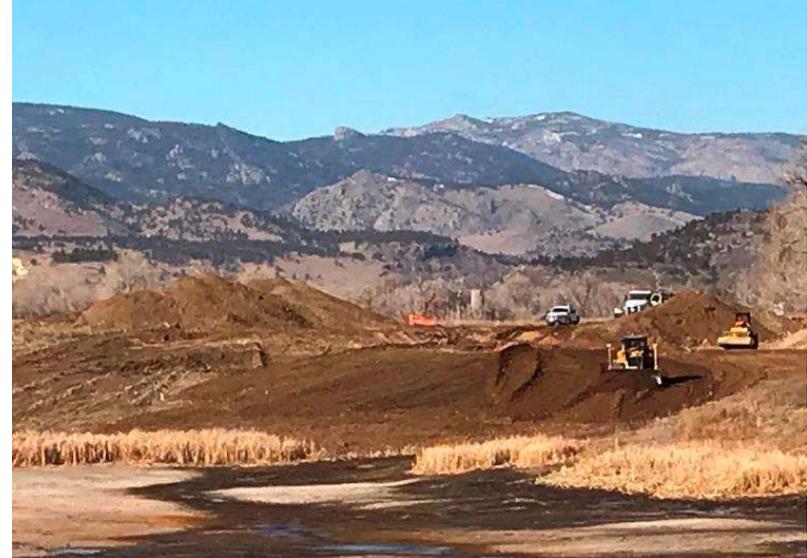
1/16 : Lake 4 spillway subgrade preparation
