# Lake 4, West Lake and A-Frame Dam Rehabilitation

## Weekly Construction Update Report

**Date:** 1/27/2020

1/20/2020 to 1/24/2020

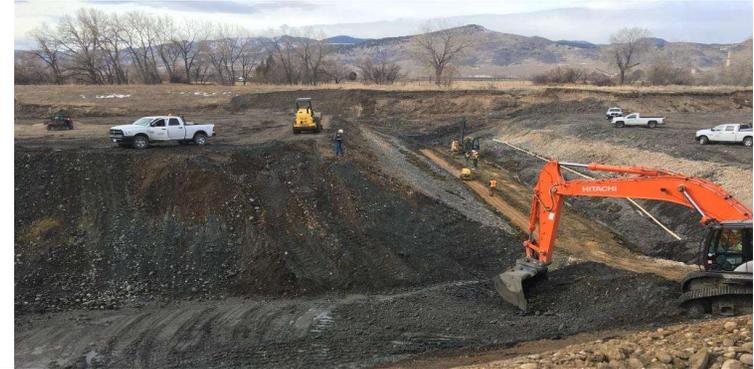
1/21: Lake 4 upstream dam (Lake 3 embankment) looking south – sub-grade excavation and placement of filter sand and clay core

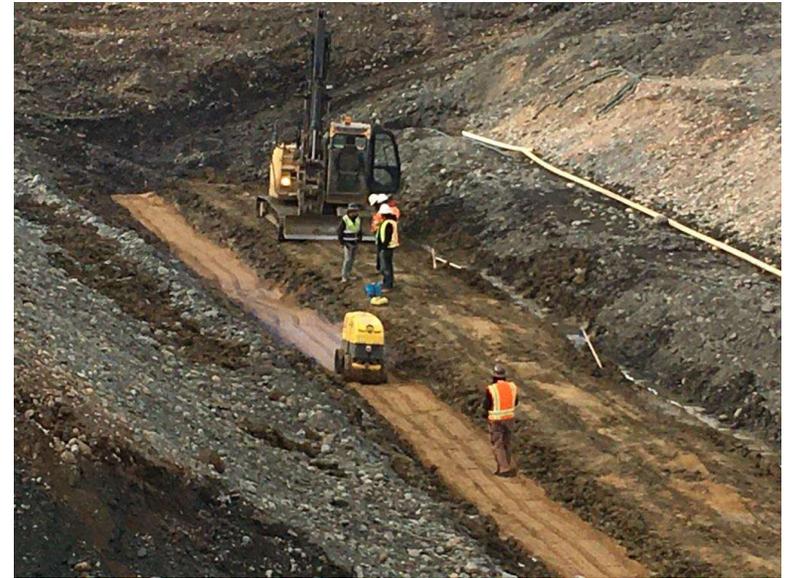
1/21: Lake 4 upstream dam (Lake 3 embankment) - placement of filter sand and clay core in foundation

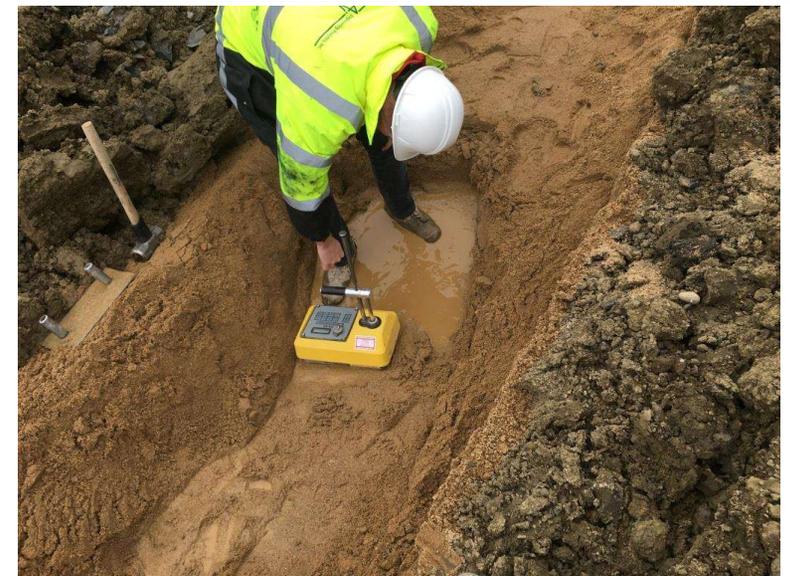
1/21: Lake 4 upstream dam (Lake 3 embankment) - Quality Assurance testing the filter sand within the dam after compaction

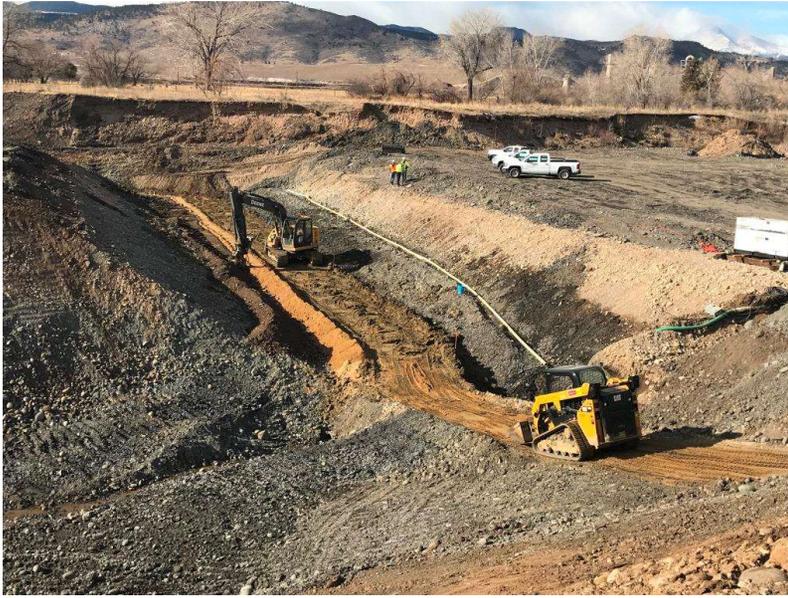
1/23: Lake 4 upstream dam (Lake 3 embankment) - Zoned material placement

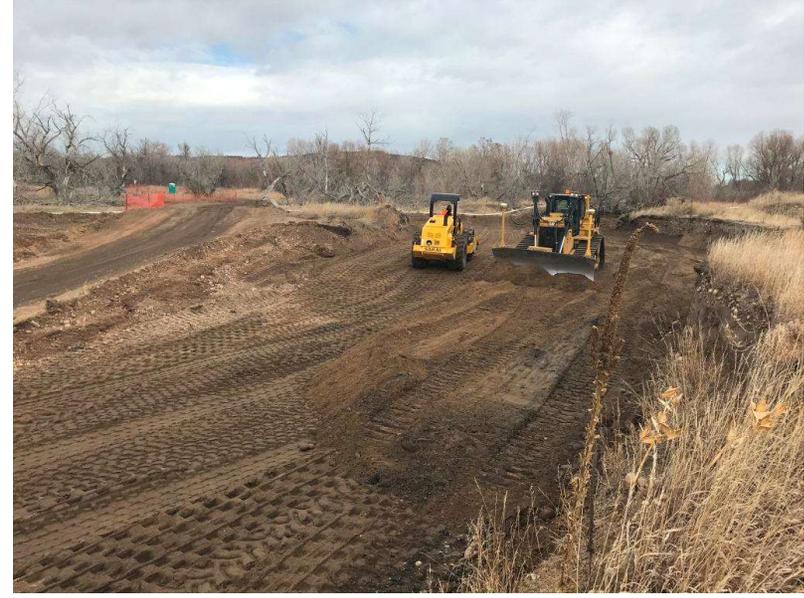
1/23: Clough and True Ditch reconstruction

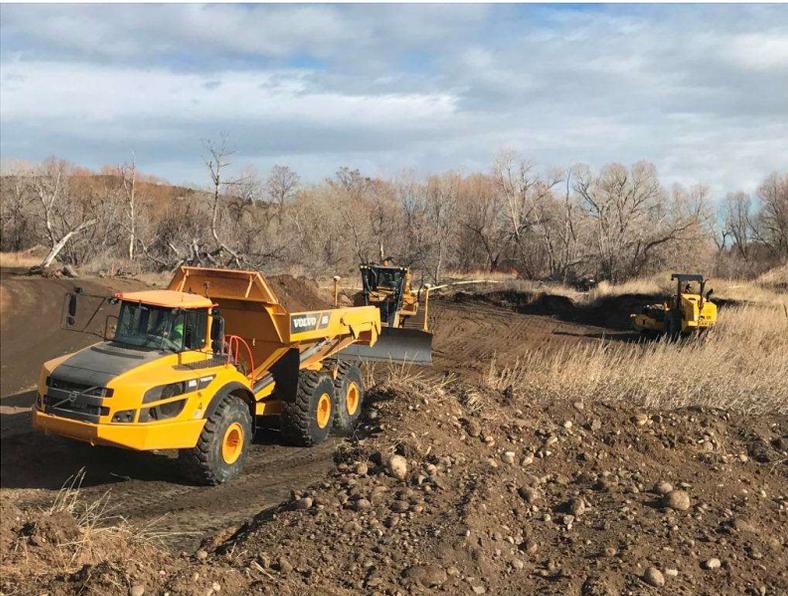
1/23: Clough and True Ditch reconstruction – fill from Lake 4 flood sediment

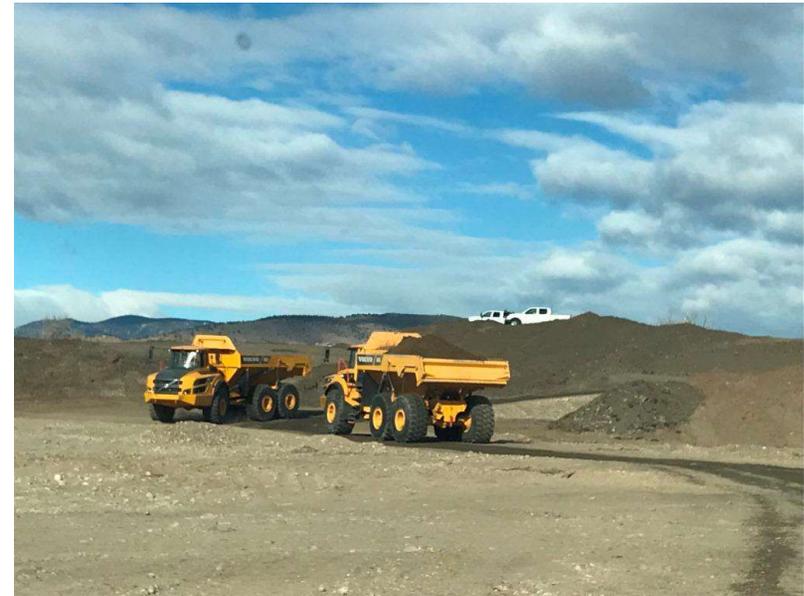
1/23: Hauling Lake 4 flood sediment from Lake bottom to Clough and True Ditch reconstruction
