# Lake 4, West Lake and A-Frame Dam Rehabilitation

## Weekly Construction Update Report

**Date:** 2/4/2020

1/27/2020 to 1/31/2020

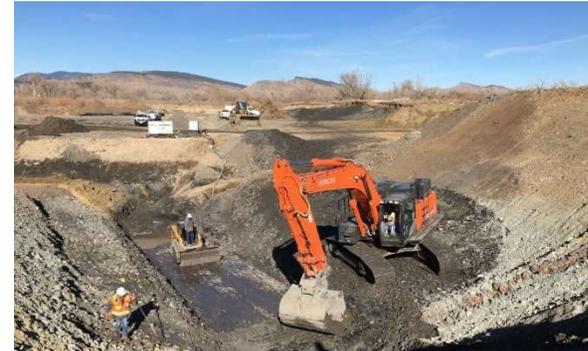
1/28: Lake 4 upstream dam (Lake 3 embankment) looking west – the excavation of sub-grade to bedrock on northside of embankment

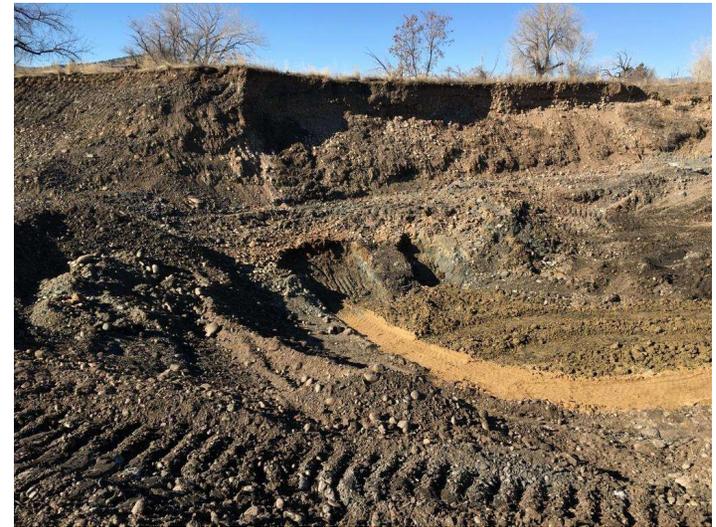
1/28: Lake 3 embankment - initial clay core tie-in to the slurry wall on southside of embankment

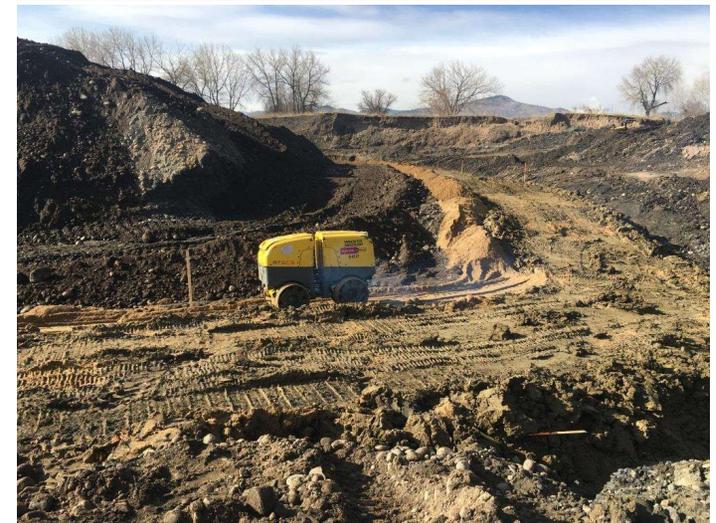
1/30: Lake 3 embankment - Remote mini-compactator compacting the filter sand on northside of embankment.

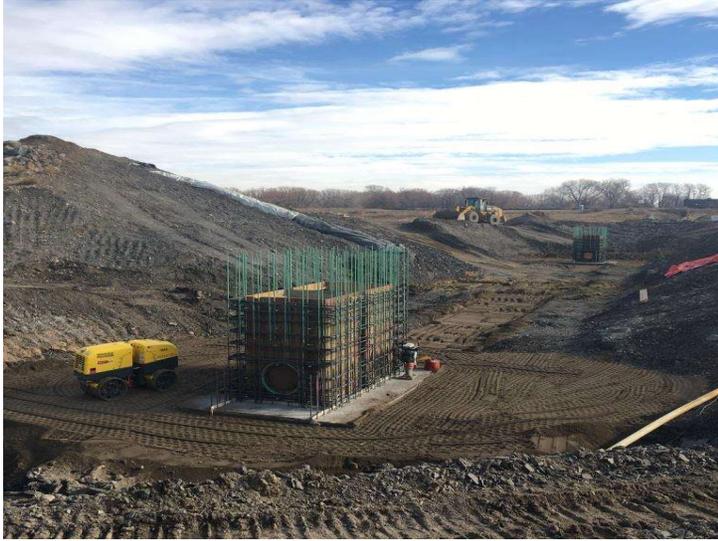
1/30: Lake 4 downstream dam – looking east at Tower 2 and Tower 1 backfill, sub-grade and formwork/rebar.

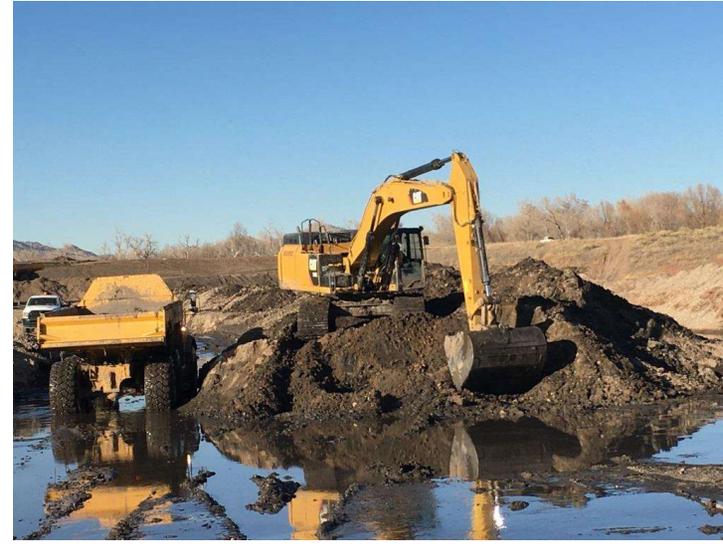
1/28: Lake 4 flood sediment removal - loading a haul truck with material from the sediment disposition area.

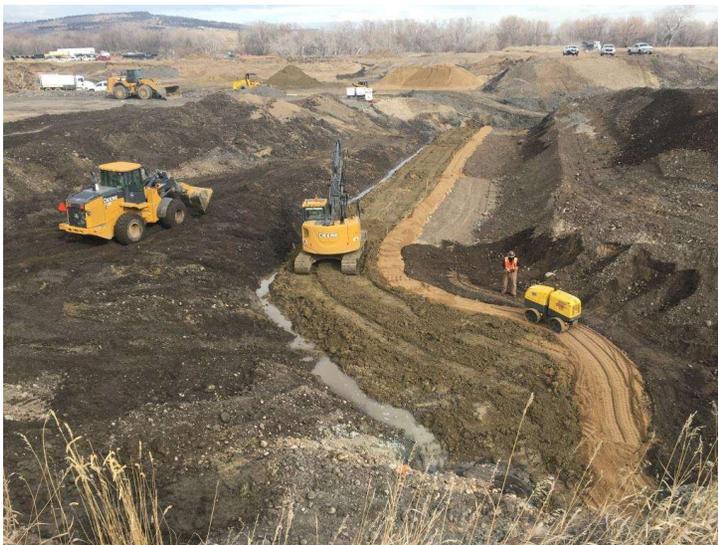
1/29: Lake 3 embankment – zone embankment repair from the southside of embankment looking north.

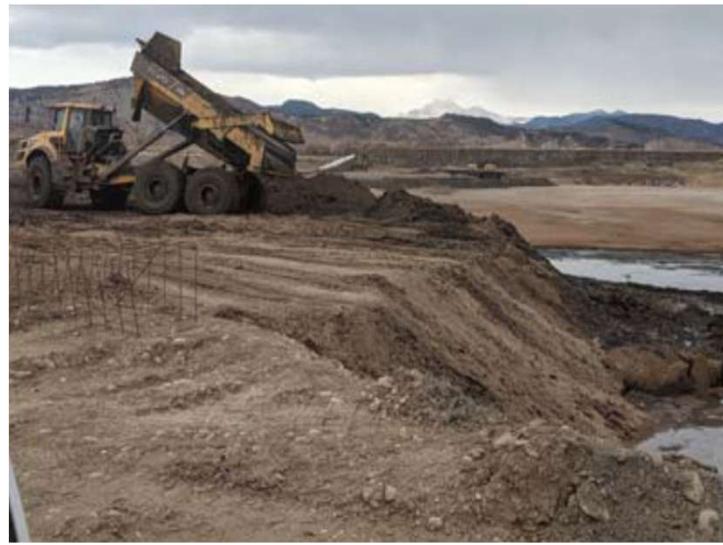
1/28: Lake 4 flood sediment - disposal of material into the disposal area within West Lake.

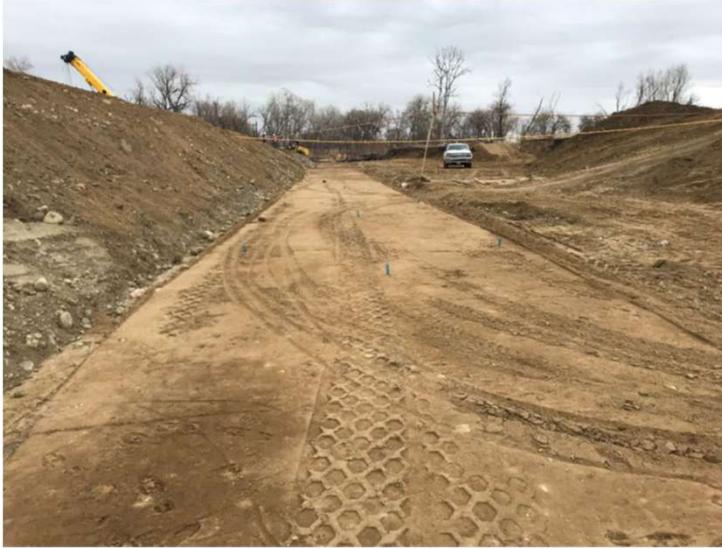
1/27: A-Frame outlet box culvert alignment subgrade. Looking to the east.

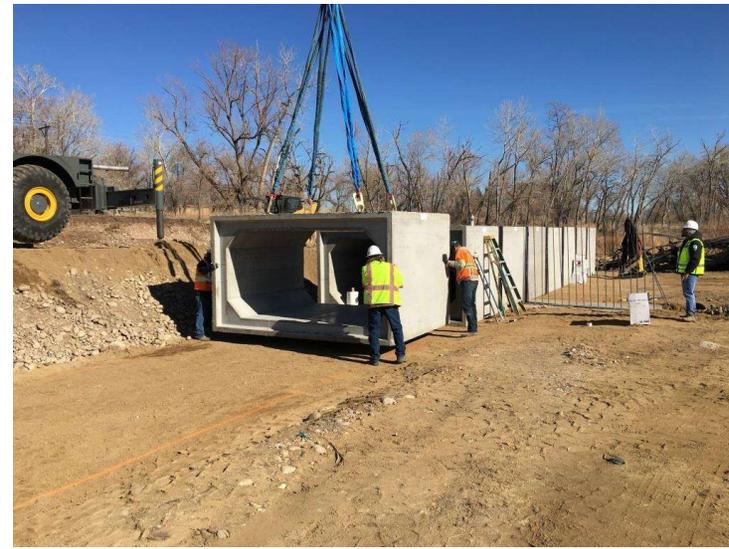
1/28: A-Frame outlet box culvert placement. Looking to the east.

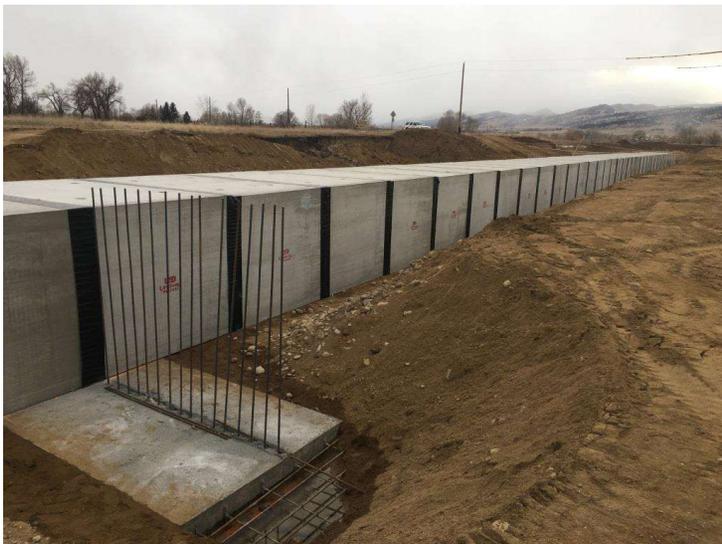
1/30: A-Frame outlet box culvert alignment. Culvert box sitting on cut-off wall foundation. Looking to the west.

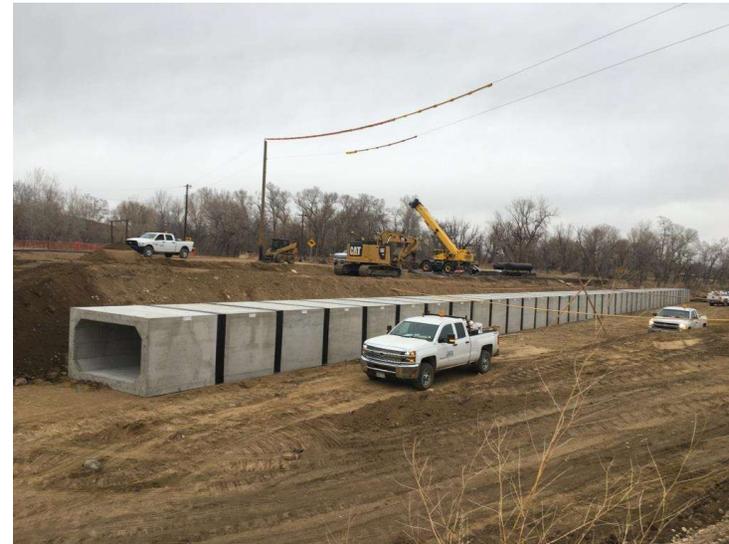
1/16 : A-Frame complete outlet box culvert alignment. Looking to the northeast.
