Lake 4, West Lake and A-Frame Dam Rehabilitation

Weekly Construction Update Report

Date: 3/19/2020

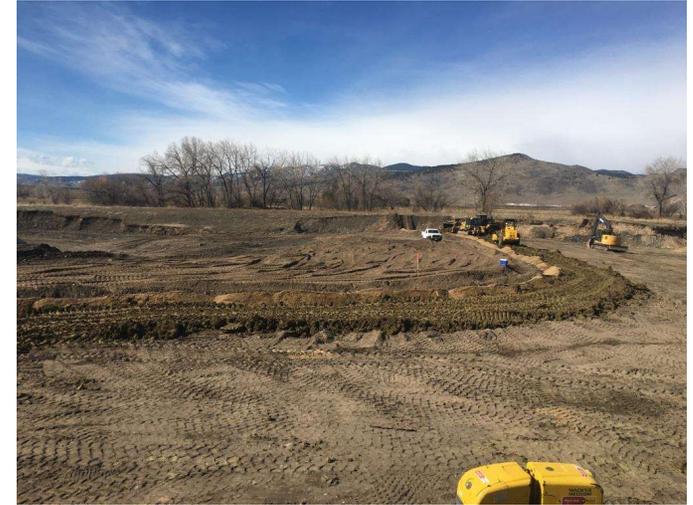
3/10: Lake 4 upstream embankment reconstruction – zone 1, Clay core and zone 3 filter sand installation.

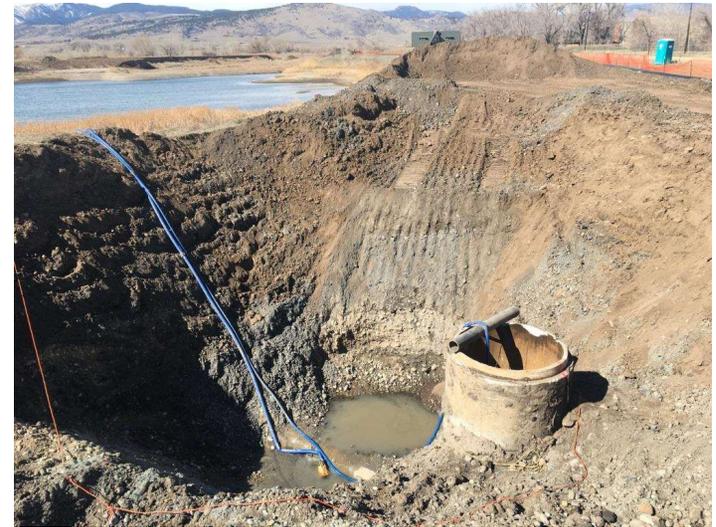
3/10: Lake 4 Outlet Pipeline – excavation of manhole #4. Existing outlet pipe identified.

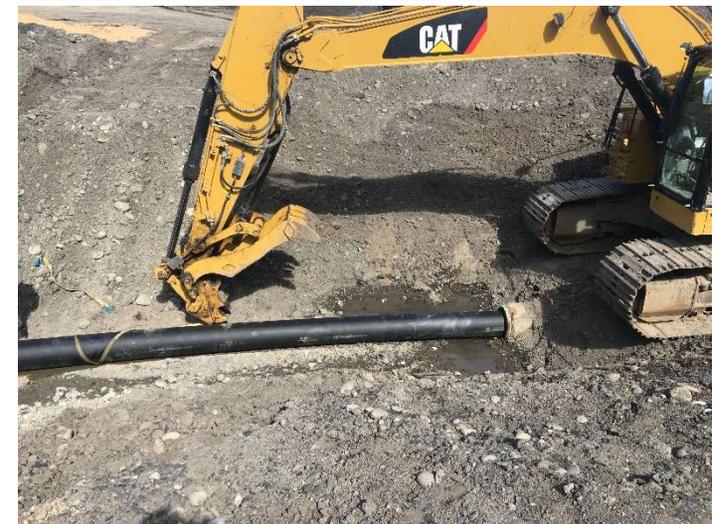
3/11: Lake 4 Outlet Pipeline – Slip lining new 14" HDPE pipe inside the existing RCP outlet pipe from Lake 4 tower 2 to expected location of manhole #1.

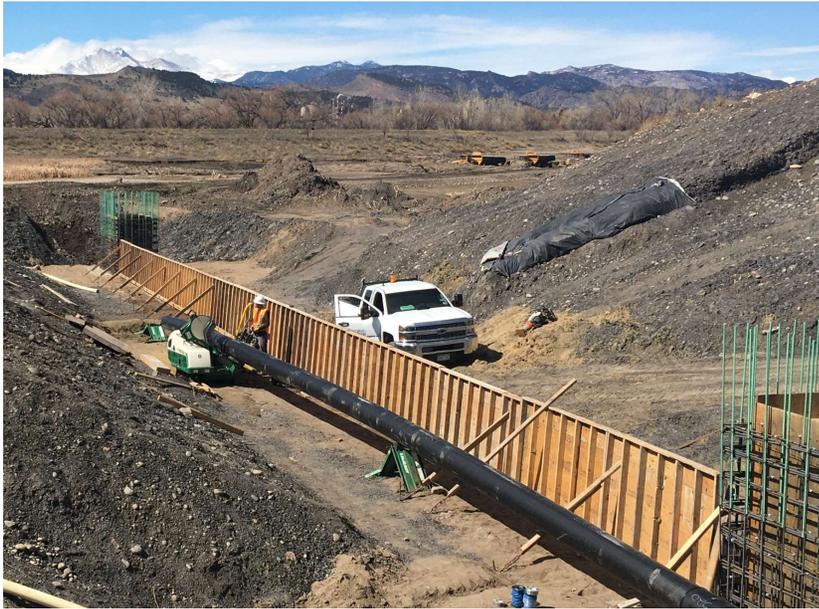
3/11: Lake 4 Outlet Pipeline – Fusing/welding the new 14”HDPE replacement pipe prior to slip lining.

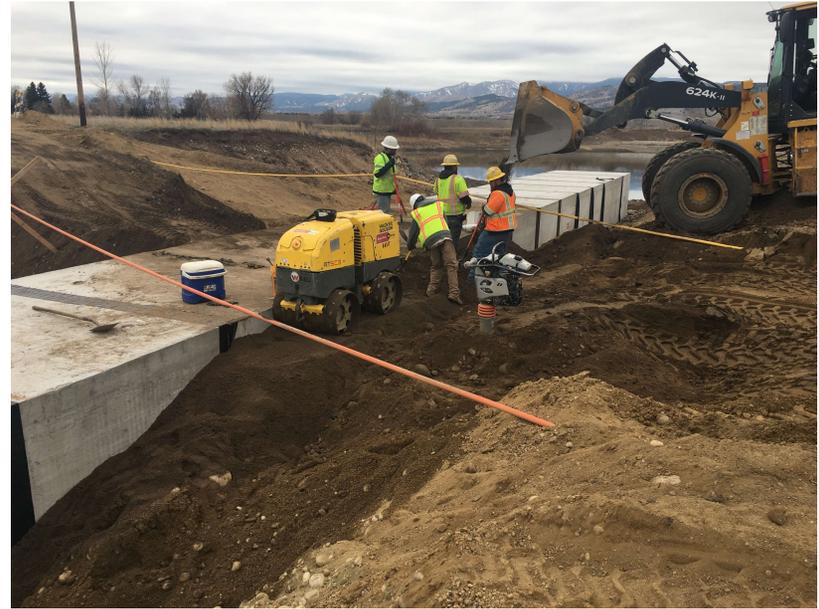
3/12: A-Frame- Backfilling the outlet box culvert with the N.61st street road prism in compacted lifts.

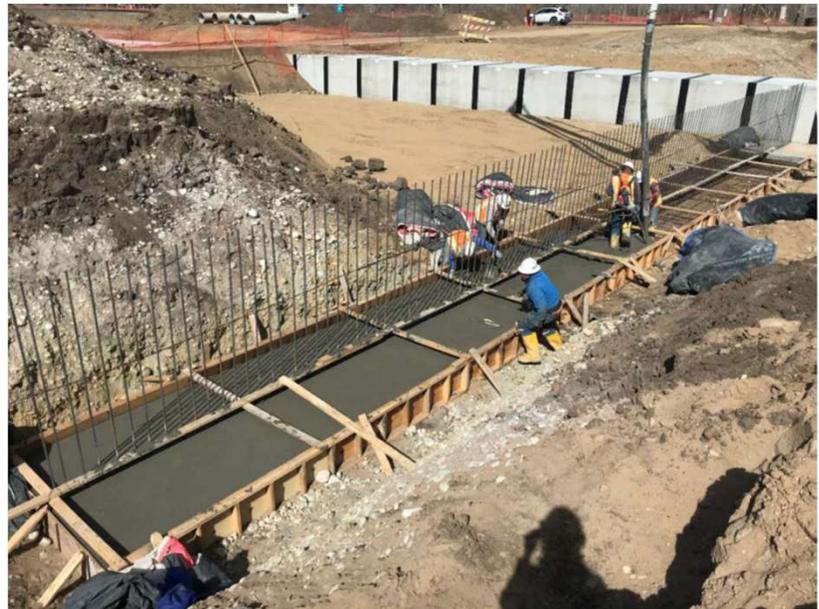
3/11: A-Frame: Pouring concrete in the cutoff wall foundations.

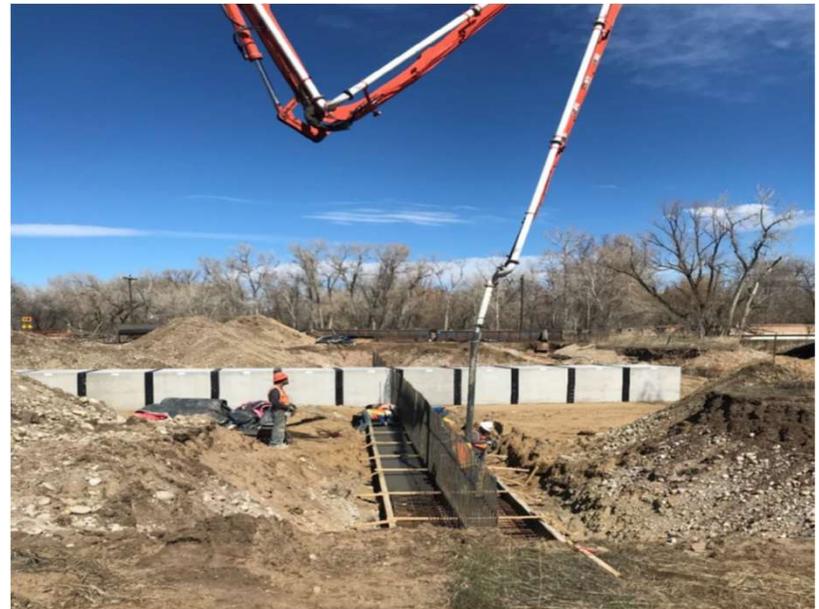
3/11: A-Frame: Pouring concrete in the cutoff wall foundations

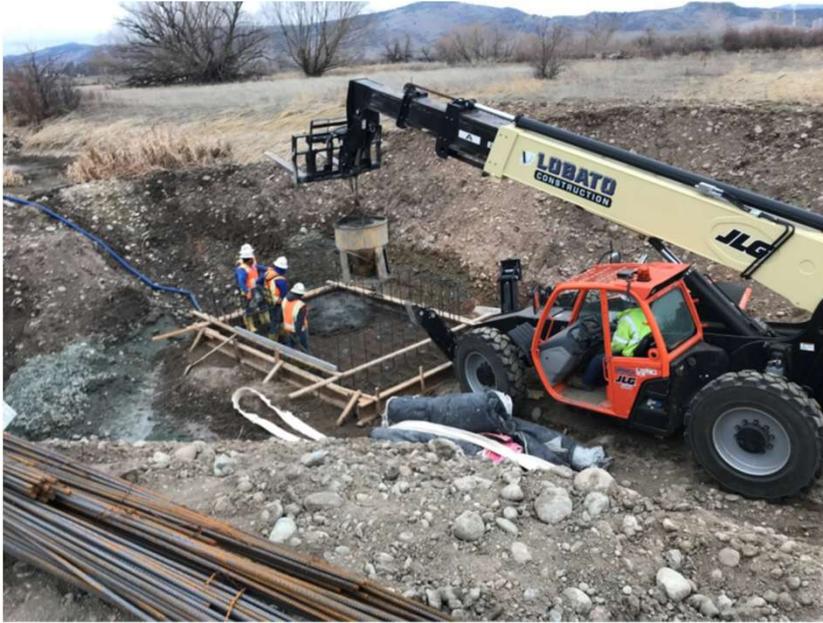
3/13: West Lake – Pouring concrete in the Foothills Outlet Ditch siphon inlet foundation slab.

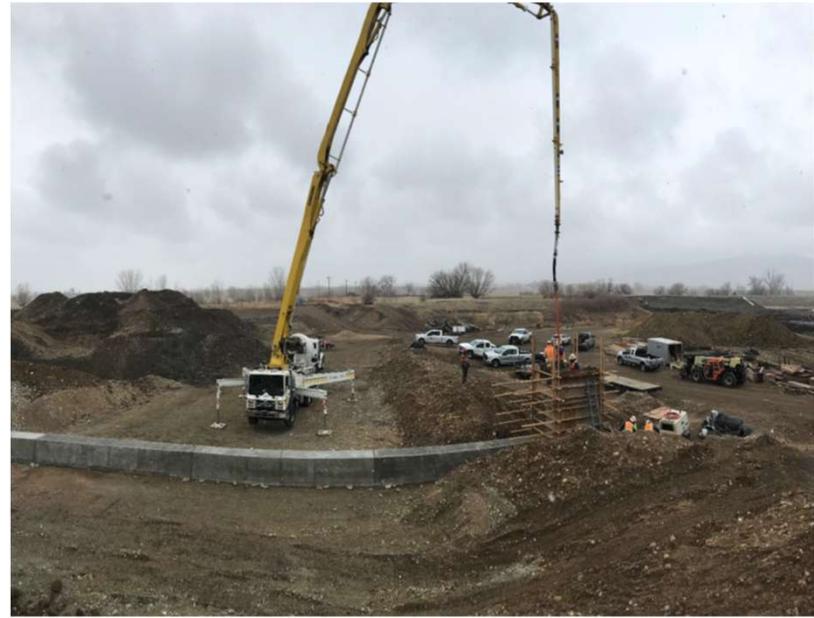
3/13: West Lake – Pump truck pouring concrete in the walls of West Lake outlet tower.

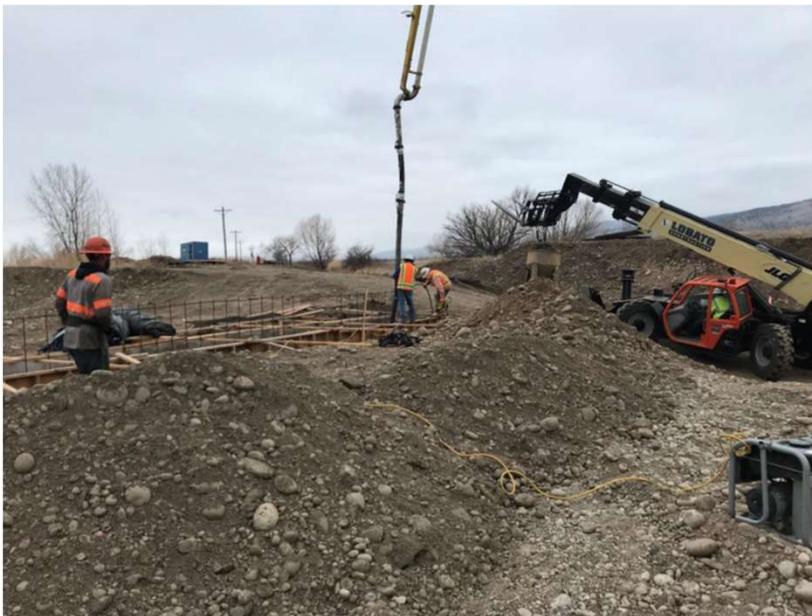
3/13: West Lake –Pouring the Clough & True Ditch outlet footer slab.

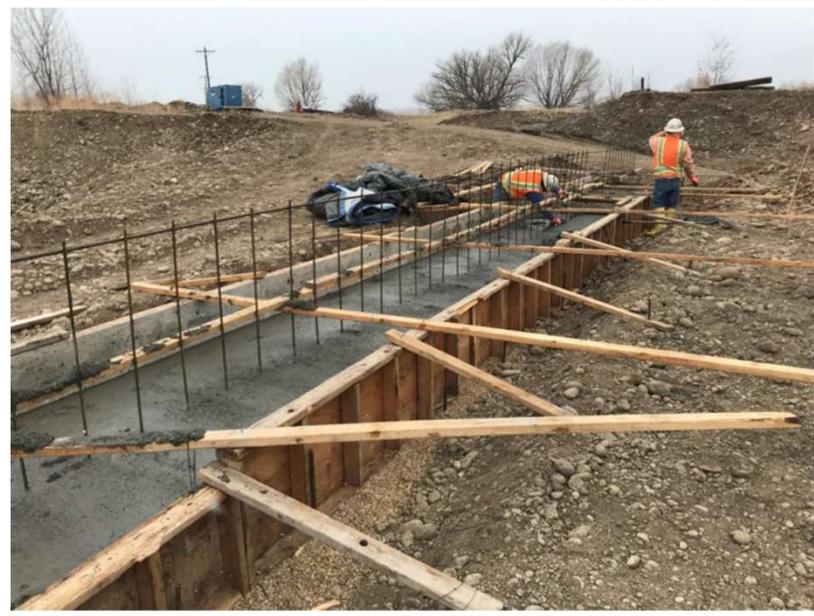
3/13: West Lake - Finishing the Clough & True Ditch outlet footer slab.
