# Lake 4, West Lake and A-Frame Dam Rehabilitation Project

## Weekly Construction Update Report

4/6/2020 to 4/10/2020

**Date:** 4/16/2020

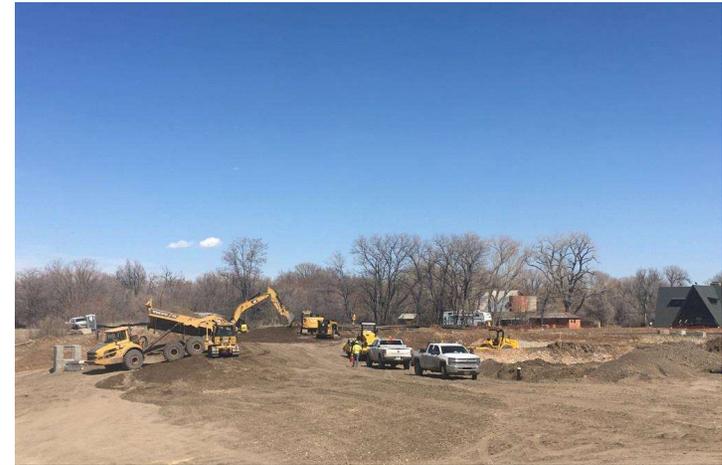
4/6: West Lake Dam – embankment reconstruction. Looking north from the south limits of the embankment repair.

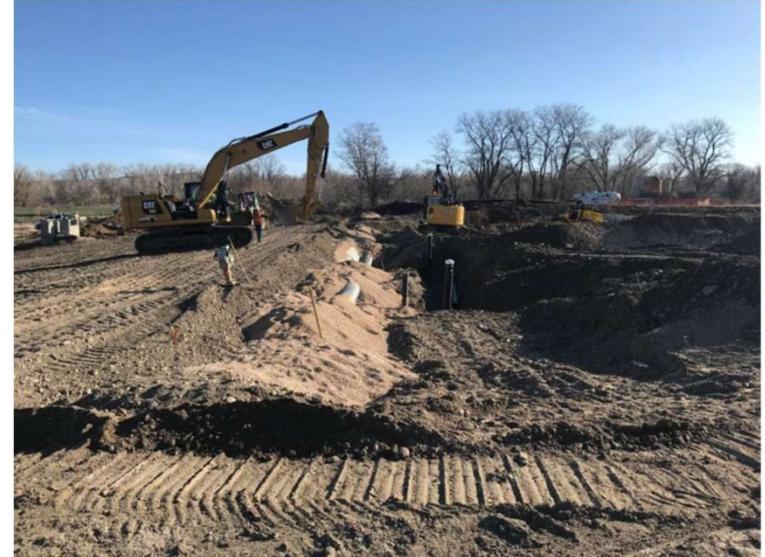
4/6: West Lake Dam – looking north at the backfilling around the Foothills Outlet Ditch and Clough and True Ditch inverted siphon pipes.

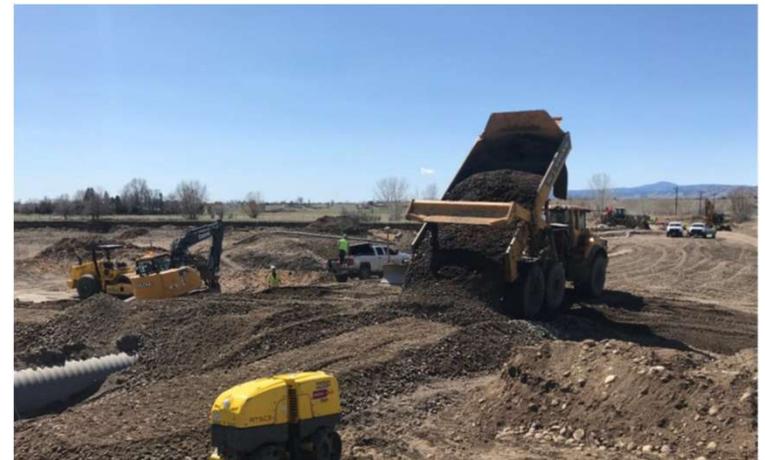
4/6: West Lake Dam – looking south. Unloading 3” minus material on dam for siphon pipe backfill near Foothills Outlet Ditch outlet structure.

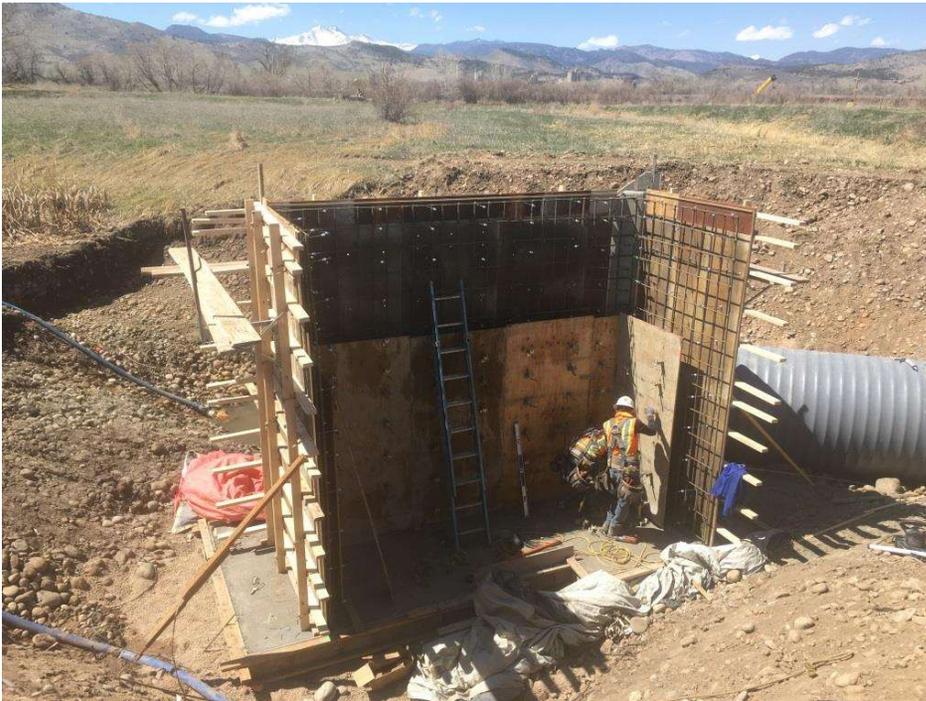
4/7: West Lake Dam – Installing formworks and rebar on the Foothills Outlet Ditch inlet structure wingwalls.

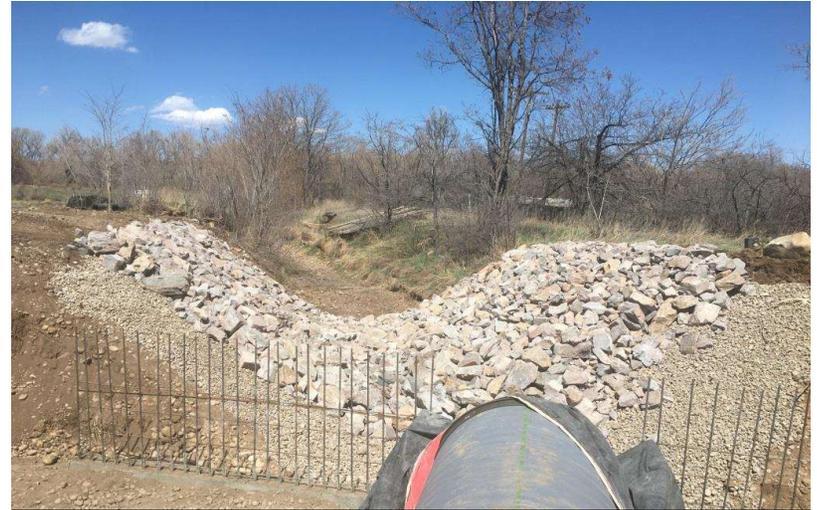
4/7: West Lake Dam – riprap and bedding placement at Foothills Outlet Ditch outlet in the ditch channel.

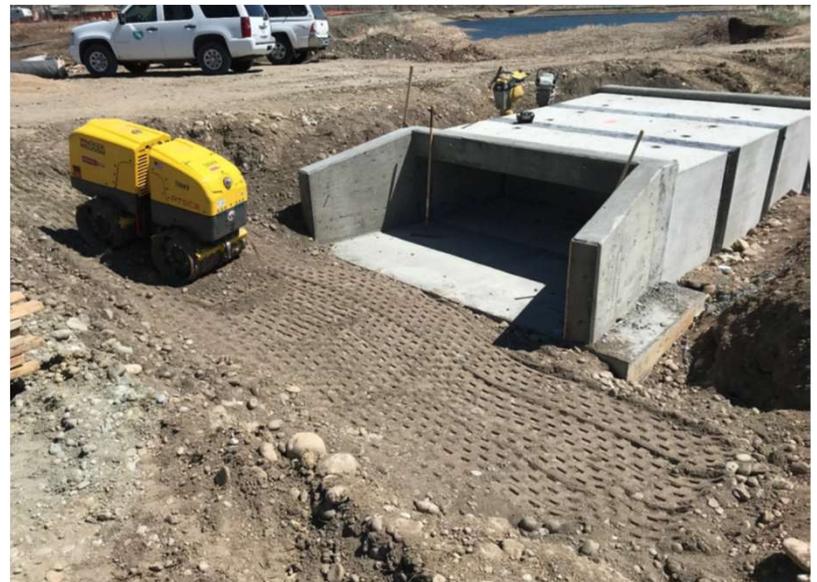
4/7: West Lake Dam – backfilling around the South Branch Ditch crossing box culvert and wingwalls.

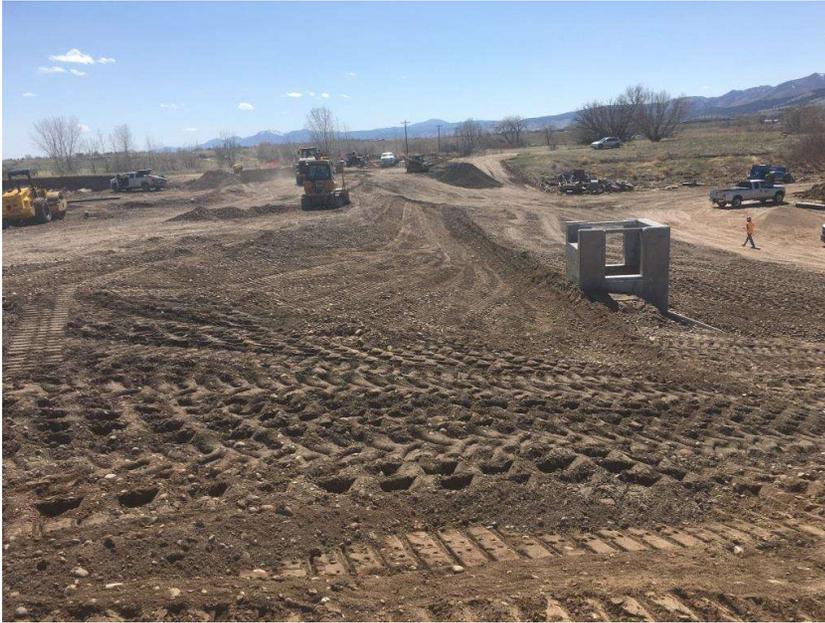
4/7: West Lake Dam - looking south at final embankment grading.

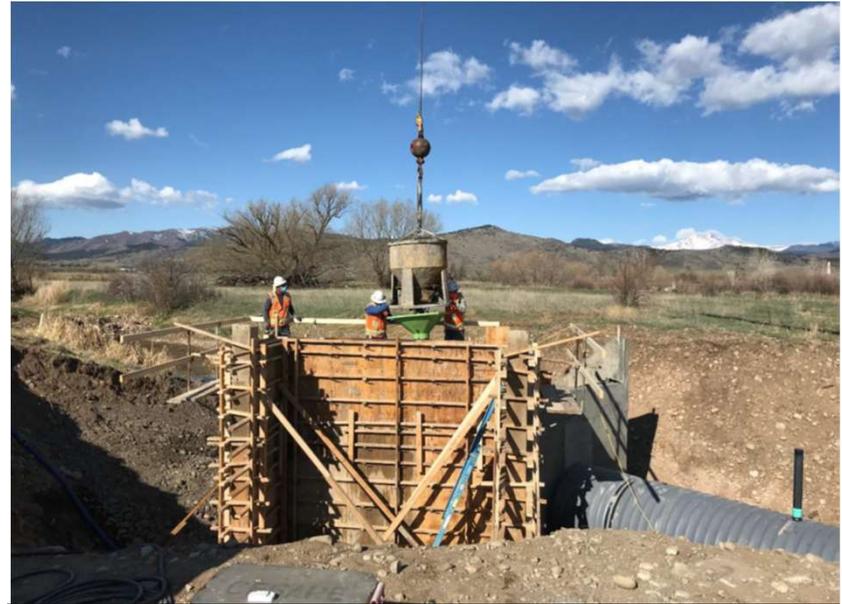
4/8: West Lake Dam - placing concrete in the Foothills Outlet Ditch inlet wingwall structure.

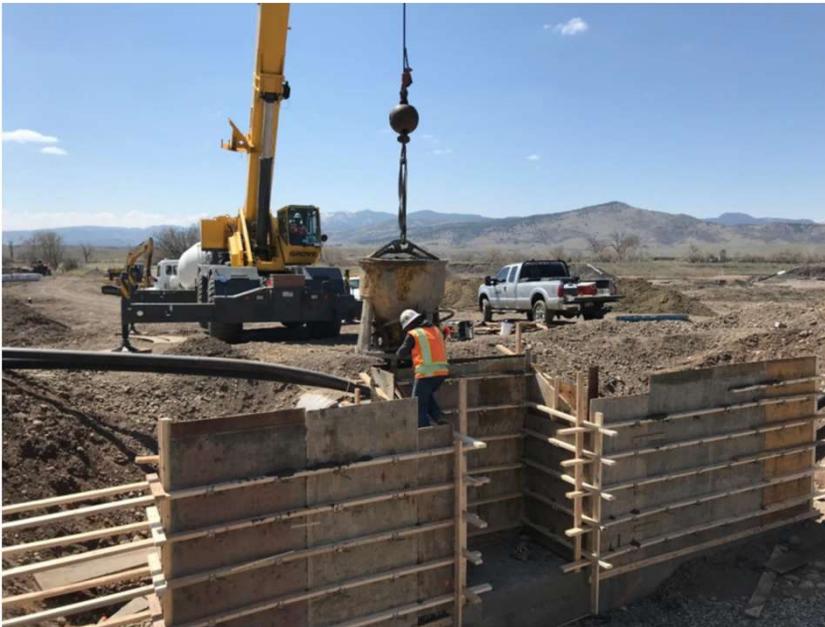
4/9: West Lake Dam - placing concrete in the Foothills Outlet Ditch outlet structure.

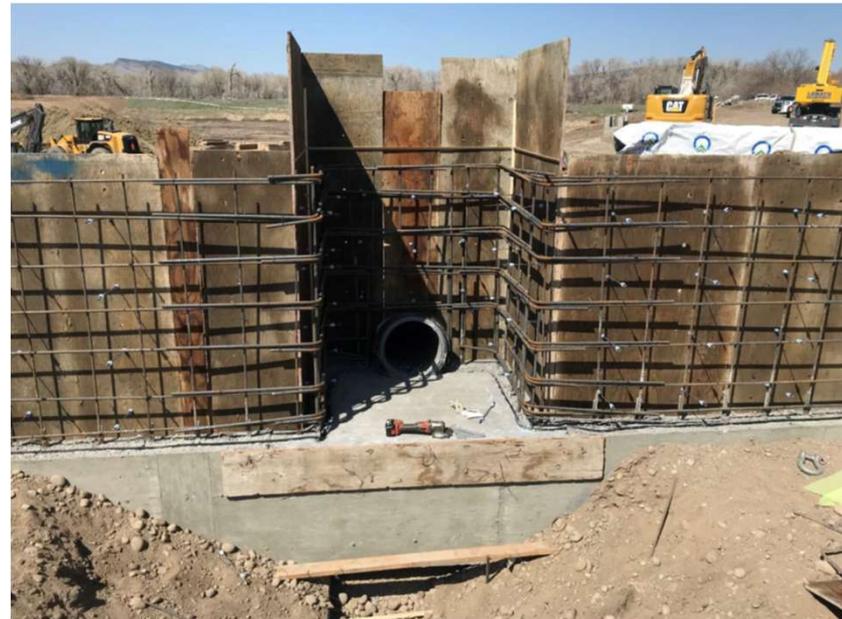
4/9: West Lake Dam – formworks and rebar in the Clough and True Ditch outlet structure.

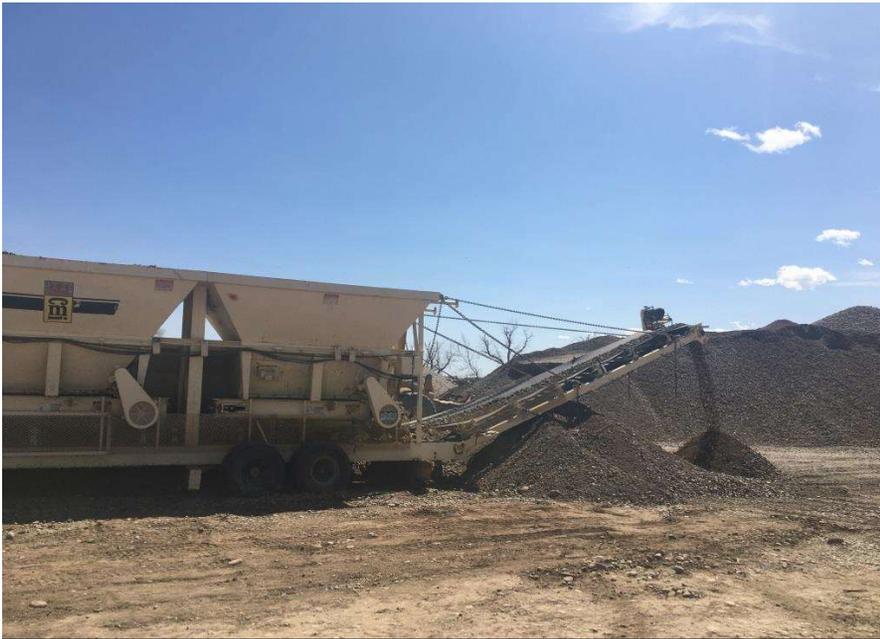
4/6: Riprap bedding bleeding operation in Lake 4 staging area.

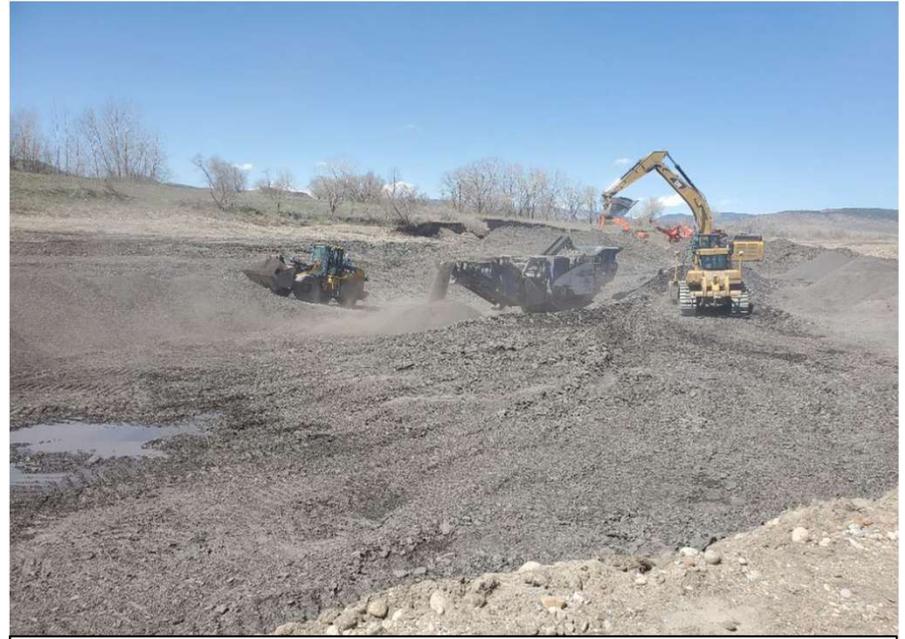
4/7: Lake 4 – claystone/bedrock crushing operation to make ¾" minus embankment fill in the Lake 4 sediment removal area.

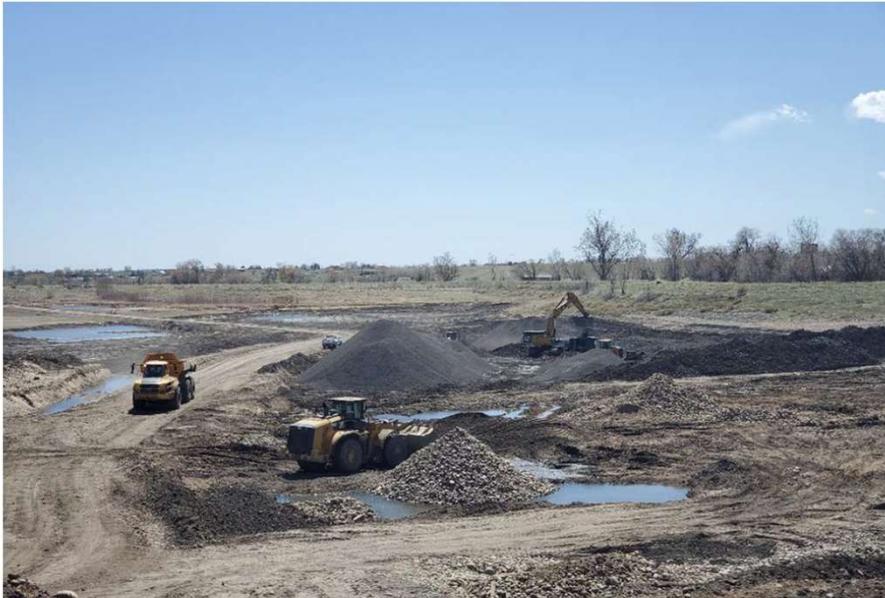
3/30: Lake 4 – overview of claystone/bedrock crushing operation to make ¾" minus embankment fill in the Lake 4 sediment removal area.

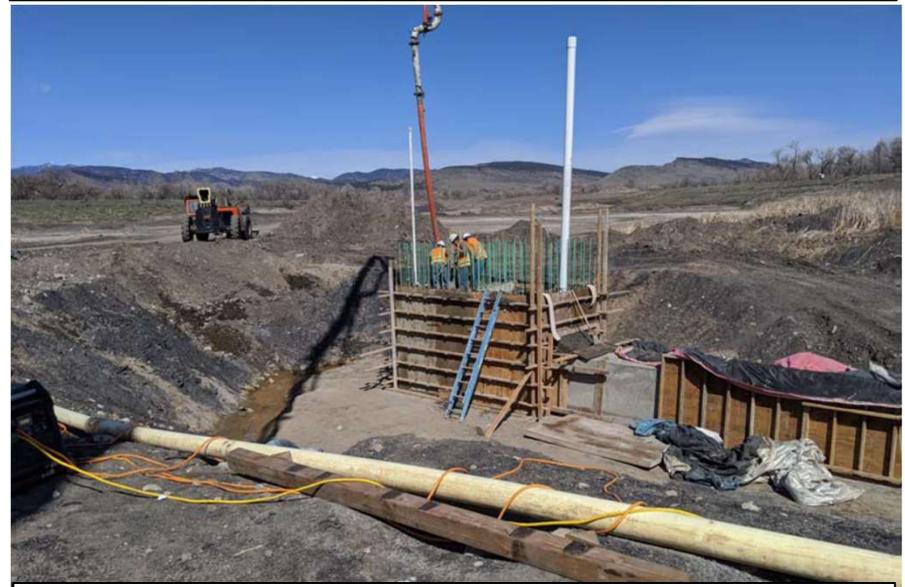
4/6 – Lake 4 Dam – placing concrete outlet tower #1.
