Lake 4, West Lake and A-Frame Dam Rehabilitation Project

Weekly Construction Update Report

Date: 4/9/2020

3/30/2020 to 4/3/2020

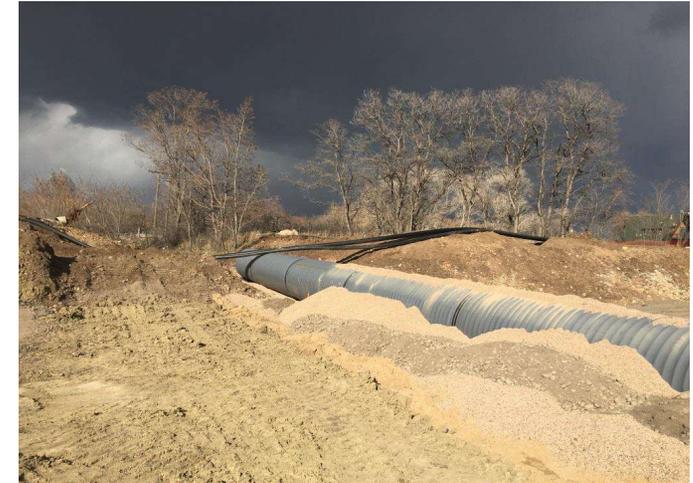
3/30: West Lake Dam – installation of Foothills Outlet Ditch 60" inverted siphon pipe within the dam embankment. Looking north towards siphon outlet into the ditch.

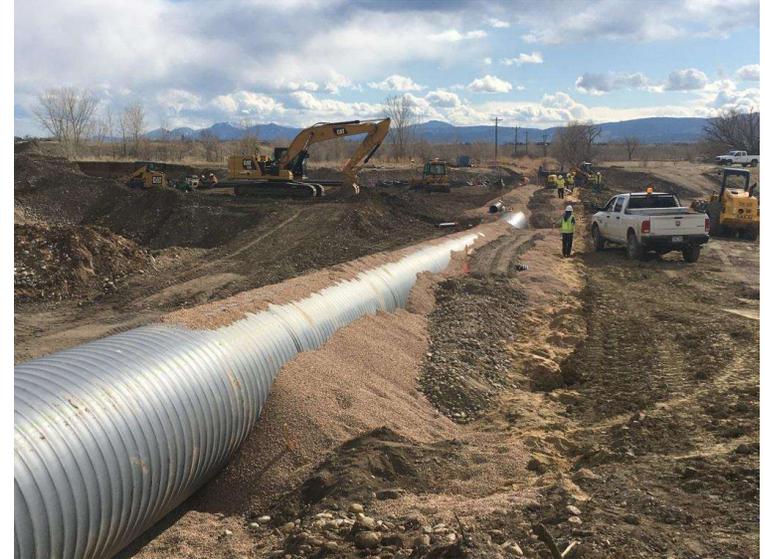
3/30: West Lake Dam – looking south at the installation of the Foothills Outlet Ditch 60” inverted siphon pipe and the Clough and True Ditch 18” inverted siphon pipe.

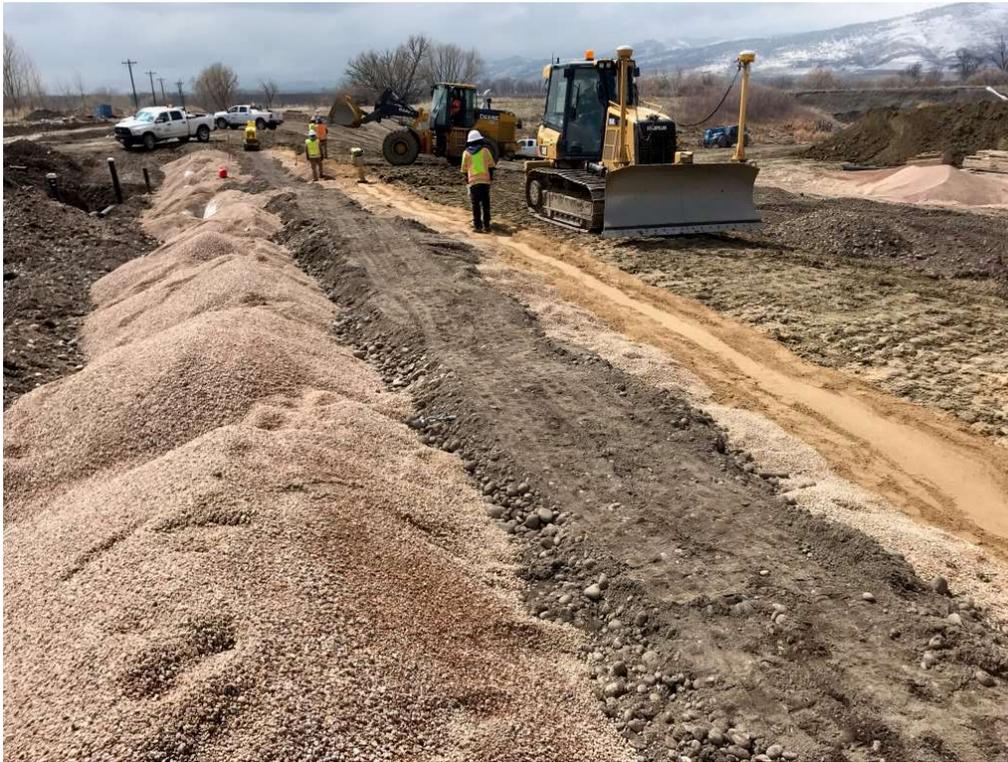
4/3: West Lake Dam – Looking south at the zoned embankment reconstruction around the two inverted siphon pipes; left to right - #8 coarse aggregate pipe encasement, 3" minus native embankment fill, #8 coarse aggregate, C33 fine aggregate, clay core, 3" minus native embankment fill.

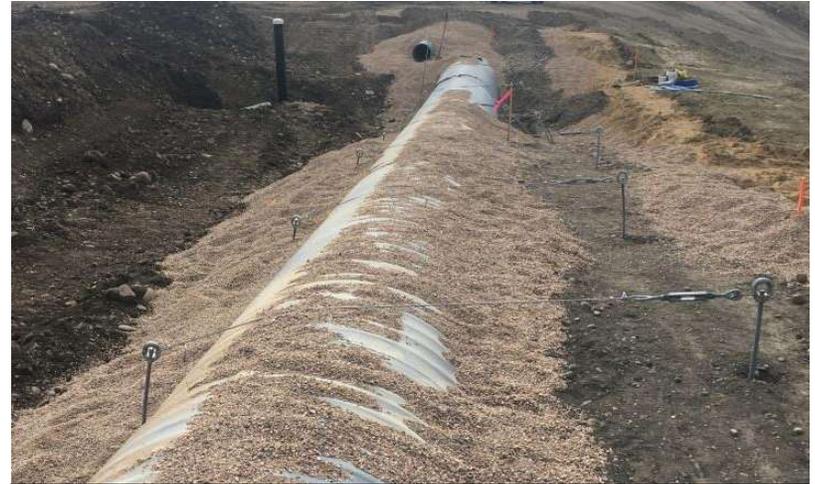
4/1: West Lake Dam – anchors around the Foothills Outlet Ditch 60" inverted siphon pipe.

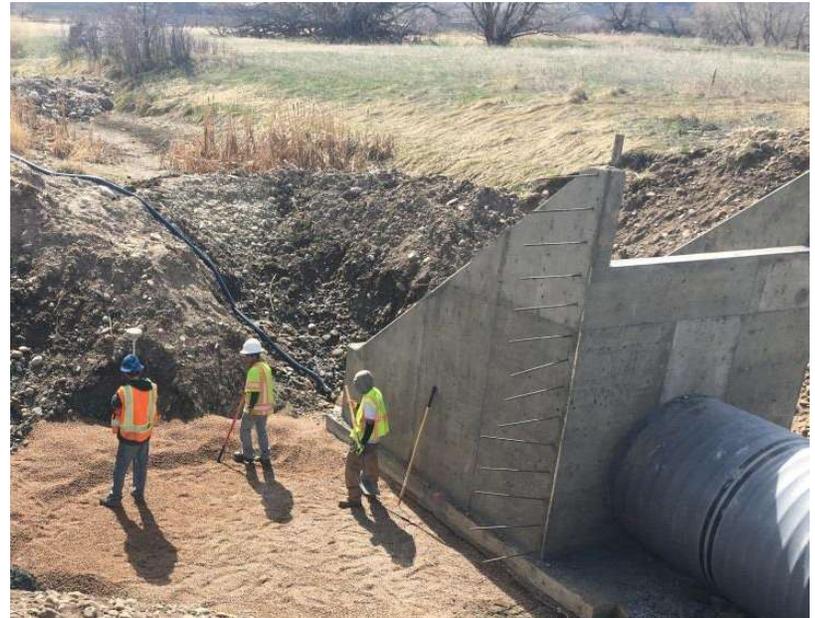
4/1: West Lake Dam – Foothills Outlet Ditch 60" inverted siphon pipe and inlet structure. Subgrade preparation for wingwalls.

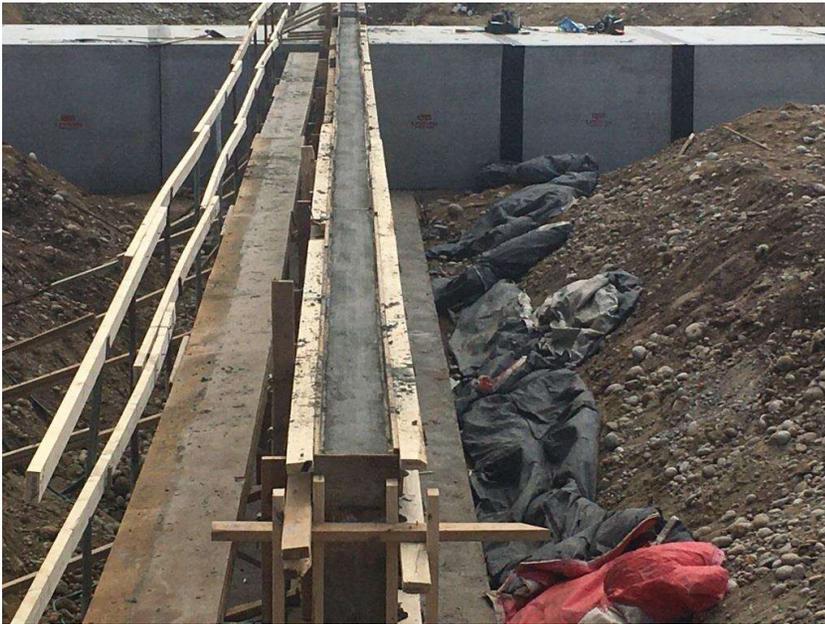
4/1: A-Frame – freshly poured concrete in the outlet cutoff walls

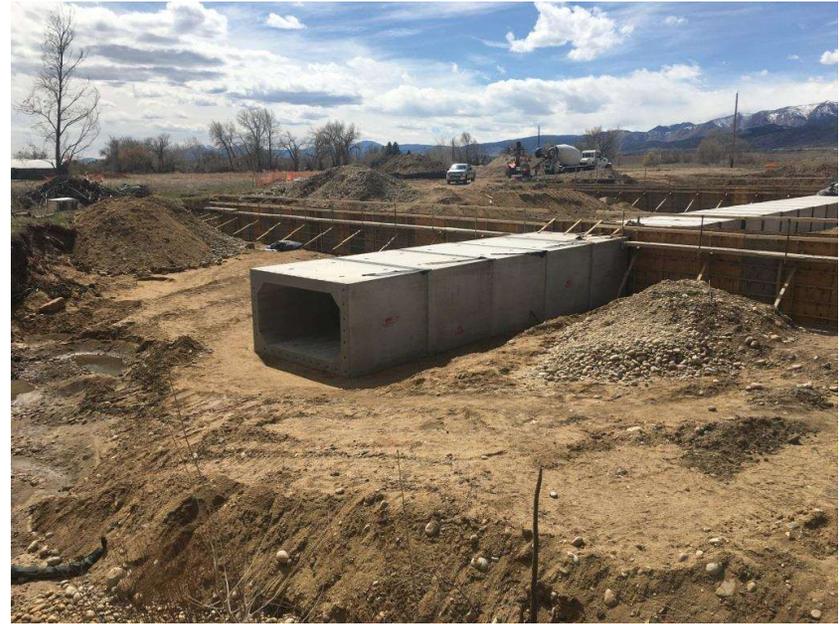
4/1: A-Frame - looking southwest; outlet box culvert and cutoff walls.

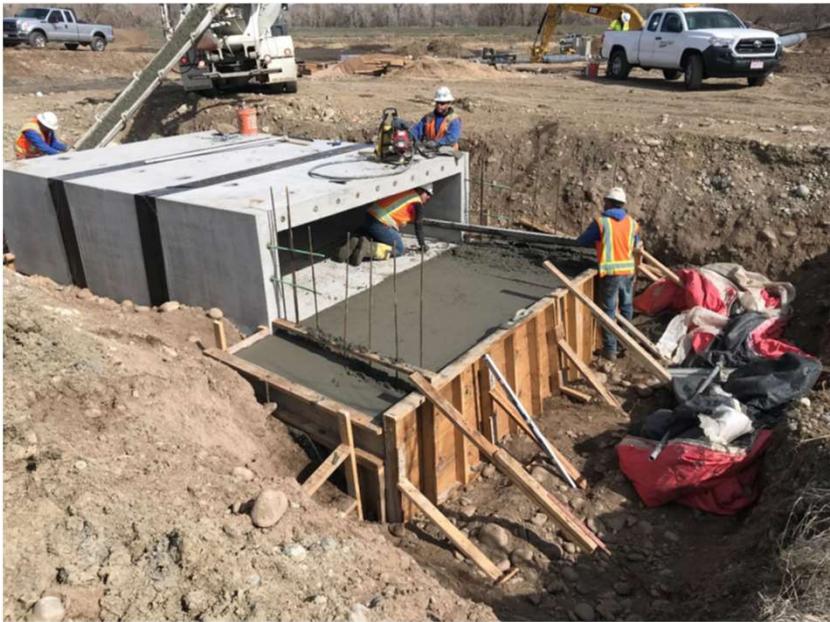
3/30: West Lake Dam - pouring concrete at the South Branch Ditch crossing.

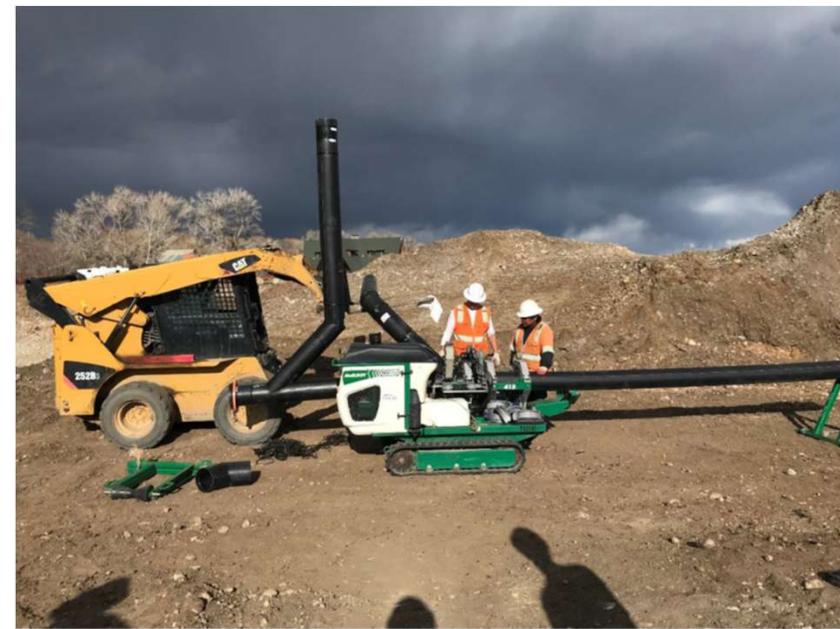
3/27: West Lake Dam – fusion welding HDPE pipe for the siphon drains.

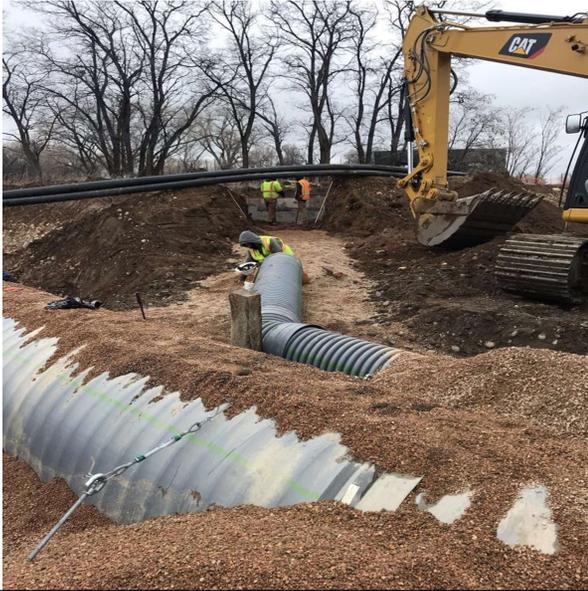
4/2: West Lake Dam – installing the Clough and True Ditch 18” inverted siphon.

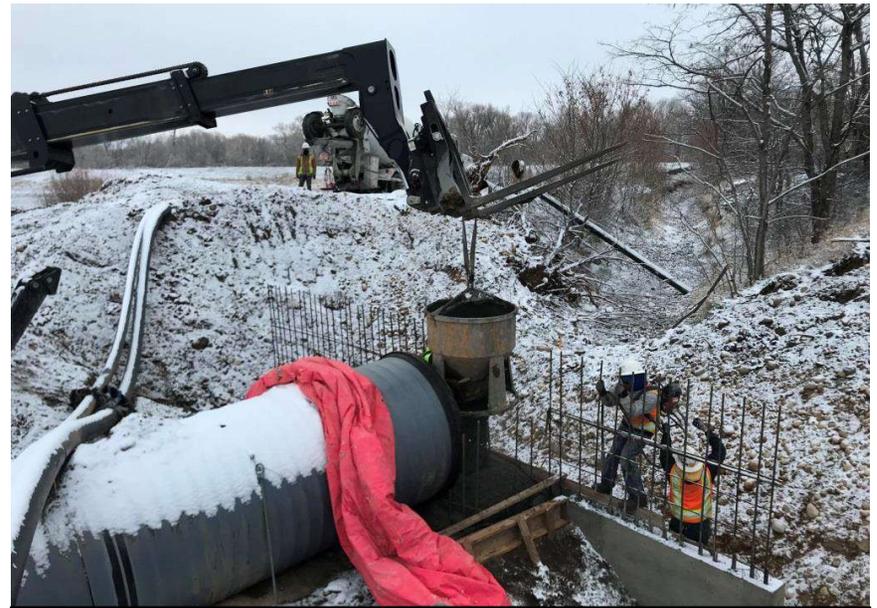
4/3: West Lake Dam – pouring concrete in the Foothills Outlet Ditch 60” outlet structure apron.

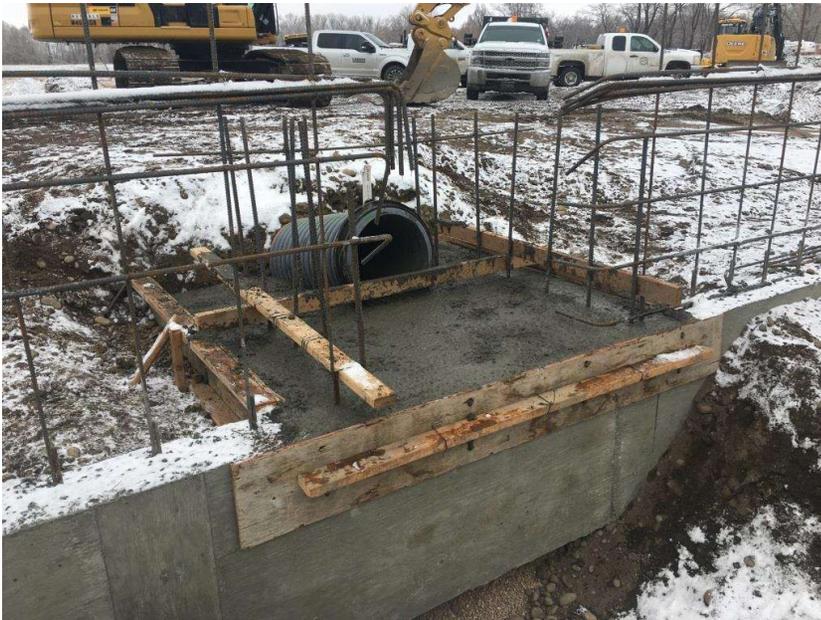
4/3: West Lake Dam - placed concrete at the Clough and True Ditch 18” inverted siphon outlet structure apron.

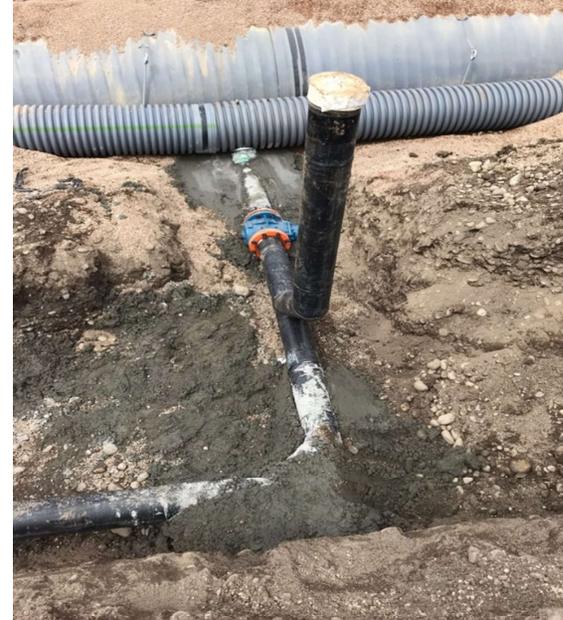
4/3: West Lake Dam – HDPE pipe siphon drains set in a supportive bed of concrete.

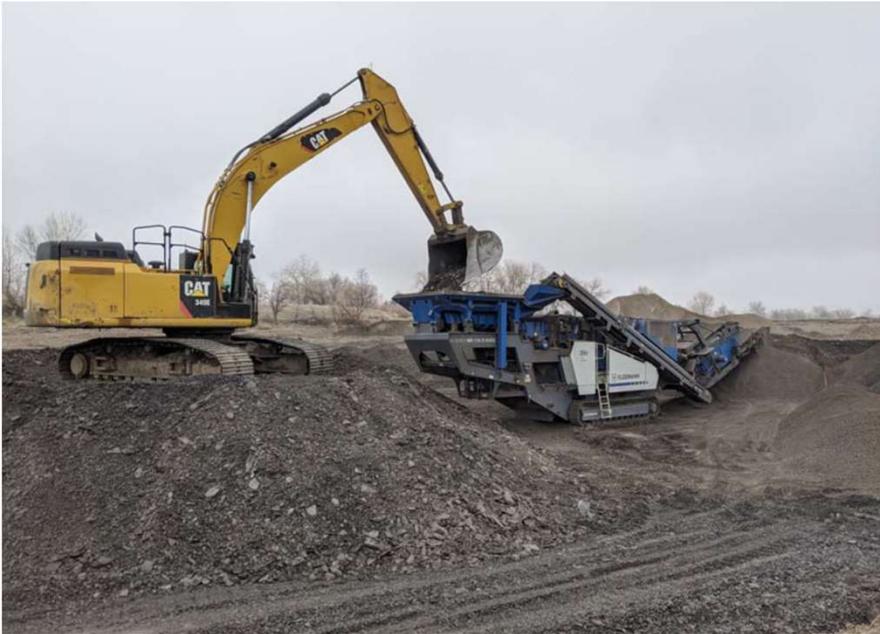
4/2: Lake 4 – claystone/bedrock crushing operation to make ¾” minus embankment fill in the Lake 4 sediment removal area.

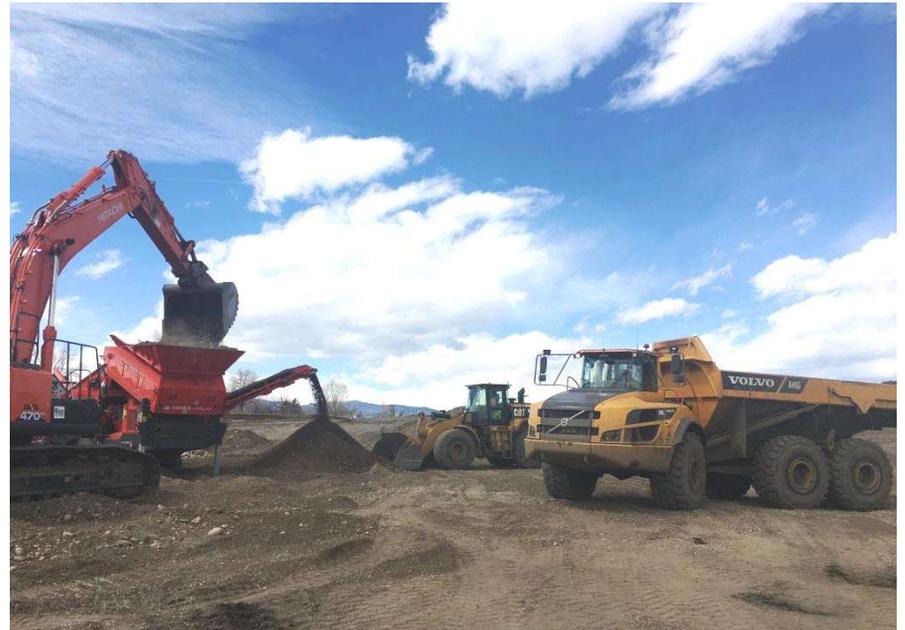
3/27: Lake 4 - Screening embankment fill to 3” minus from the flood deposited sediment in the Lake 4 sediment removal area.

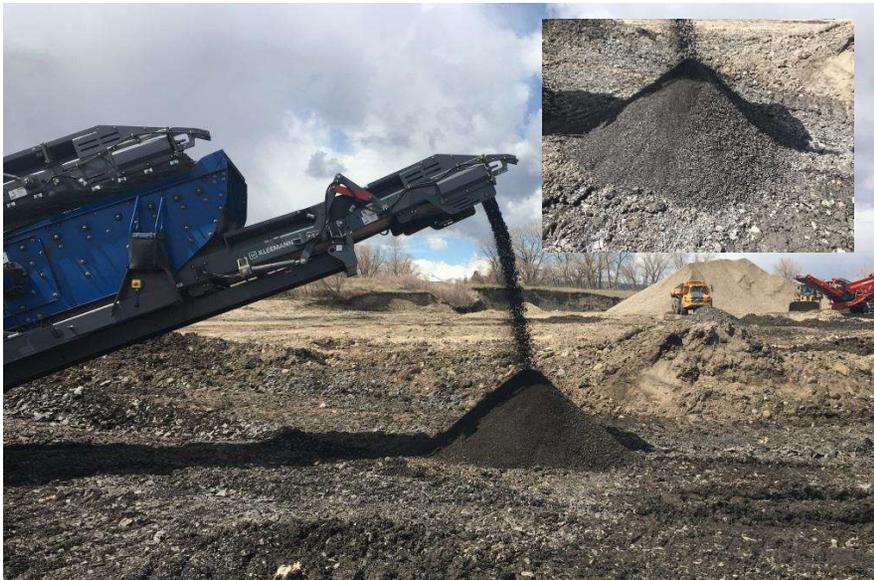
3/30: Lake 4 – claystone/bedrock crushing operation to make ¾” minus embankment fill in the Lake 4 sediment removal area.

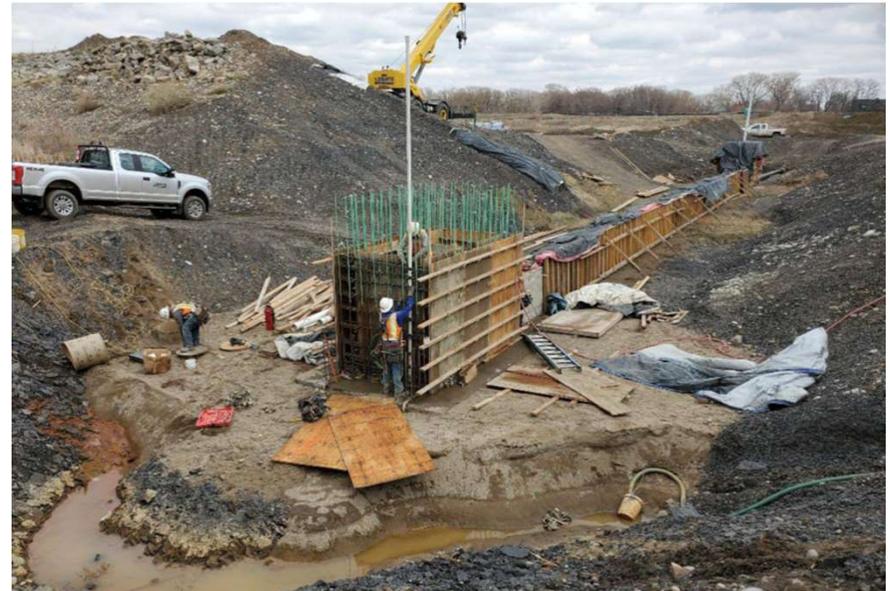
4/3 – Lake 4 Dam – installing outlet tower #1 piezometer.
