# Upper Coal Creek Watershed Restoration Master Plan

November 2014

Jefferson and Boulder Counties

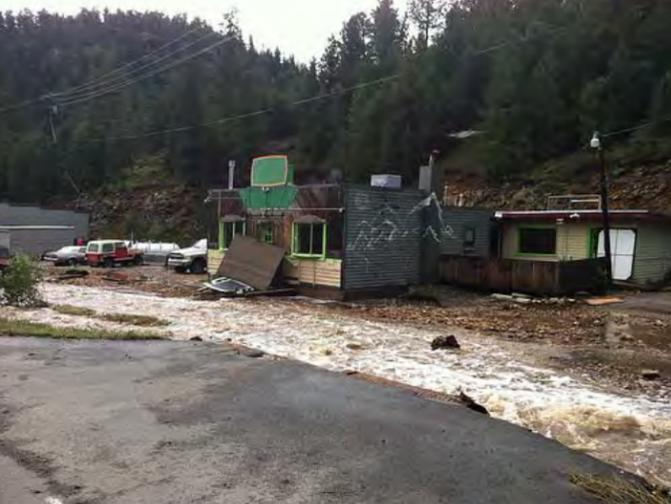
As noted previously, the rainfall event on September 12, 2013, was unprecedented in the Coal Creek watershed. Damage throughout the corridor was widespread. In particular, downstream of Twin Spruce Gap Road, nearly every access culvert failed, was washed out, or was significantly damaged. The channel eroded significantly, leading to visible scour through the La Duwaik Estates and other central residential corridors. Highway culverts also plugged with debris, further exasperating flooding effects on the highway and downstream infrastructure. The culvert crossing at the Union Pacific Railroad (UPRR) did manage to pass the peak flows; however, a sedimentation zone was formed in the valley upstream of the culvert, where much of the eroded material was deposited. With the exception of the old Real Estate building at Twin Spruce Gap Road, no homes or buildings were destroyed in this area, although some were badly damaged. This building has since been demolished, and the land acquired by the Colorado Department of Transportation (CDOT).

Photo 1 – West of Twin Spruce Gap Road on Highway 72

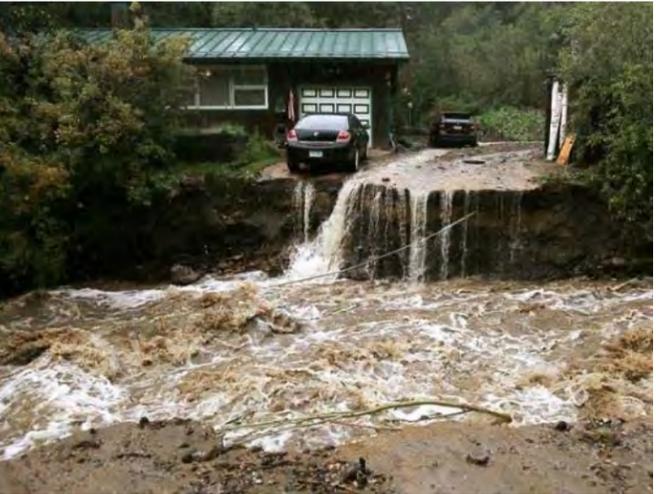
The Coal Creek Canyon community center is located upstream of Twin Spruce Gap Road. Significant damage was also evident in this area, including structure inundation and culvert failures. Runoff from the Crescent Park Tributary eroded drainages and moved sediment through this corridor. Flood damage was widespread at both commercial and residential locations. A new channel was excavated at the intersection of Crescent Park Drive and Highway 72 to help direct discharges from the Crescent Park Tributary to Coal Creek.

Photo 2 – Driveway Culvert Failure on Coal Creek

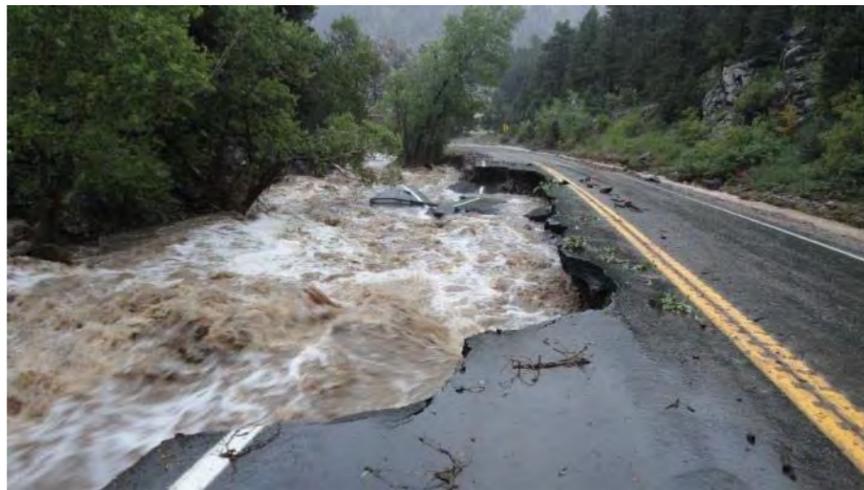
Along Highway 72, CDOT has been active in repairing and reopening the highway. This work has included debris removal, roadway reconstruction/resurfacing, and bank reinforcement in areas adjacent to the highway with high erosive susceptibility. Much of this initial work was an immediate response to the flood event and CDOT is currently in the planning stages to provide more infrastructure improvements along Highway 72.

Photo 3 – One of Numerous Washouts along Highway 72

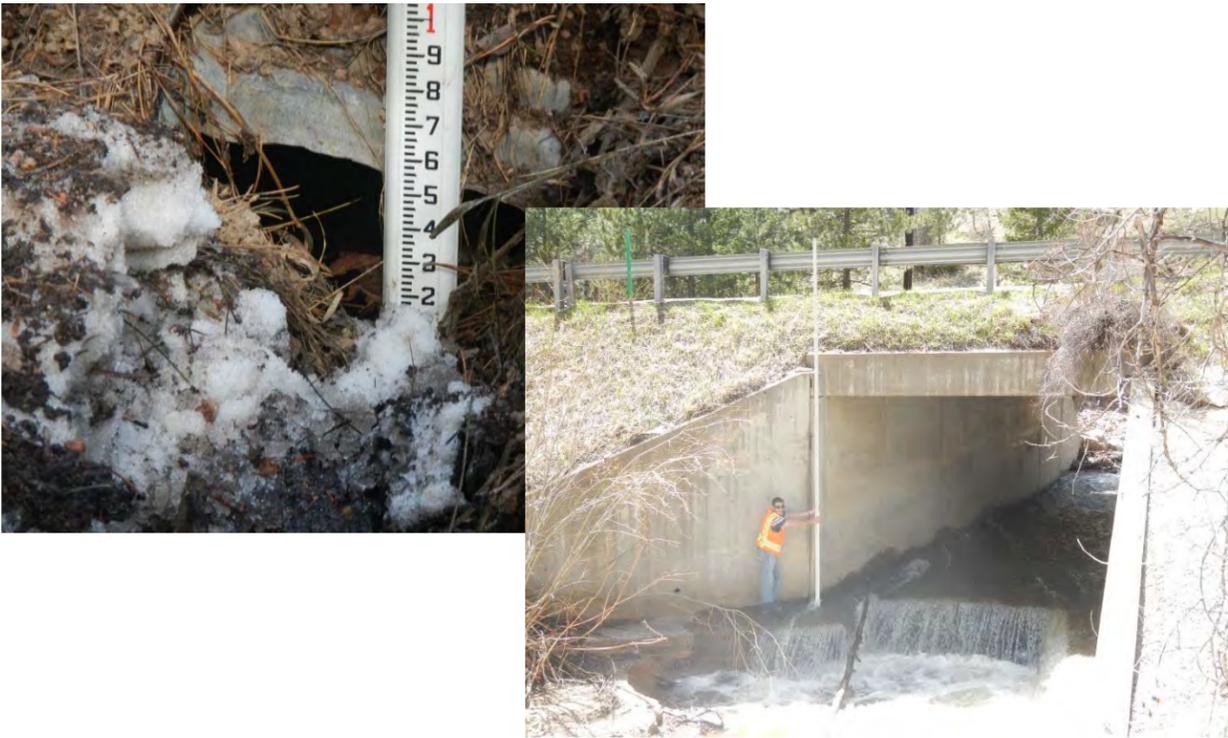
Existing drainage facilities along Coal Creek and its tributaries vary in size, shape, and material. Capacity throughout the canyon varies, and nearly every culvert is undersized compared to the 100-year discharges. Private culverts are

Photo 4 – Culverts range from small and mostly blocked to large box culvert roadway crossings

generally round corrugated metal pipe (CMP), with smaller capacities, whereas CDOT or other publicly-owned culvert crossings are generally concrete box culverts (CBC's) or round pipe (RCP). Condition also varies greatly, with some of the older culverts nearly full of sediment, while newer installations are cleaner. Individual culvert crossing sizes and dimensions were measured along each stream reach and incorporated into the hydraulic modeling for this report. Culvert dimensions were field verified by ICON in April and May of 2014.

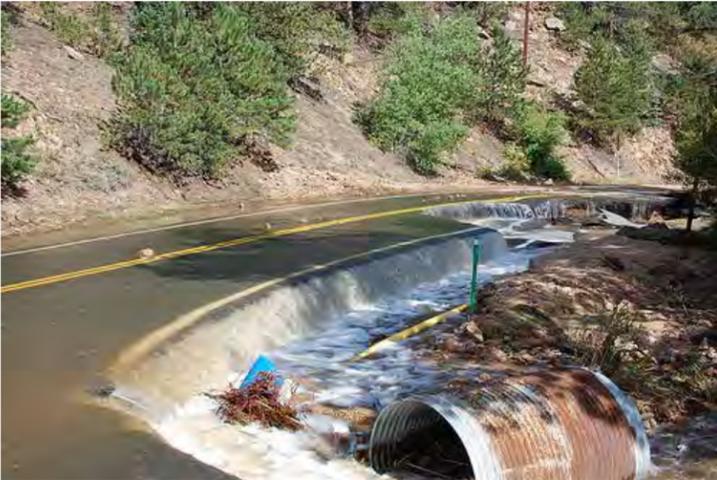
Photo 5 – Highway Inundation at Twin Spruce Gap Road

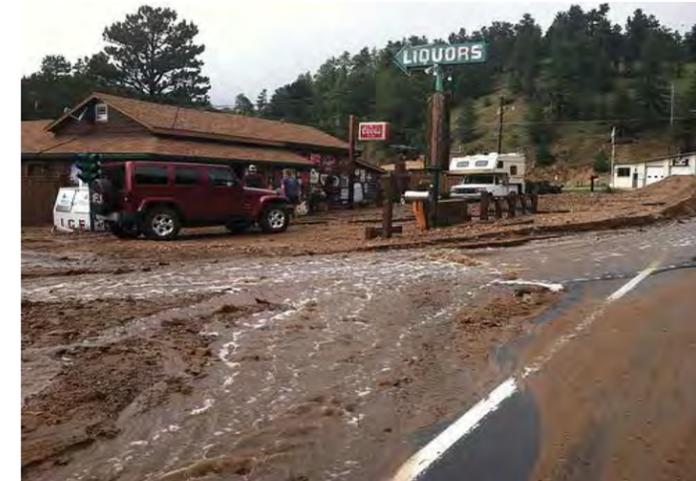
Photo 6 - Flooding at Highway 72 and Crescent Park Drive

Highway 72 and other county roadways are also periodically inundated by rainfall events less than the 100-year frequency. Flooding potential is prevalent at nearly all highway stream crossings west of the railroad crossing. Nearly 0.5 miles of highway is inundated at the bends near mile marker 15, and 0.6 miles of highway has the potential to become inundated east of Twin Spruce Gap Road, around the 'S' curves (mile marker 17). Further upstream flood risk was identified at the confluence with the Crescent Park Tributary, where improved culvert crossings only have an estimated 10-year capacity, and along Twin Spruce Gap Road, where much of the roadway is inundated downstream of the confluence with South Beaver Creek. Inundation of the roadways during flood events has the potential to not only damage the roadways, but also to prevent emergency access to the canyon community.

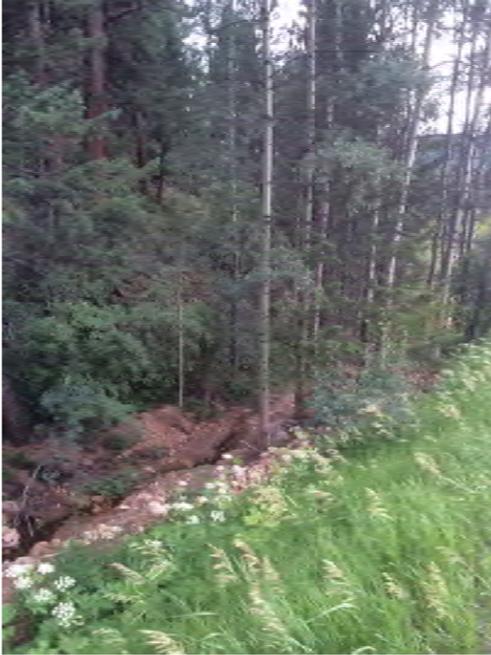
Photo 7 – Type Aa+ Tributary to Coal Creek

Stream Type Aa+ streams are defined as “very steep, deeply entrenched, cascading, debris transport, torrent streams,” that have high relief and typical bedforms containing chutes, debris flows, and waterfalls (Rosgen 1996). Type Aa+ streams are steeper than Type A streams (average slopes greater than 0.10 ft/ft), and may have lower sinuosity (between 1.0 and 1.1). Photo 7 gives a representative example of a portion of a Type Aa+ channel that was observed in the study area.

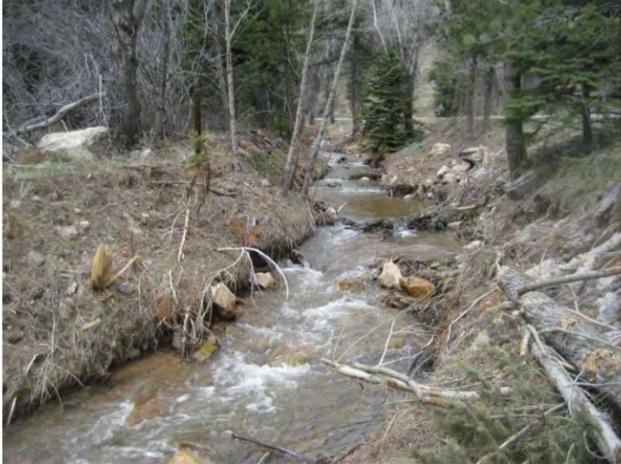
Stream Type A streams are defined as “steep, entrenched, cascading, step/pool streams,” with high energy and high debris-transport potential (Rosgen 1996). Type A streams are steeper than Types B and C (average slopes between 0.04 and 0.10 ft/ft), and have slightly lower sinuosity (between 1.0 and 1.2). The meander width ratio of Type A streams typically ranges between 1 and 3 (Rosgen 1996). Photo 8 gives a representative example of a portion of a Type A channel that was observed at Coal Creek.

Photo 8 – Type A Section of Coal Creek

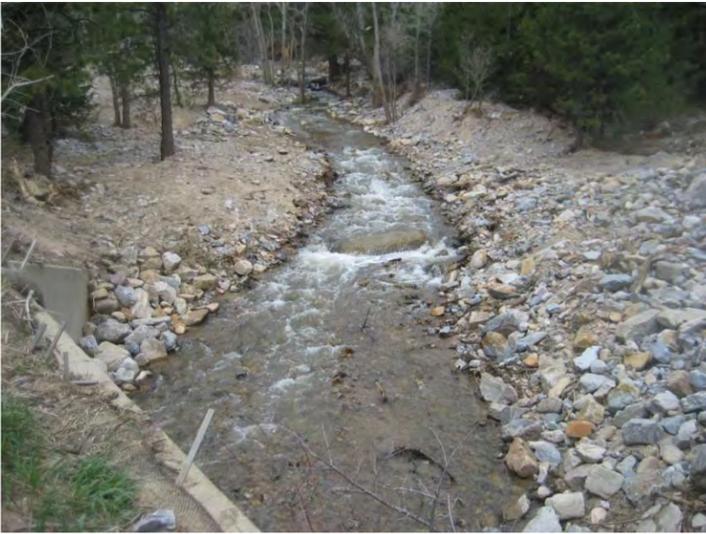
infrequently spaced pools” (Rosgen 1996). The plan, profile, and banks of Type B streams are all considered to be stable. The sinuosity of these stream types are greater than 1.2, with an average slope between 0.02 and 0.039 ft/ft, and a typical meander width ratio between 2 and 8. Type B streams are usually seen in narrower, steeper valleys than Type C streams, and contain colluvial deposition in the reach. Rapids and scour pools are characteristic of Type B streams. Photo 9 gives a representative example of a portion of a Type B channel that was observed at Coal Creek.

Photo 9 - Type B Section of Coal Creek

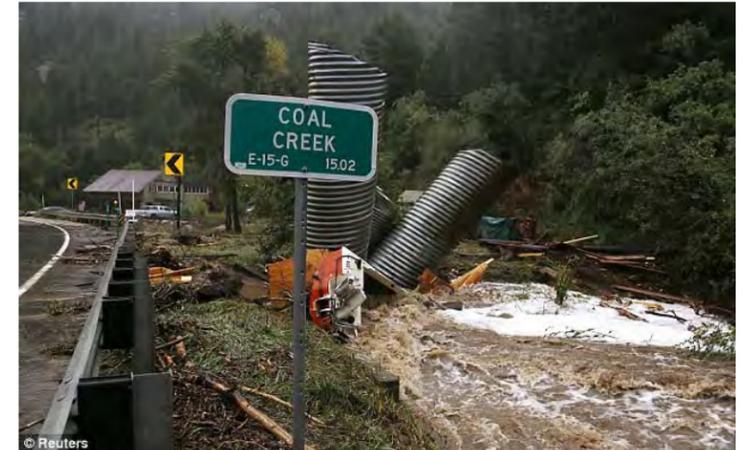
The mid to lower portions of the project area convey a larger portion of the watershed, and thus experienced higher flood flows and moderate disturbance. These areas exhibit various degrees of vegetation disturbance, particularly in the understory strata, ranging from 1) complete loss of riparian shrubs and grasses along large sections of the stream bank to 2) small isolated areas of riparian understory damage to 3) areas where shrubs remain intact with no understory grasses present. Loss of native soils is also widespread in these lower portions of the watershed. Areas of moderate disturbance may require physical streambank stabilization, import of soil material and/or re-vegetation of one or more strata to restore the native riparian community. Areas of high disturbance can be found throughout the mid to lower reaches of the watershed and are characterized by complete loss of all vegetation strata in the riparian zone. These areas will require more substantial restoration to provide long-term stabilization and re-

Photo 10 – Debris within Coal Creek due to Sediment Flows

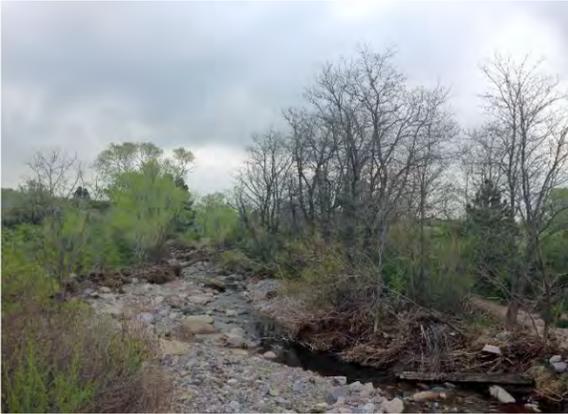
Photo 11 - Example of low disturbance to the riparian zone. This photo depicts a more ideal riparian zone vegetation community along Coal Creek at the downstream end of project area. In this section, the riparian zone is dominated by an overstory of narrowleaf cottonwood and ponderosa pine tree canopy intermixed with dense shrub understory with native grass species.

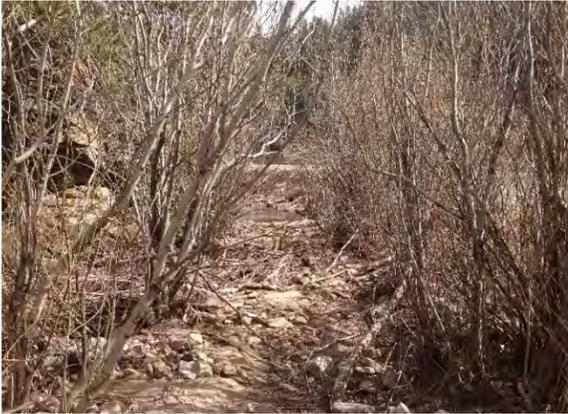
Photo 12 - Example of moderate disturbance to the riparian zone. This photo depicts a common condition in the middle to lower portions of the project area where scouring has removed herbaceous understory. A dense willow-dominated midstory is present which provides streambank stabilization however the lack of a stable understory can lead to soil erosion or root damage further limiting riparian functions.

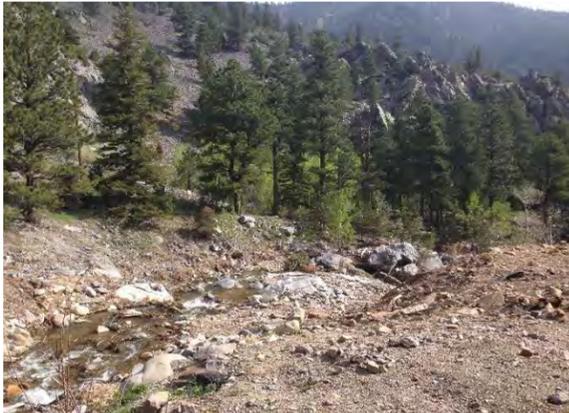
Photo 13 - Example of high disturbance to the riparian zone. Flood flows and transport of large alluvial material/wood have eroded the channel of Coal Creek, completely removing vegetation within the riparian zone.

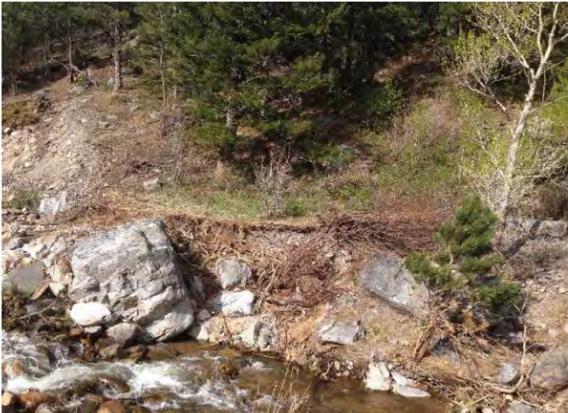
Photo 14 - Example of high disturbance to the riparian zone. High flows and debris have severely eroded the riparian zone shrub and understory community and damaged trees.

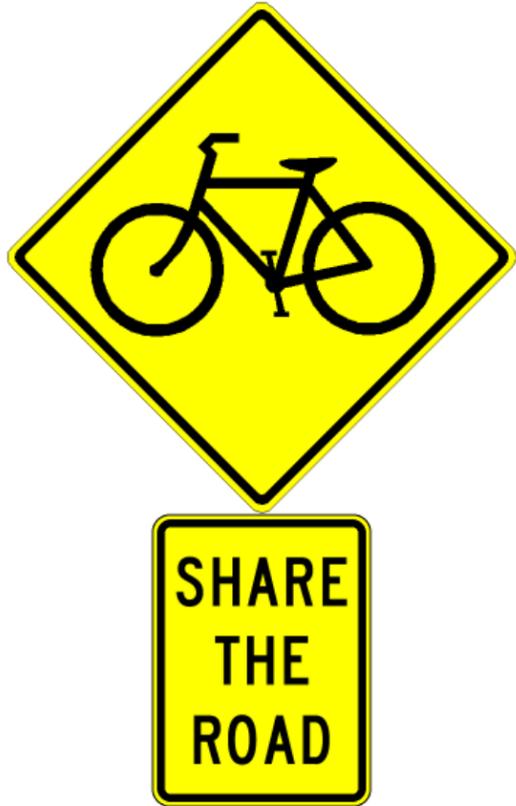
It has been the policy of CDOT to discourage bicycle or pedestrian use along State Highways—particularly due to reduced shoulders and fast traffic within the canyon. However CDOT has been evaluating the use of extending shoulders as a means for resiliency in traffic access in the event of another flood. Discussions with CDOT should continue to look at expanding the drive lane and shoulder to accommodate safe passage of vehicles and bicycles along Highway 72.

W11-1 / W16-1  
Share the Road with Bicyclists assembly

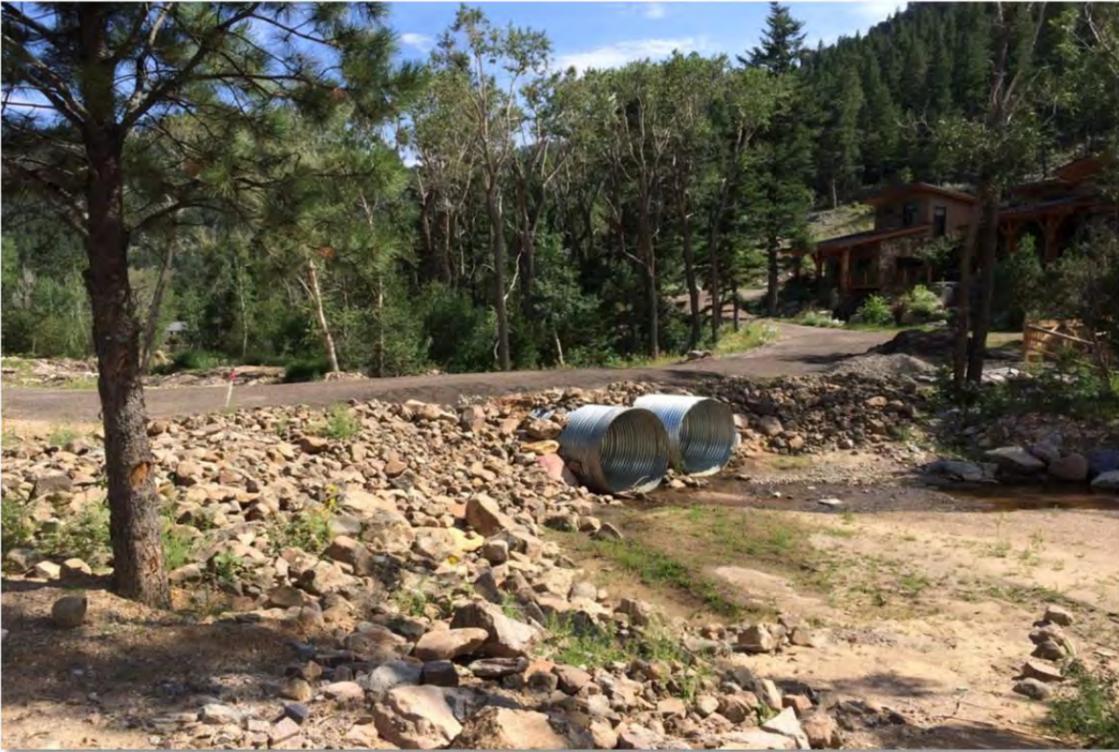
Stream Corridor 1 – Current Conditions

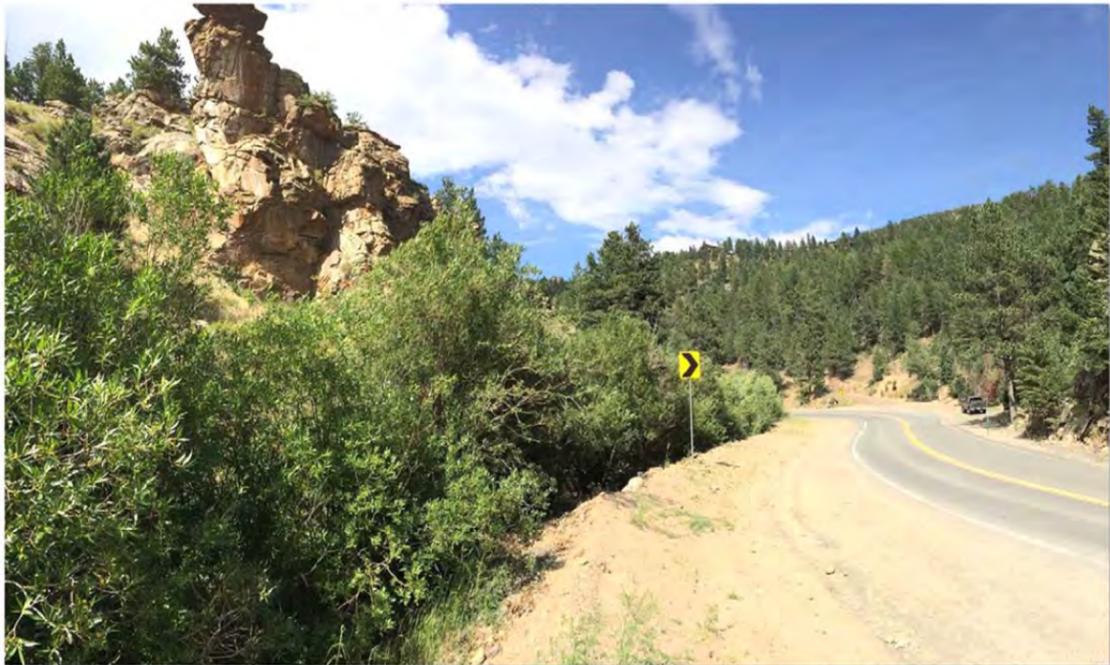
Stream Corridor 2 ('S' Bend Corridor)– Current Conditions

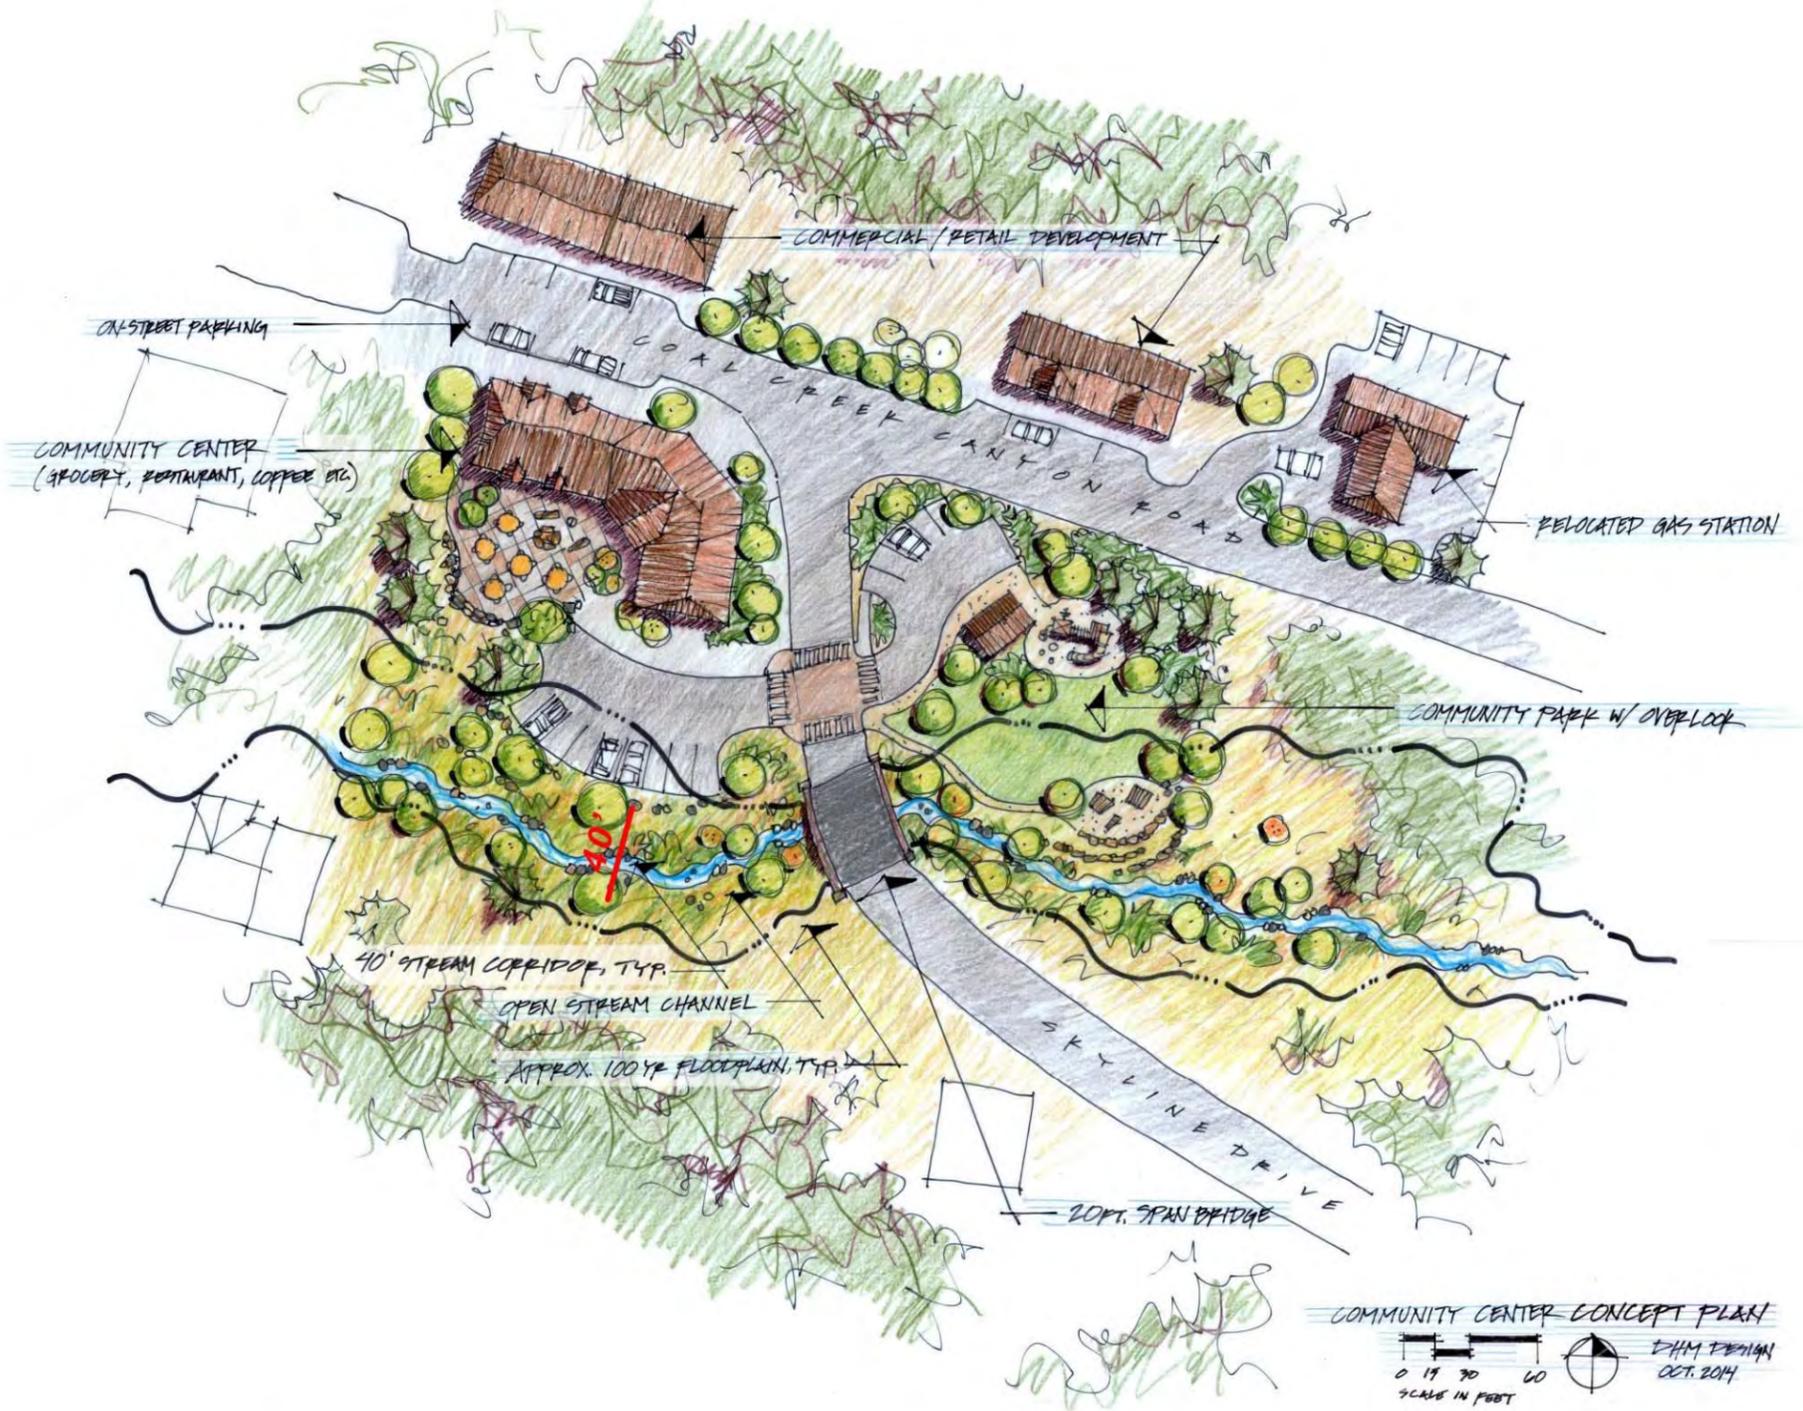
Stream Corridor 3 – Typical Redevelopment Plan Layout

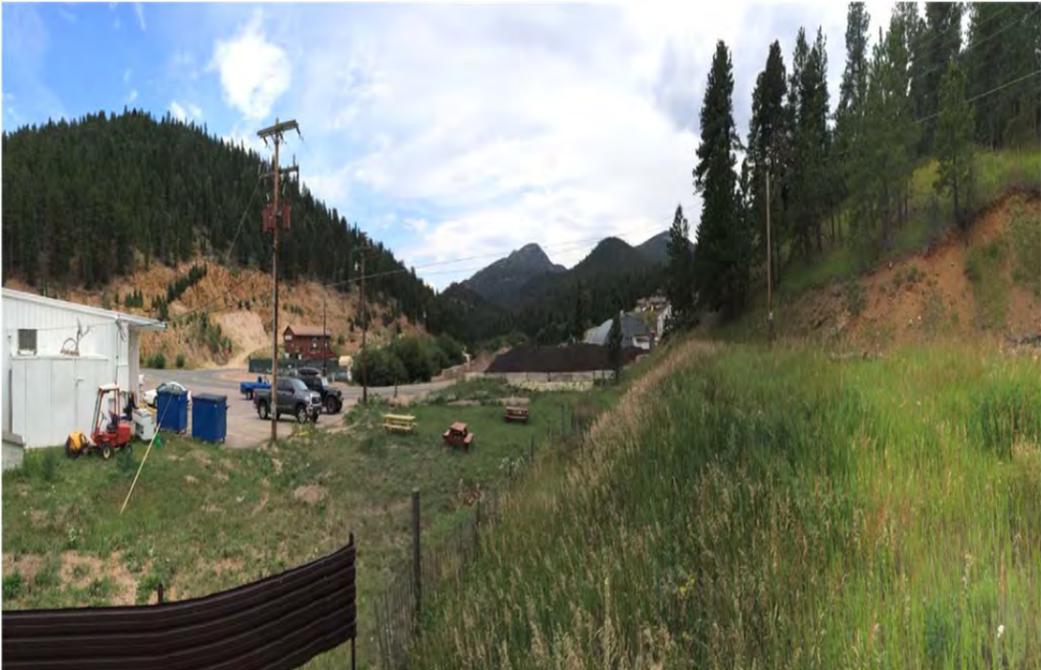
Stream Corridor 3 – Current Conditions

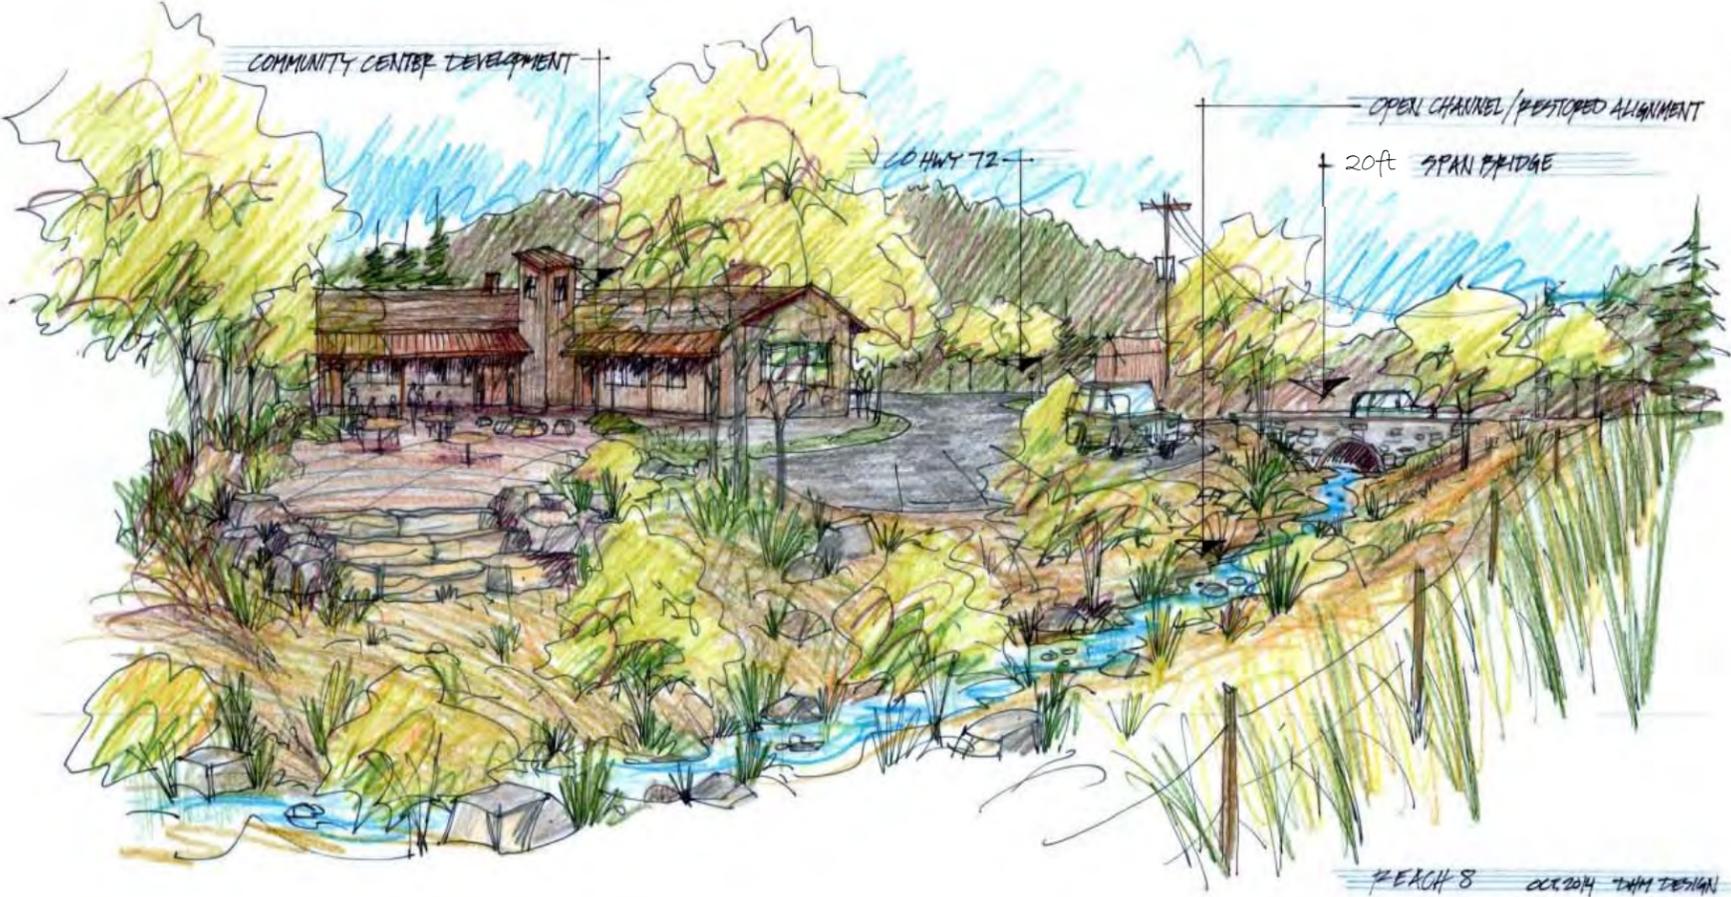
Stream Corridor 3 - Post-Project Rendering

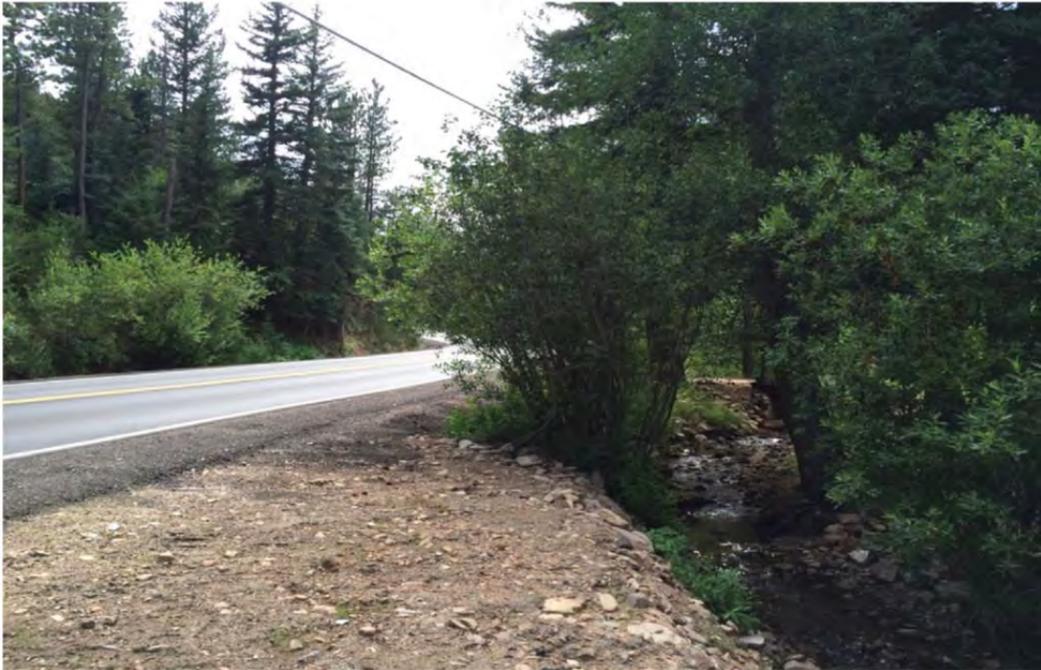
Stream Corridor 4 (near Coal Creek)– Current Conditions

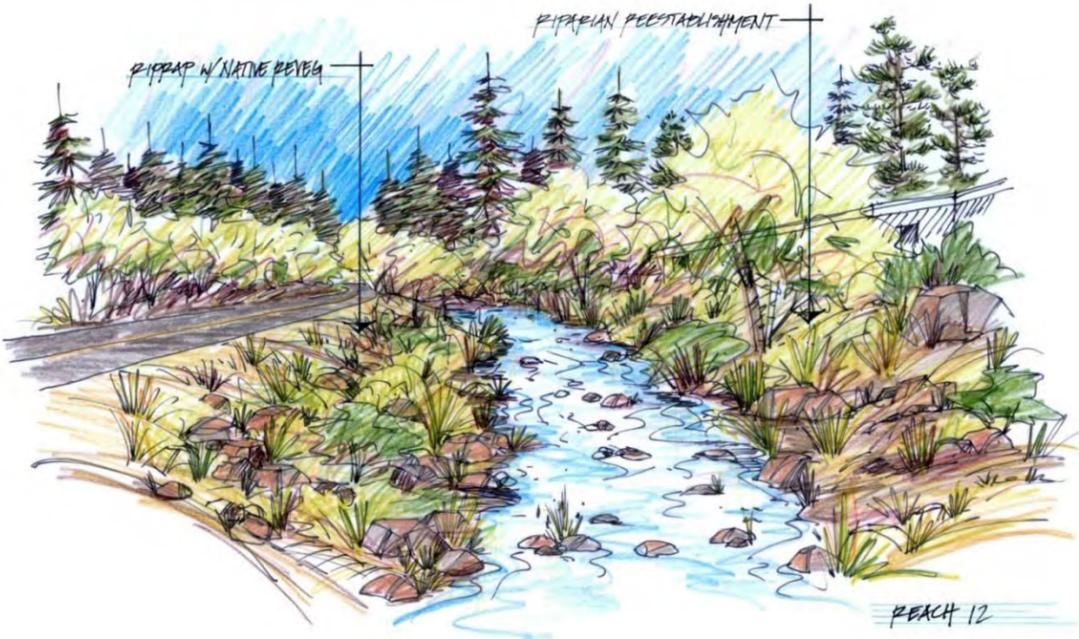
Stream Corridor 4 (near Coal Creek) - Post-Project Rendering

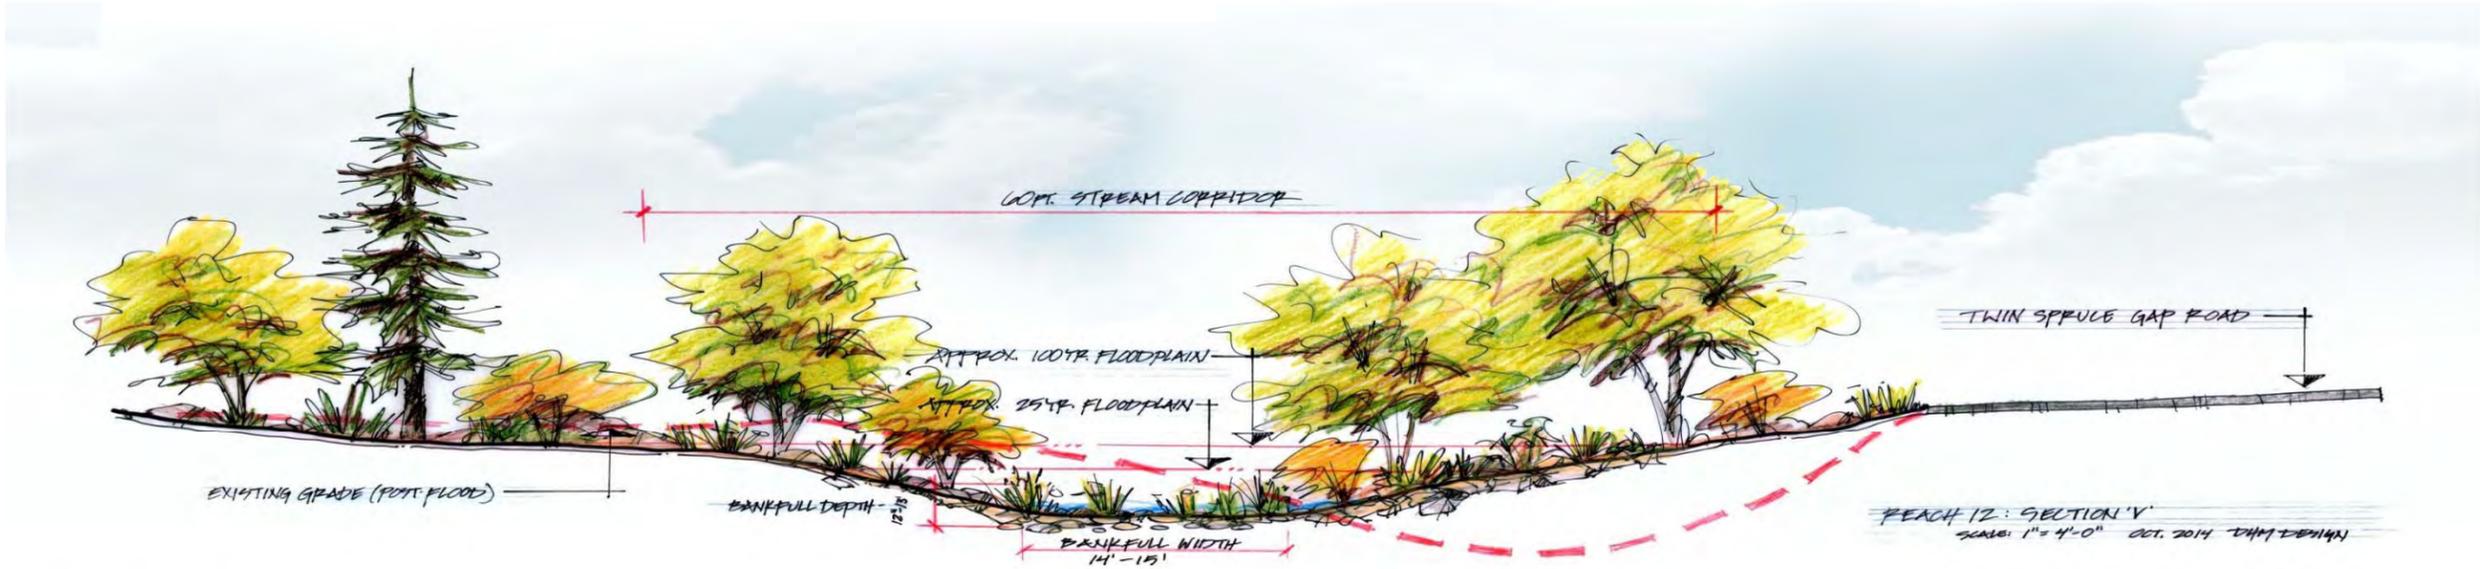
Stream Corridor 4 – Typical Section

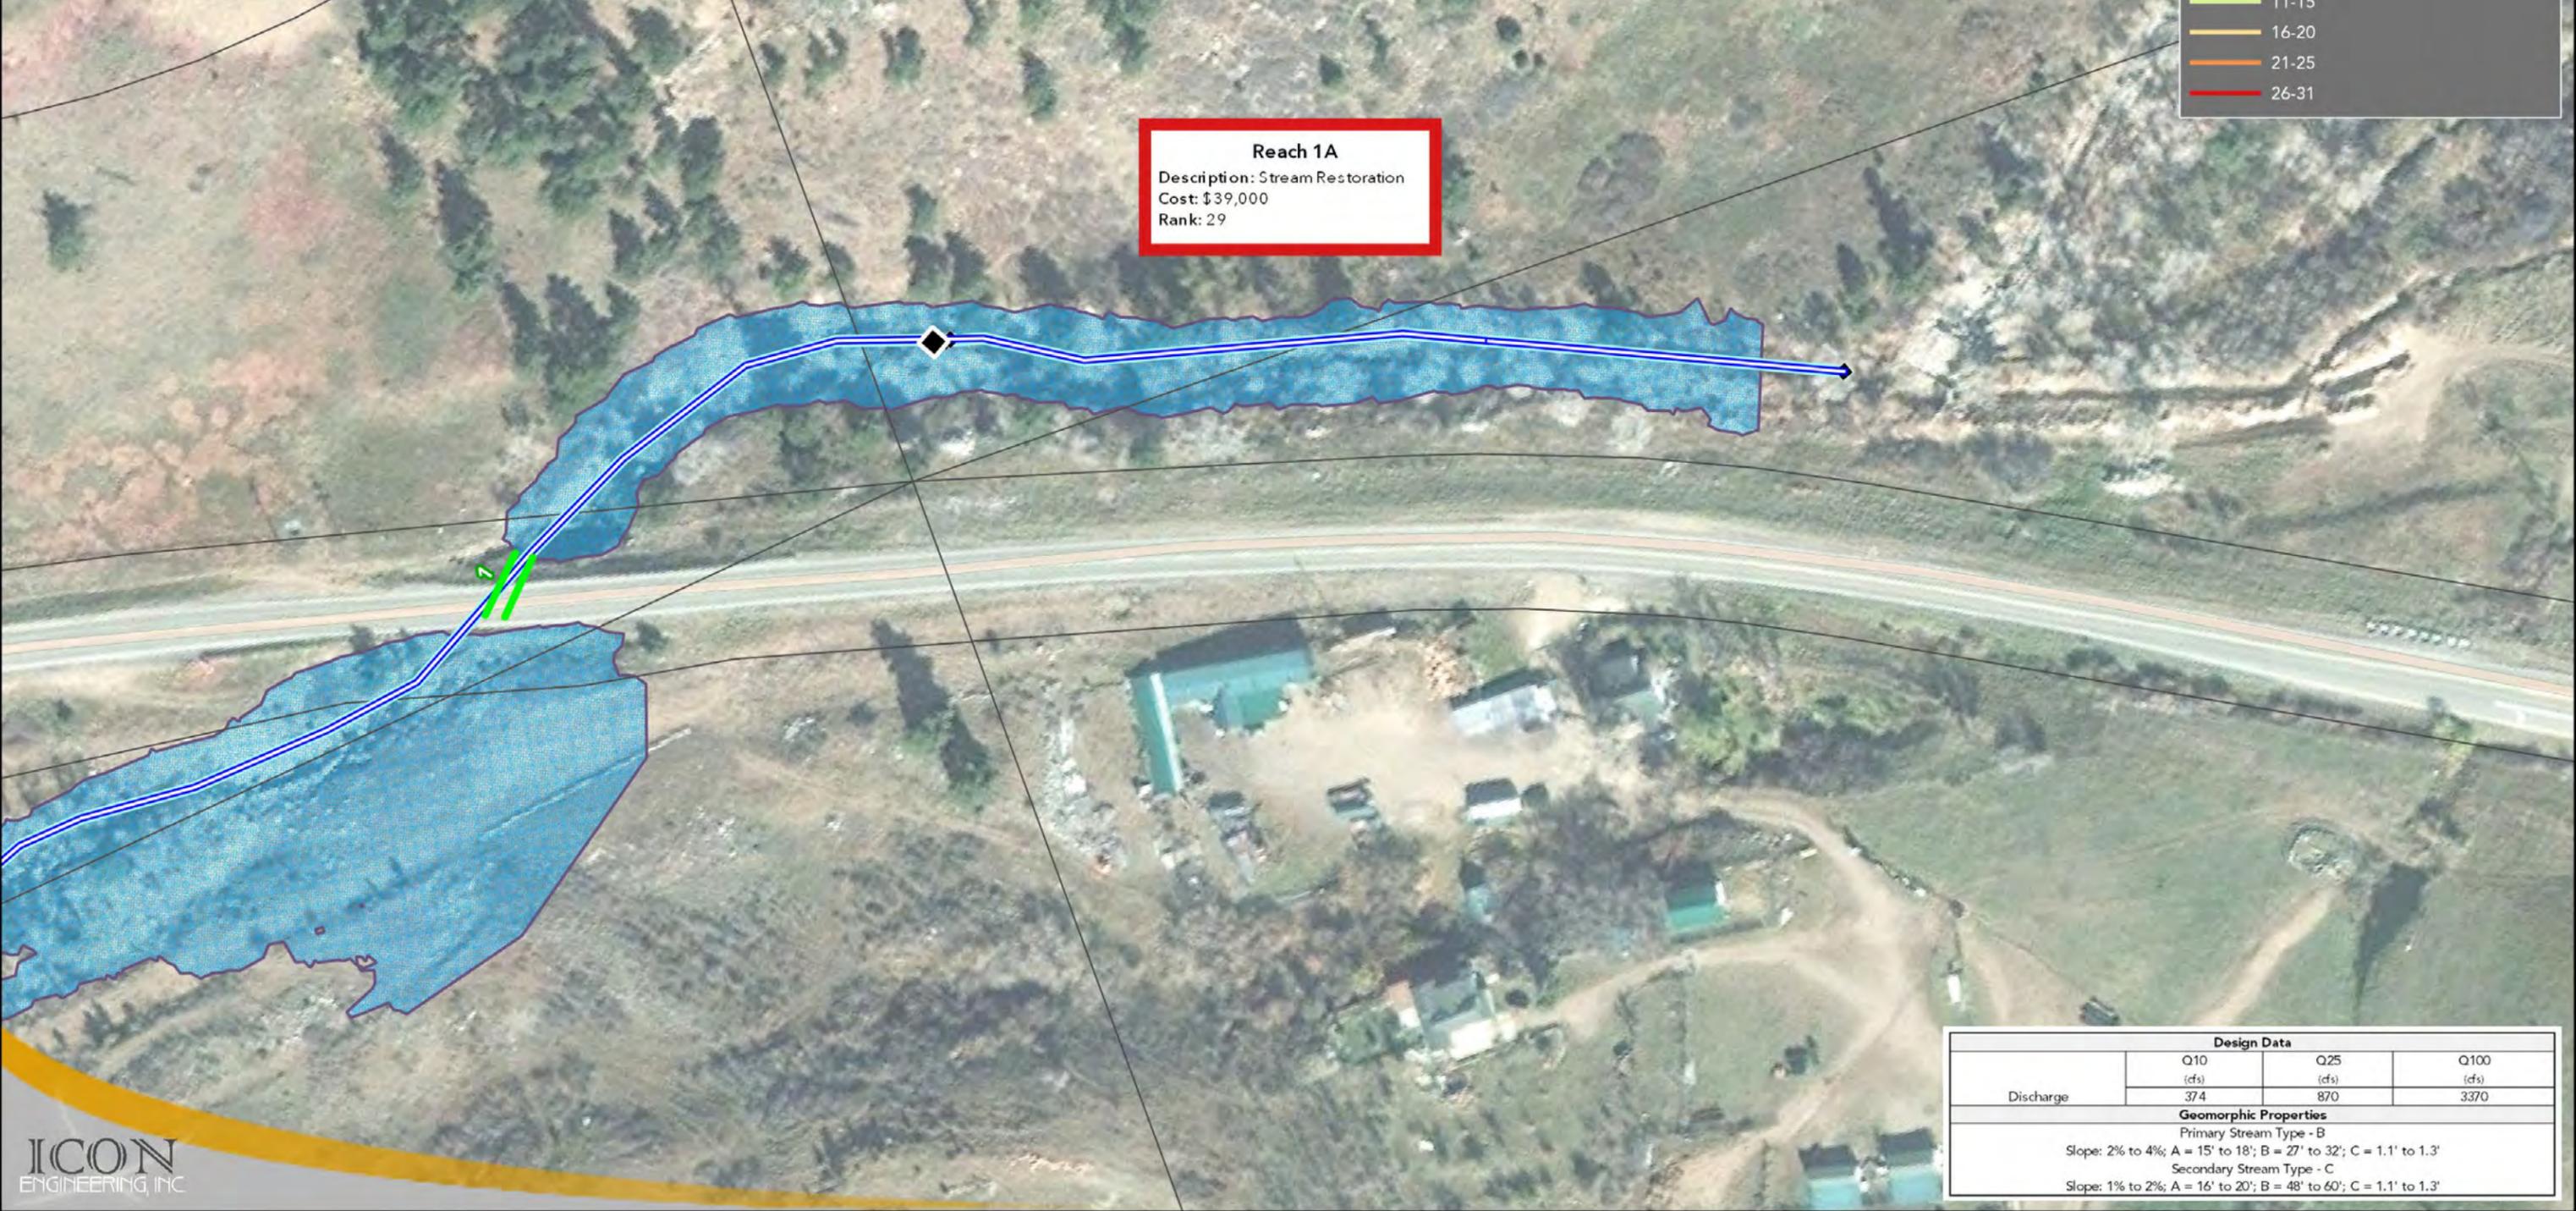
**Reach 1A**  
 Description: Stream Restoration  
 Cost: \$39,000  
 Rank: 29

Design Data			
	Q10	Q25	Q100
Discharge	(cfs) 374	(cfs) 870	(cfs) 3370
Geomorphic Properties			
Primary Stream Type - B			
Slope: 2% to 4%; A = 15' to 18'; B = 27' to 32'; C = 1.1' to 1.3'			
Secondary Stream Type - C			
Slope: 1% to 2%; A = 16' to 20'; B = 48' to 60'; C = 1.1' to 1.3'
