# Upper Coal Creek Watershed Restoration Master Plan

November 2014

Jefferson and Boulder Counties

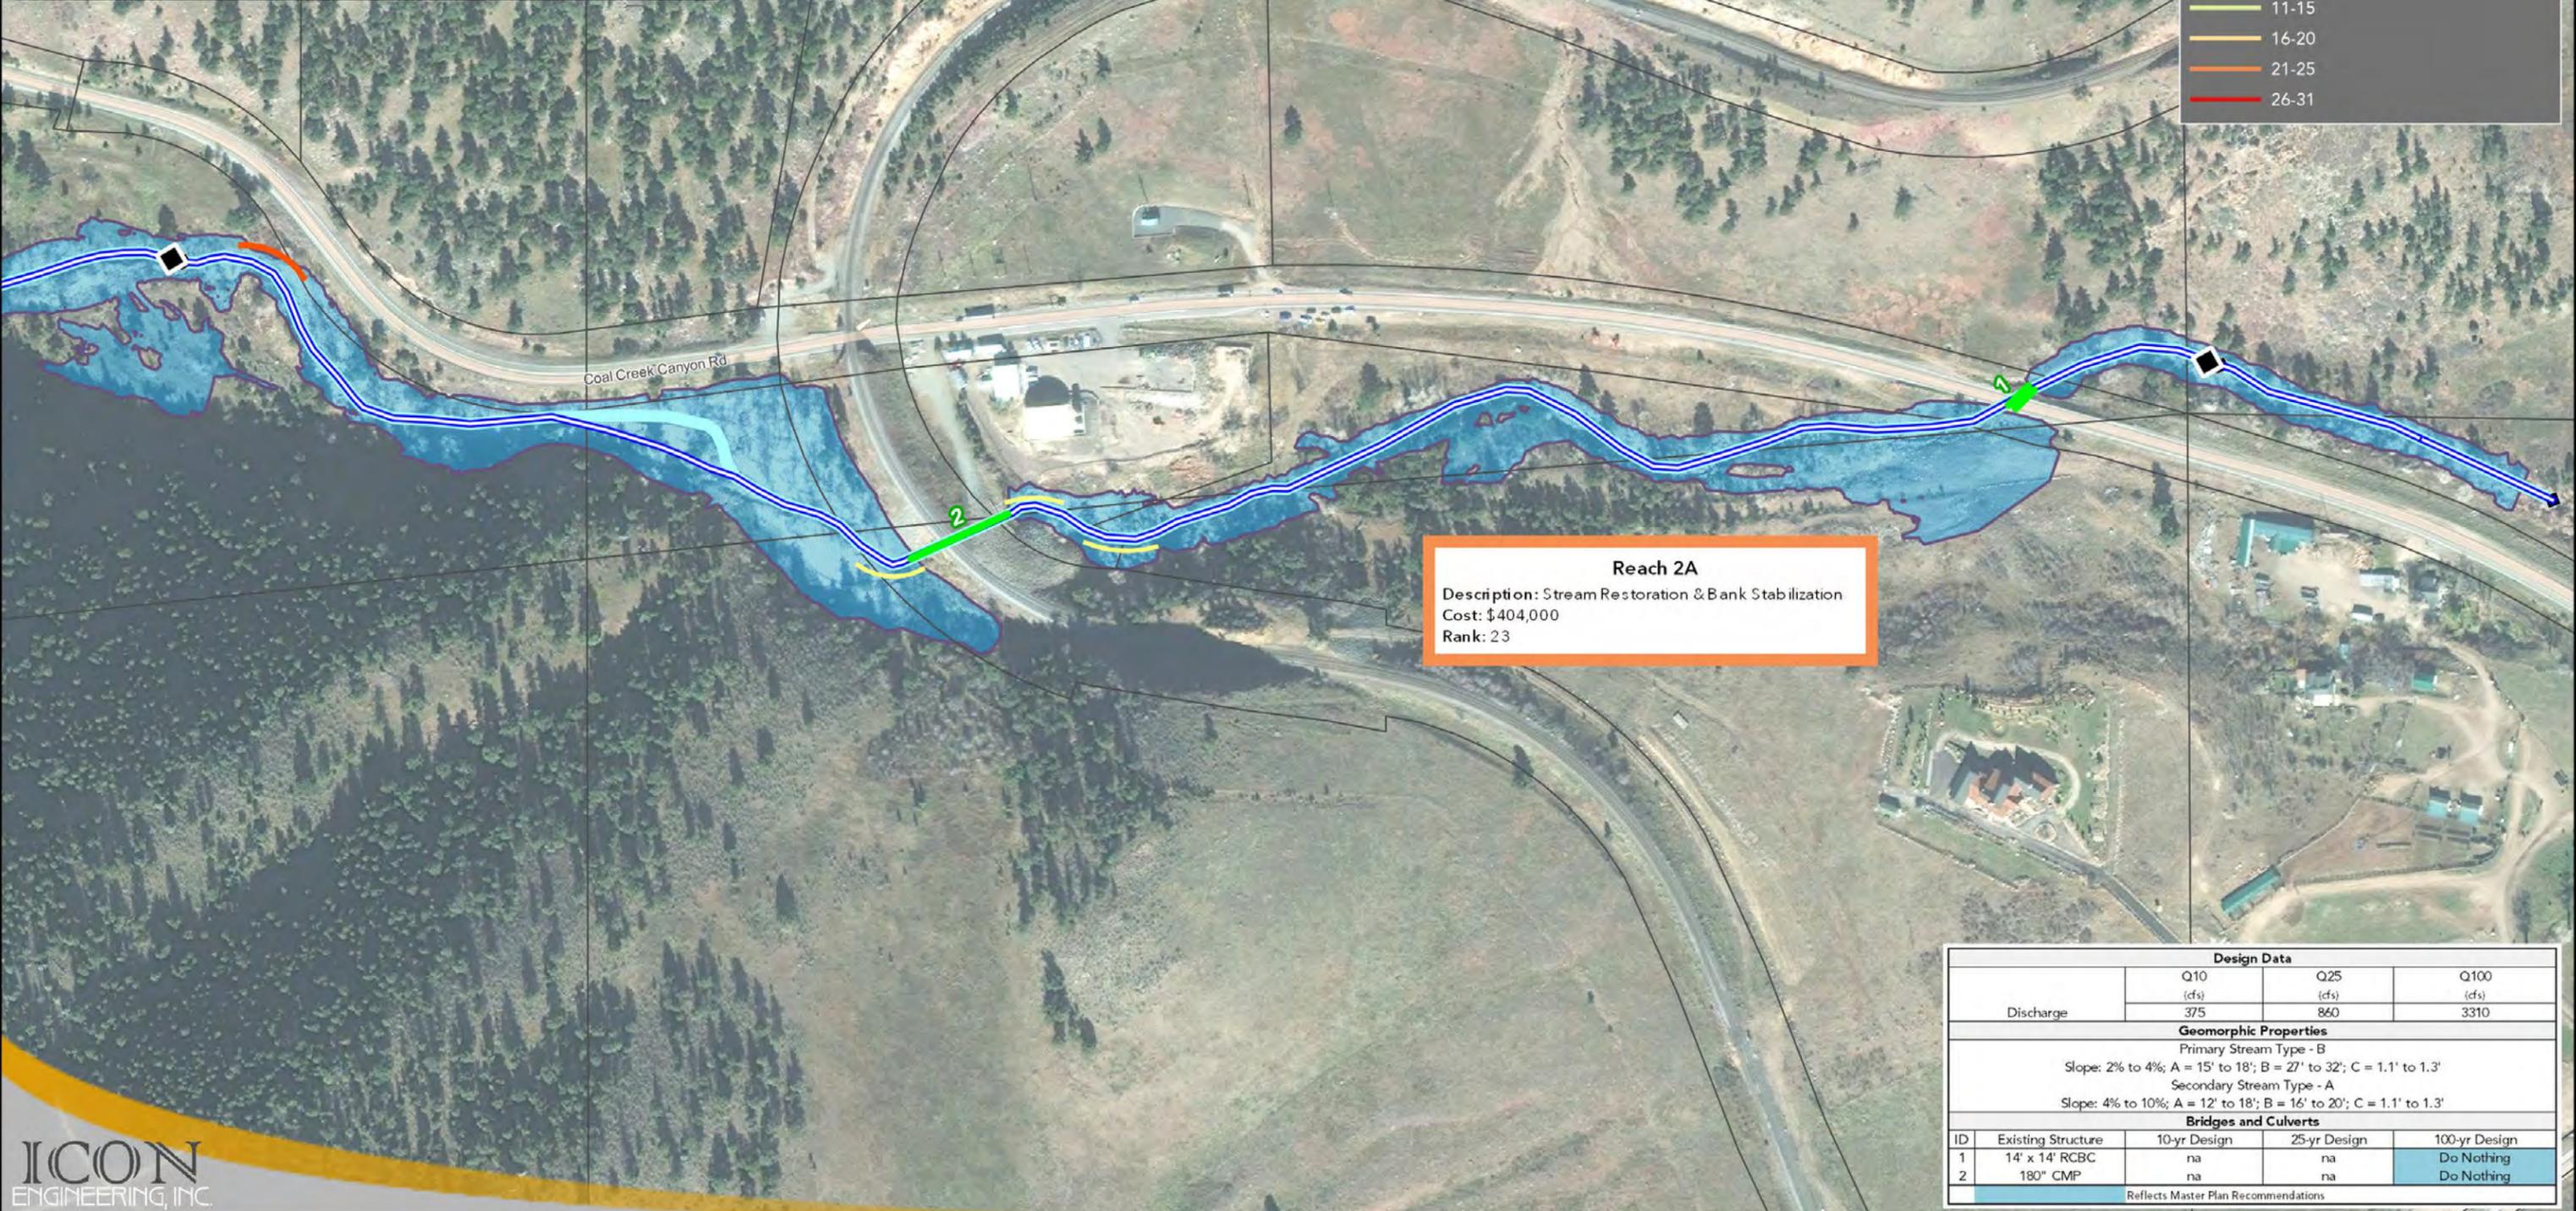
**Reach 2A**  
 Description: Stream Restoration & Bank Stabilization  
 Cost: \$404,000  
 Rank: 23

Design Data				
	Q10 (cfs)	Q25 (cfs)	Q100 (cfs)	
Discharge	375	860	3310	
Geomorphic Properties				
Primary Stream Type - B				
Slope: 2% to 4%; A = 15' to 18'; B = 27' to 32'; C = 1.1' to 1.3'				
Secondary Stream Type - A				
Slope: 4% to 10%; A = 12' to 18'; B = 16' to 20'; C = 1.1' to 1.3'				
Bridges and Culverts				
ID	Existing Structure	10-yr Design	25-yr Design	100-yr Design
1	14' x 14' RCBC	na	na	Do Nothing
2	180" CMP	na	na	Do Nothing

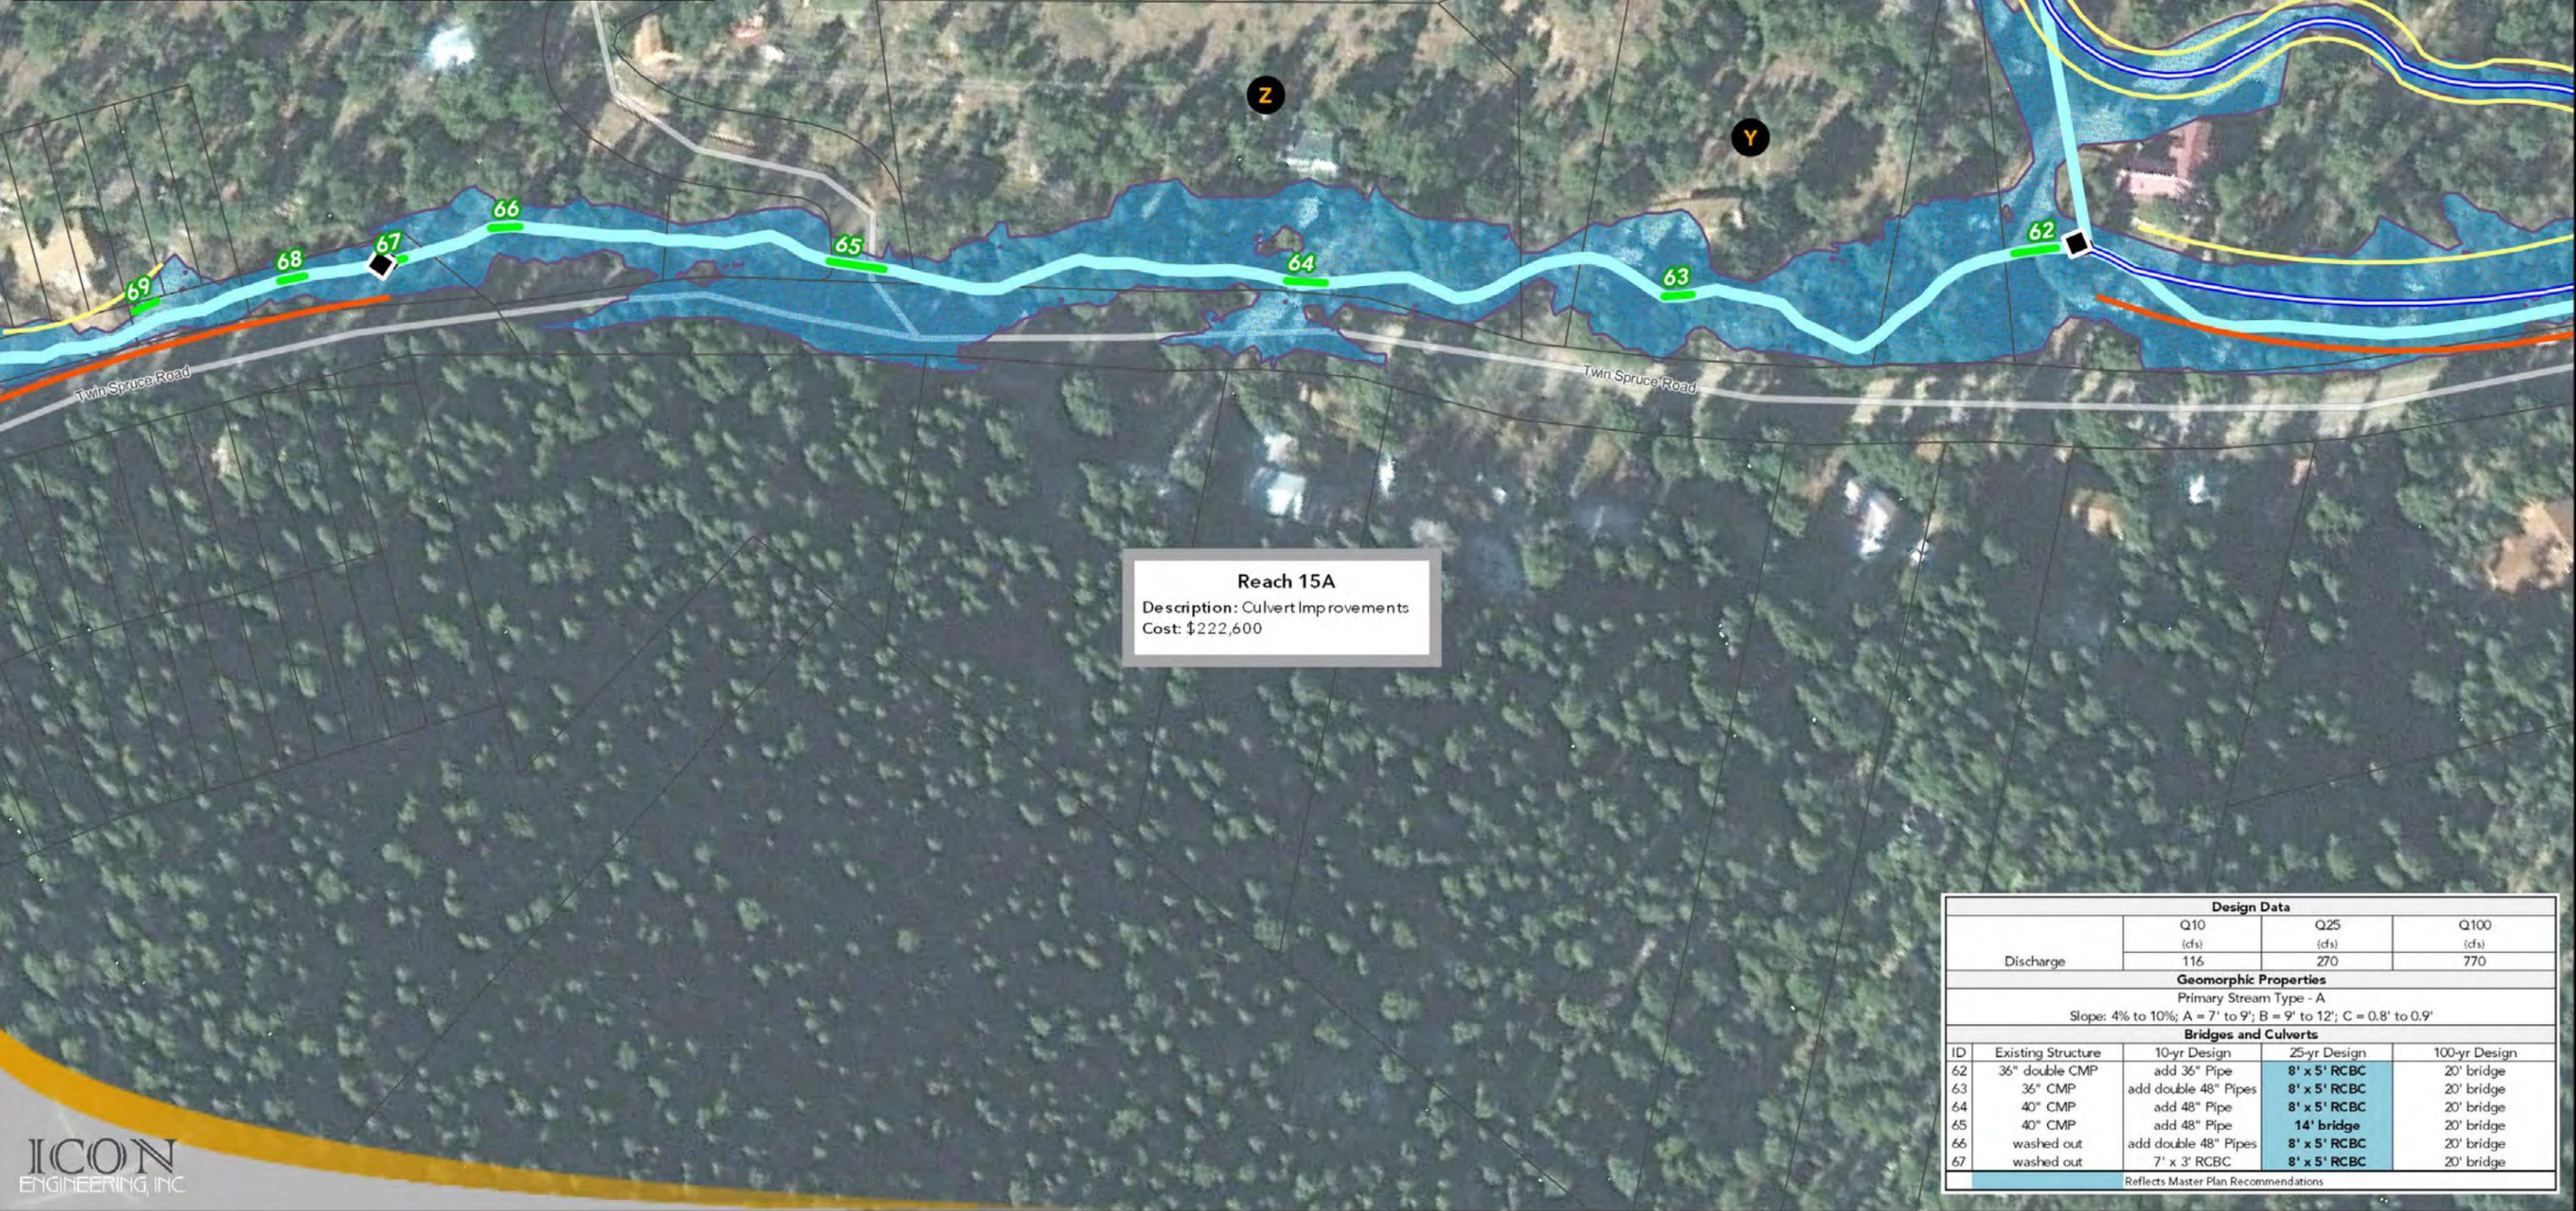
**Reach 15A**  
 Description: Culvert Improvements  
 Cost: \$222,600

Design Data				
	Q10	Q25	Q100	
	(cfs)	(cfs)	(cfs)	
Discharge	116	270	770	
Geomorphic Properties				
Primary Stream Type - A				
Slope: 4% to 10%; A = 7' to 9'; B = 9' to 12'; C = 0.8' to 0.9'				
Bridges and Culverts				
ID	Existing Structure	10-yr Design	25-yr Design	100-yr Design
62	36" double CMP	add 36" Pipe	8' x 5' RCBC	20' bridge
63	36" CMP	add double 48" Pipes	8' x 5' RCBC	20' bridge
64	40" CMP	add 48" Pipe	8' x 5' RCBC	20' bridge
65	40" CMP	add 48" Pipe	14' bridge	20' bridge
66	washed out	add double 48" Pipes	8' x 5' RCBC	20' bridge
67	washed out	7' x 3' RCBC	8' x 5' RCBC	20' bridge

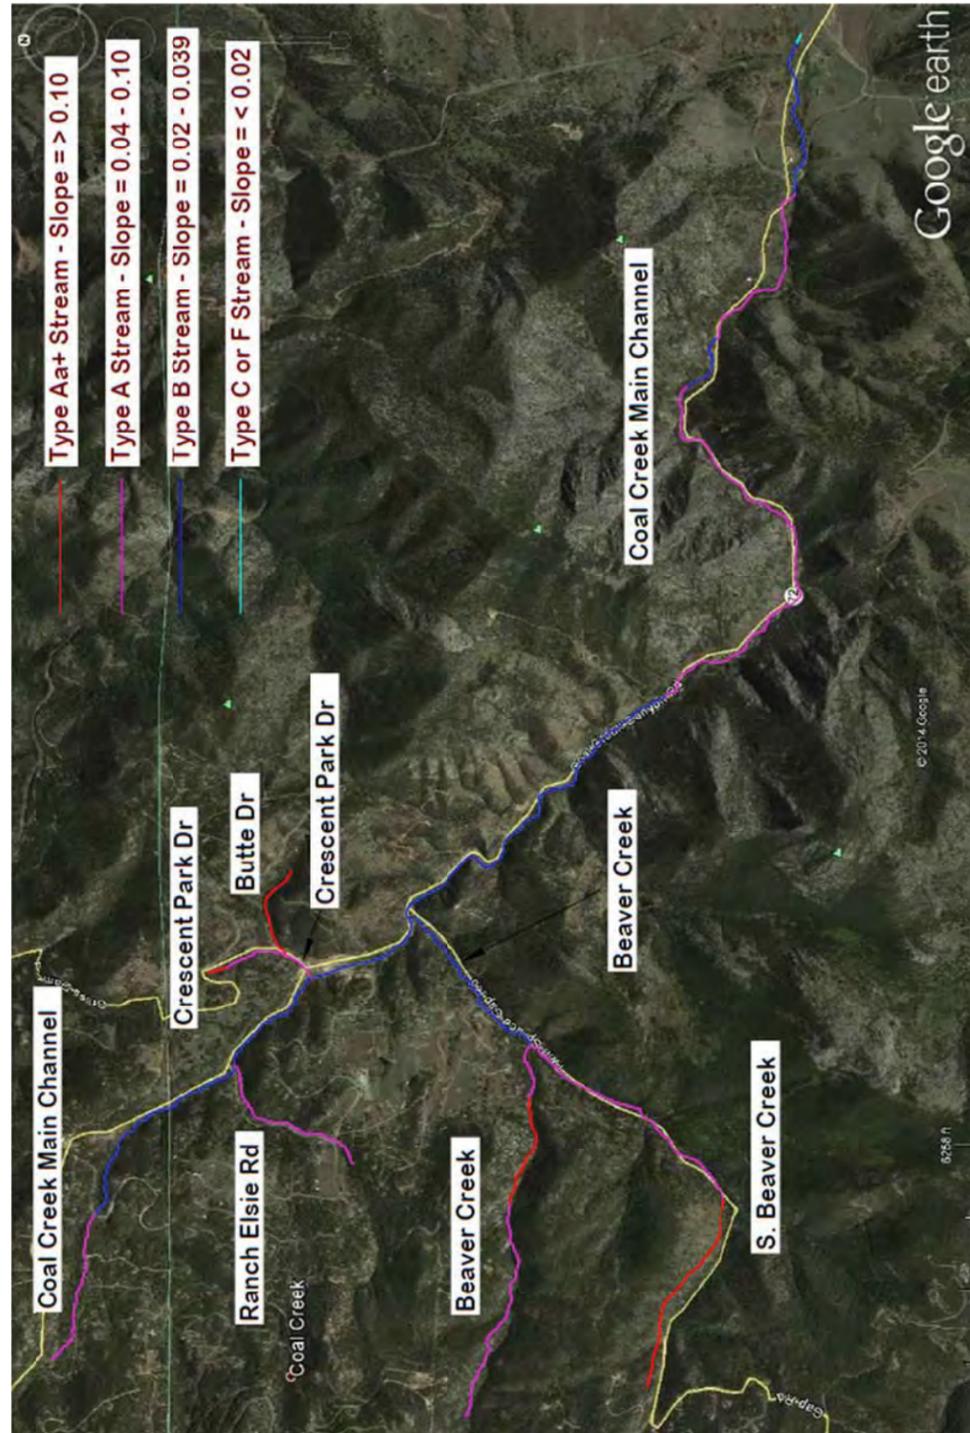
Figure 1 – Stream Classification Results

The location of each of the different stream segments with the resultant stream classification is presented on **Figure 1** with color coding used to identify different stream types.

The four stream types that were found to occur based on the Level I analysis are Types Aa+, A, B and C. Generic descriptions of each of these four stream types is given below:

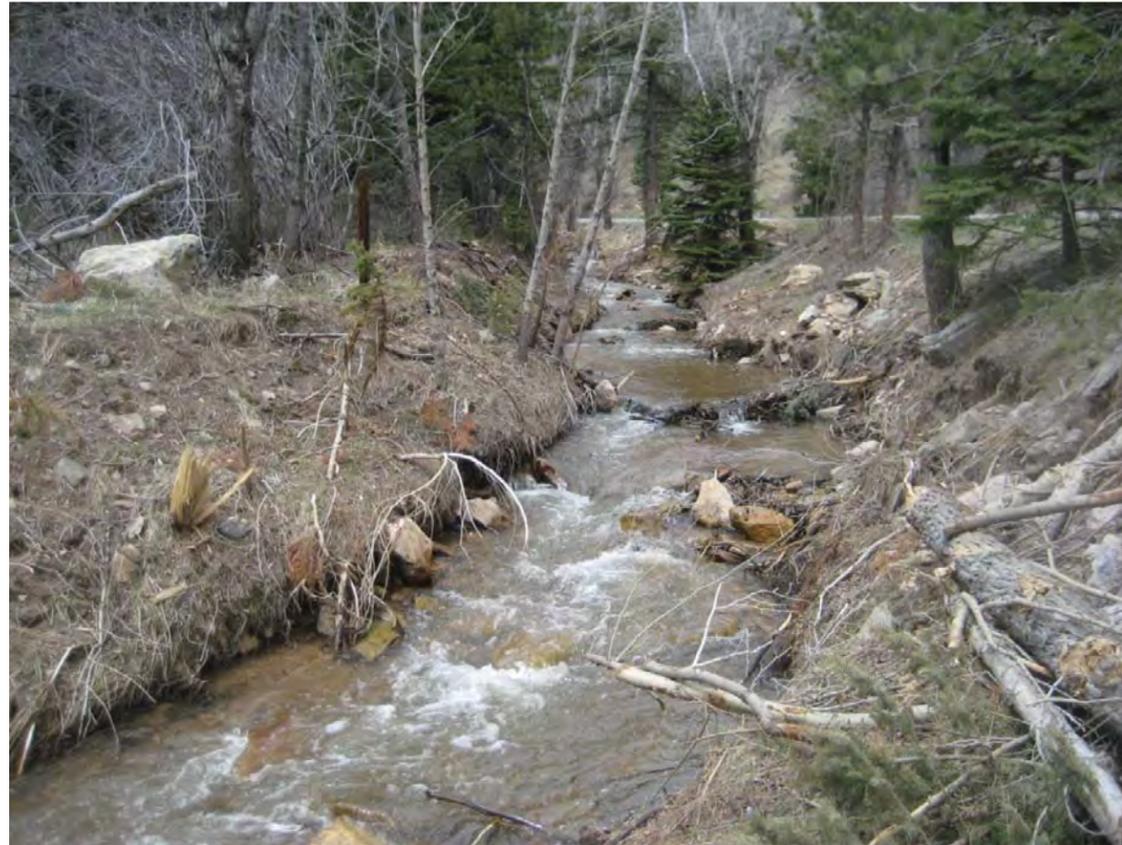
Photo 2 – Type A Section of Coal Creek

Stream Type A streams are defined as “steep, entrenched, cascading, step/pool streams,” with high energy and high debris-transport potential (Rosgen 1996). Type A streams are steeper than Types B and C (average slopes between 0.04 and 0.10 ft/ft), and have slightly lower sinuosity (between 1.0 and 1.2). The meander width ratio of Type A streams typically ranges between 1 and 3 (Rosgen 1996). **Photo 2** gives a representative example of a portion of a Type A channel that was observed at Coal Creek.

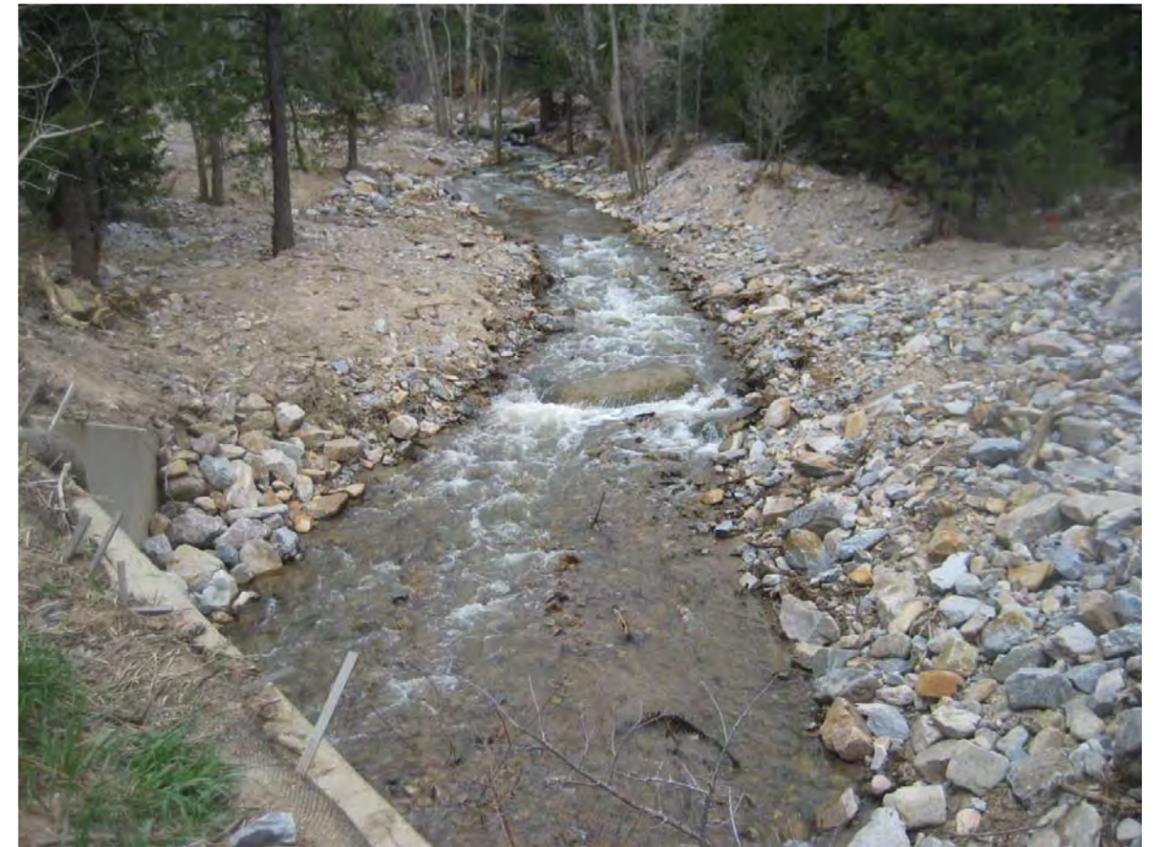
Photo 3 – Type B Section of Coal Creek

Type B streams are defined as having “moderately entrenched, moderate gradient, riffle-dominated channels, with infrequently spaced pools” (Rosgen 1996). The plan, profile, and banks of Type B streams are all considered to be stable. The sinuosity of these stream types are greater than 1.2, with an average slope between 0.02 and 0.039 ft/ft, and a typical meander width ratio between 2 and 8. Type B streams are usually seen in narrower, steeper valleys than Type C streams, and contain colluvial deposition in the reach. Rapids and scour pools are characteristic of Type B streams. **Photo 3** gives a representative example of a portion of a Type B channel that was observed at Coal Creek.

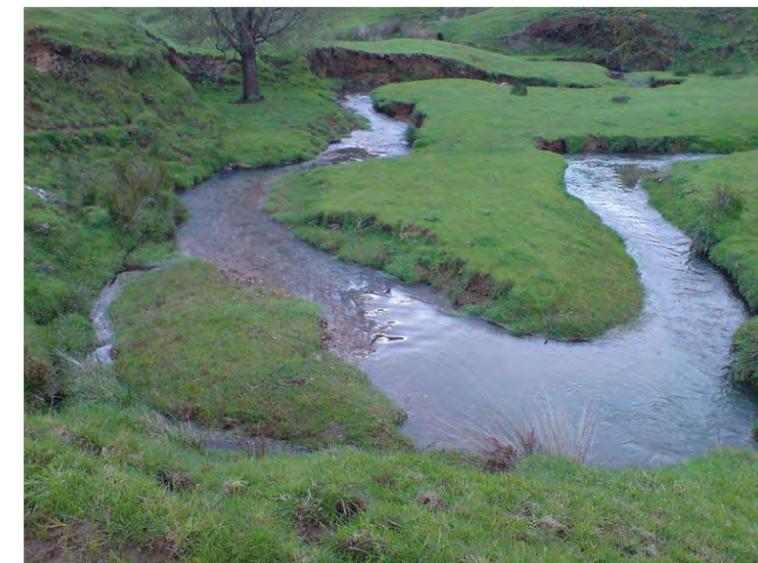
Figure 4 – Example of Riffle/Pool Sequence

Riffle/pool sequences are alternating stretches of shallow, fast-moving sections (riffles) and deeper, slower pools, with glides or runs in between the end of a pool and beginning of the next riffle to allow for gradual bedform transformation. Riffle/pool sequences are typical bedforms seen in meandering, Type C streams (Rosgen 1996). A schematic of a riffle/pool sequence, along with glides and runs, is shown below in **Figure 3** (obtained from the Public Works Research Institute’s Aquatic Restoration Research Center, 2004). A photo of a riffle and pool sequence on a stream is shown in **Figure 4** (public domain, 2007).

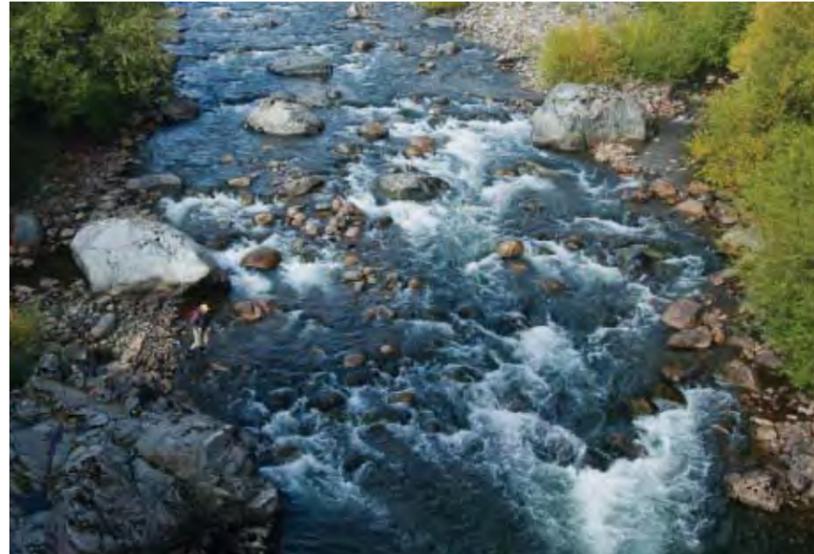
Figure 5 – Example of Rapid and Scour Pool Sequence

Rapids and scour pools are typical bedforms of Type B streams (Rosgen 1996). These bedforms have steeper gradients than riffle/pool sequences and larger bed material. This results in a rougher water surface in the rapids section as water crashes over boulders and cobbles in the channel bed, and irregularly-located scour pools, sometimes called pocket water, exist between the rapids. **Figure 5** shows an example of rapids and scour pools in a stream (image obtained from Deneki Outdoors, 2010).

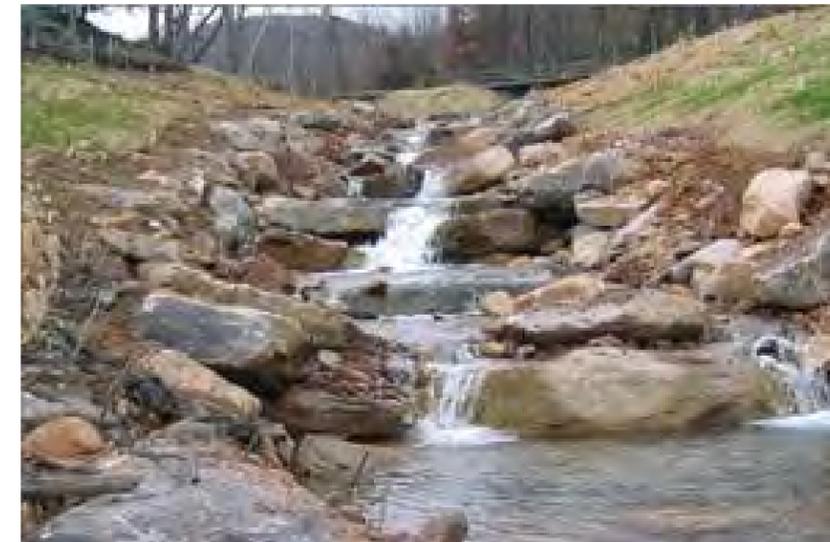
Figure 7 – Example of Step/Pool Sequence

Step/pool sequences are the dominant bedform in Type A streams (Rosgen 1996). Step/pools consist of a series of deep pools with irregularly spaced drops into the pools below. The overall gradient of these channels is steeper than that in Type B or C streams. **Figure 6** demonstrates the plan and profile of a step/pool bedform (Colorado State University, 2014). A photo of a typical step/pool system is shown in **Figure 7** (Image obtained from Moses 2010).

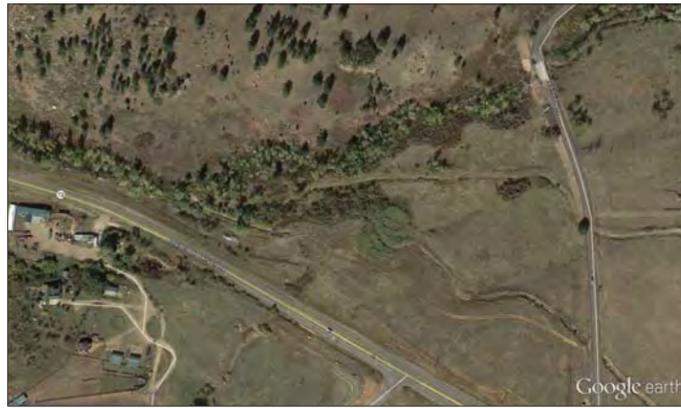
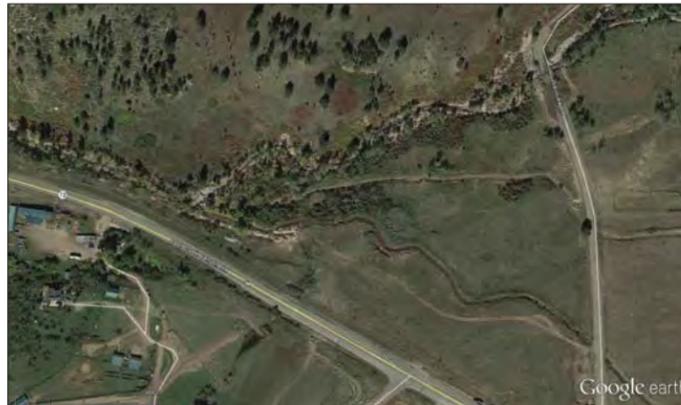
Coal Creek  
 Top: Aerial imagery from 10/7/12  
 Bottom: Aerial imagery from 10/6/13  
 Comments: Noticeable scour and loss of vegetation at channel banks

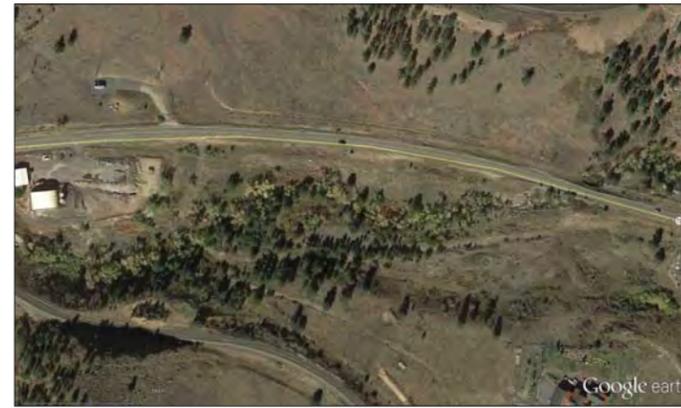
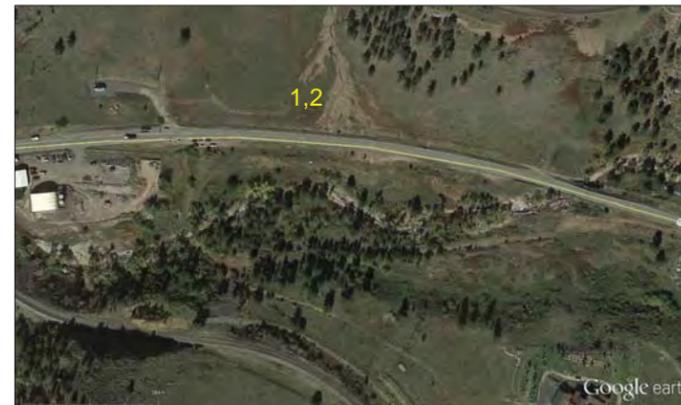
Project No.: 1005-1401	Date: July 2014
Scale: Shown on Images	Drawing No.: 01 of 55

Coal Creek  
 Top: Aerial imagery from 10/7/12  
 Bottom: Aerial imagery from 10/6/13  
 Comments: Noticeable scour and loss of vegetation at channel banks  
 Photos Present: 1 and 2

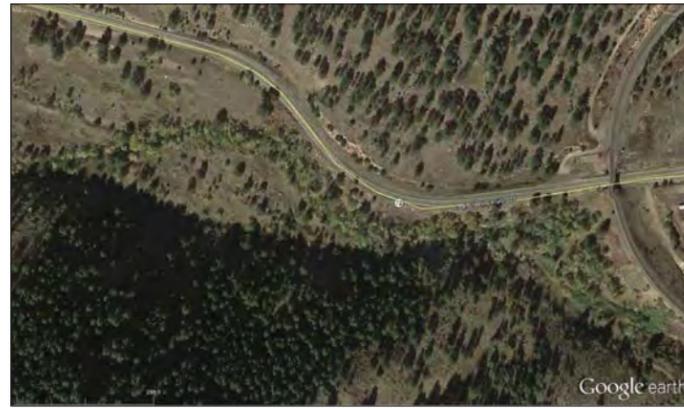
Coal Creek  
 Top: Aerial imagery from 10/7/12  
 Bottom: Aerial imagery from 10/6/13  
 Comments: Noticeable scour and loss of vegetation at channel banks, scour along slope below culvert under Highway 72  
 Photos Present: 3-6

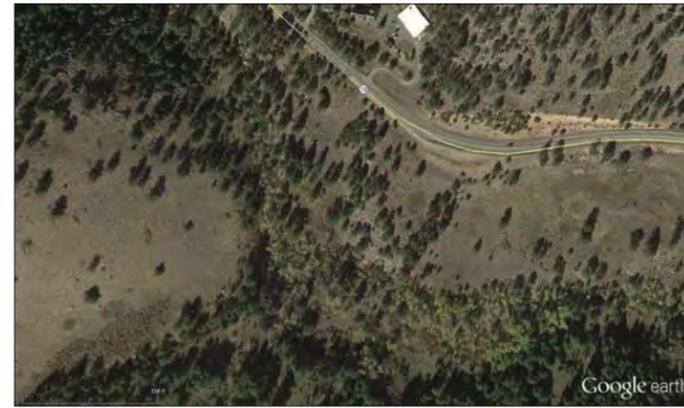
Coal Creek  
 Top: Aerial imagery from 10/7/12  
 Bottom: Aerial imagery from 10/6/13  
 Comments: Noticeable scour and loss of vegetation at channel banks

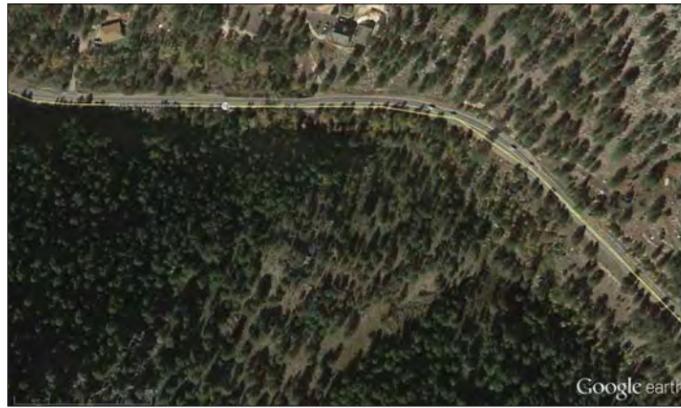
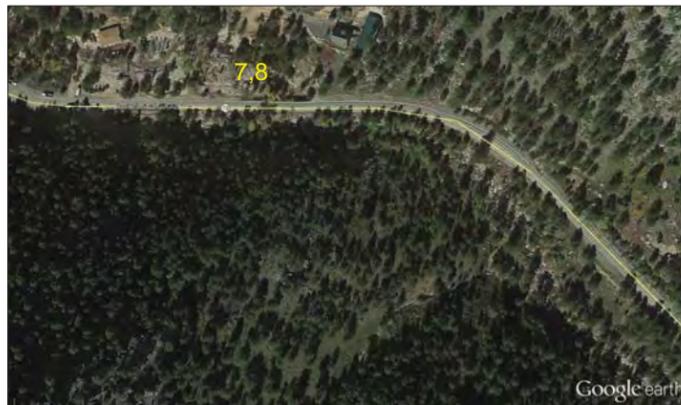
Project No.: 1005-1401	Date: July 2014
Scale: Shown on Images	Drawing No.: 04 of 55

Coal Creek  
 Top: Aerial imagery from 10/7/12  
 Bottom: Aerial imagery from 10/6/13  
 Comments: Noticeable scour and loss of vegetation at channel banks, especially at channel bend as it follows the highway  
 Photos Present: 7 and 8

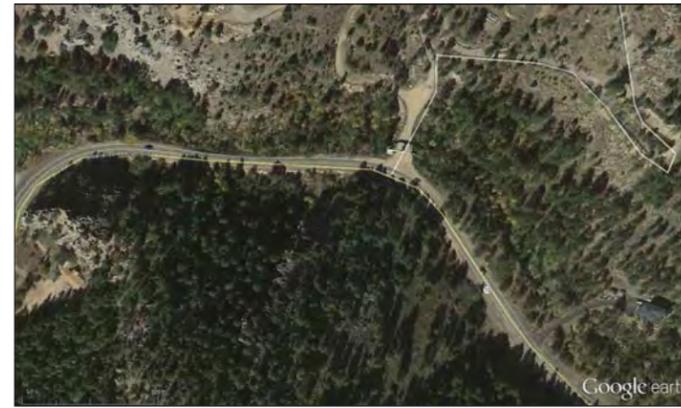
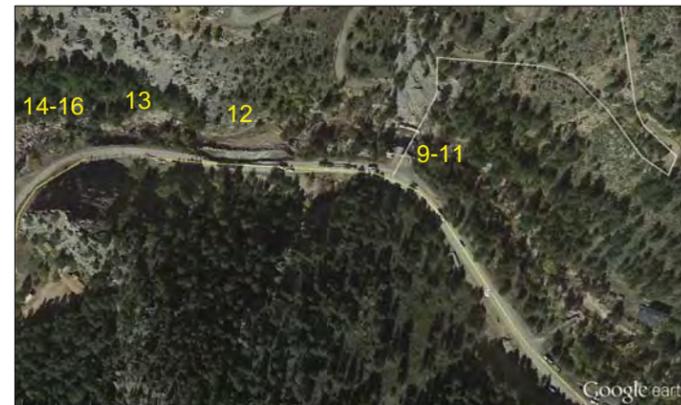
Project No.: 1005-1401	Date: July 2014
Scale: Shown on Images	Drawing No.: 05 of 55

Coal Creek  
 Top: Aerial imagery from 10/7/12  
 Bottom: Aerial imagery from 10/6/13  
 Comments: Noticeable scour and loss of vegetation at channel banks, bridge crossing the creek north of the highway has been destroyed  
 Photos Present: 9-16

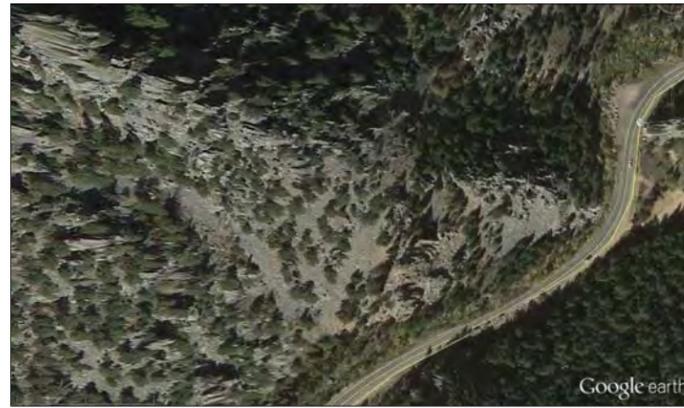
Coal Creek  
 Top: Aerial imagery from 10/7/12  
 Bottom: Aerial imagery from 10/6/13  
 Comments: Large amounts of deterioration to the right channel bank along the highway, and to the highway itself

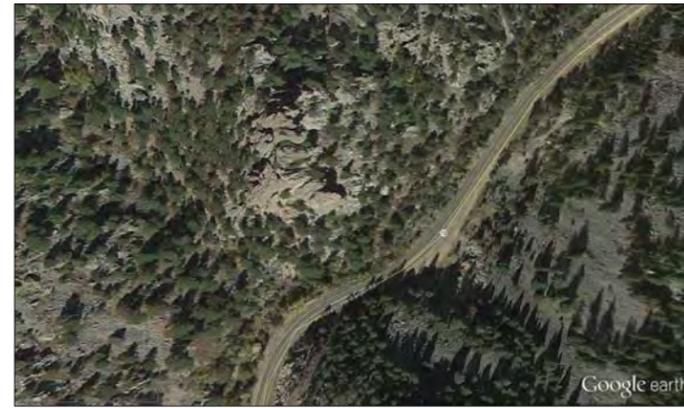
Coal Creek  
 Top: Aerial imagery from 10/7/12  
 Bottom: Aerial imagery from 10/6/13  
 Comments: Large amounts of deterioration to the right channel bank along the highway, and to the highway itself  
 Photos Present: 17 and 18

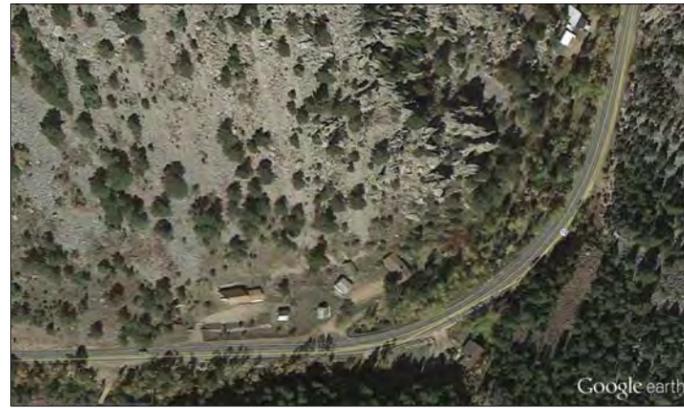
Coal Creek  
 Top: Aerial imagery from 10/7/12  
 Bottom: Aerial imagery from 10/6/13  
 Comments: Noticeable scour and vegetation loss at channel banks, driveways to houses destroyed, amount of damage upstream of the highway crossing is inconclusive due to vegetation impeding the view, although heavy scouring appears likely  
 Photos Present: 19-24

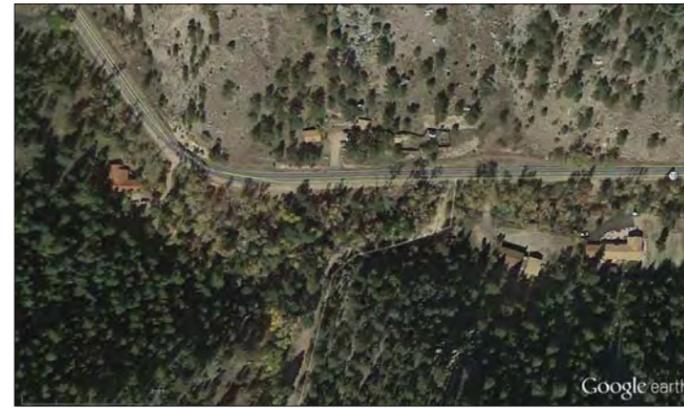
Coal Creek  
 Top: Aerial imagery from 10/7/12  
 Bottom: Aerial imagery from 10/6/13  
 Comments: Noticeable scour and vegetation loss at channel banks, driveways to houses destroyed, deterioration to highway on opposite side of the road from the creek  
 Photos Present: 25-28

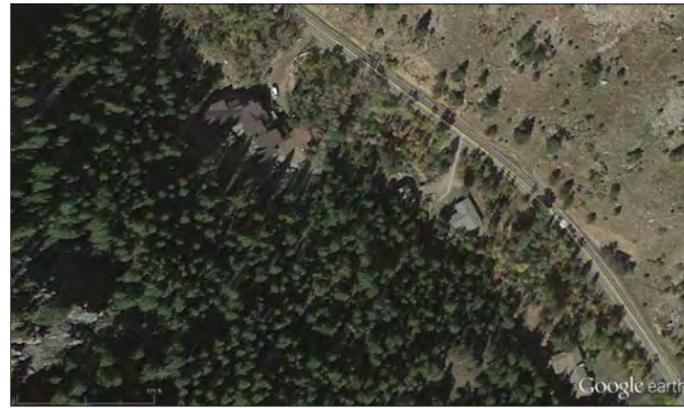
Coal Creek  
 Top: Aerial imagery from 10/7/12  
 Bottom: Aerial imagery from 10/6/13  
 Comments: Noticeable scour and vegetation loss at channel banks, driveways to houses destroyed

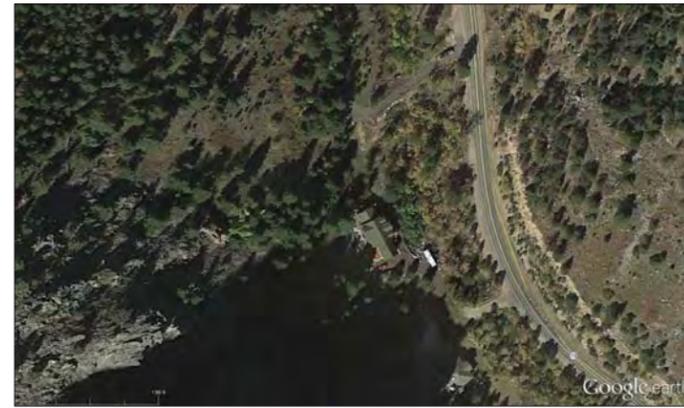
Coal Creek  
 Top: Aerial imagery from 10/7/12  
 Bottom: Aerial imagery from 10/6/13  
 Comments: Noticeable scour and vegetation loss at channel banks, driveways to houses destroyed  
 Photos Present: 29 and 30

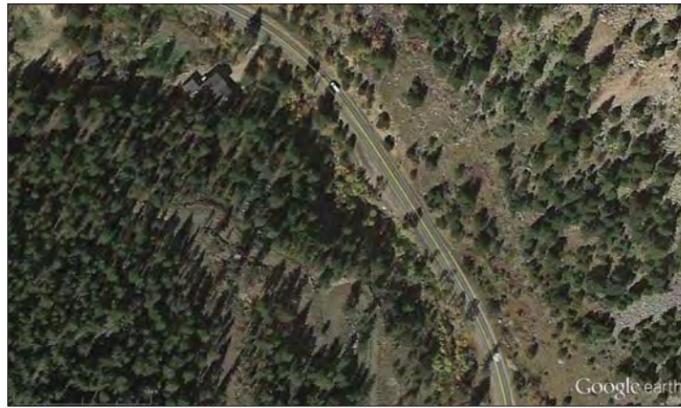
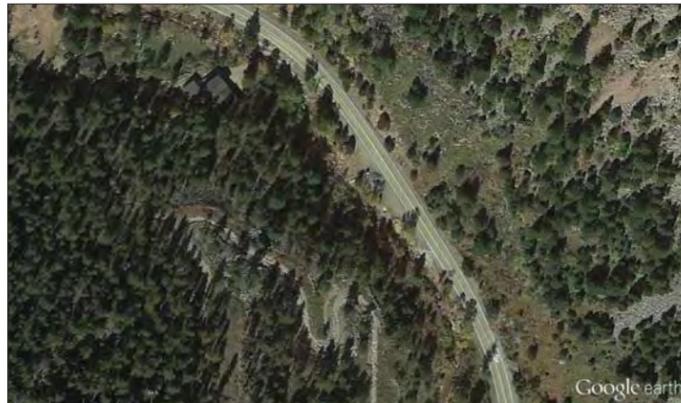
Project No.: 1005-1401	Date: July 2014
Scale: Shown on Images	Drawing No.: 12 of 55

Coal Creek  
 Top: Aerial imagery from 10/7/12  
 Bottom: Aerial imagery from 10/6/13  
 Comments: Noticeable scour and vegetation loss at channel banks, driveways to houses destroyed, deterioration of roadways higher uphill may have potentially impacted the creek as well

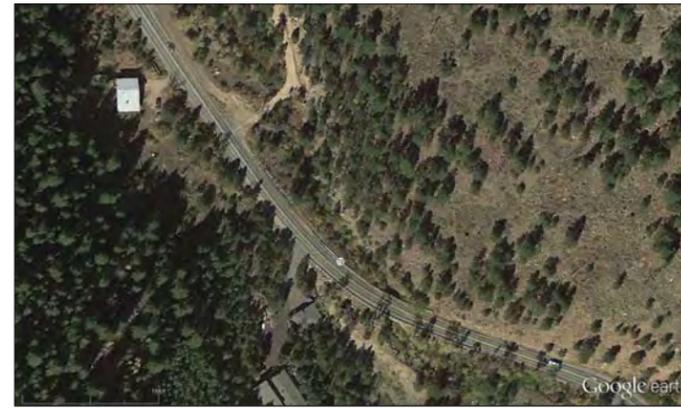
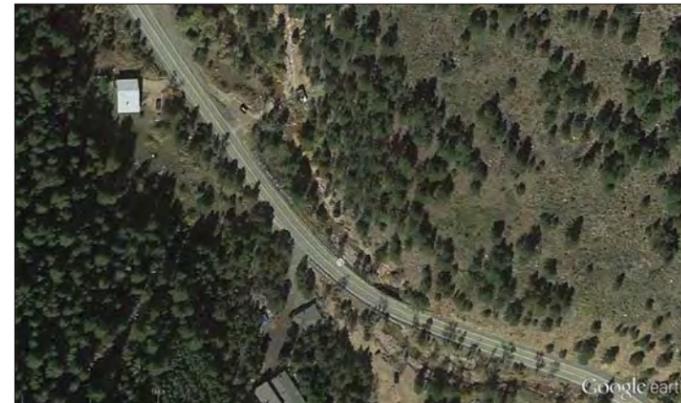
Project No.: 1005-1401	Date: July 2014
Scale: Shown on Images	Drawing No.: 13 of 55

Coal Creek  
 Top: Aerial imagery from 10/7/12  
 Bottom: Aerial imagery from 10/6/13  
 Comments: Noticeable scour and vegetation loss at channel banks, roadway crossing the creek northeast of the highway destroyed, highway crossing over the creek still intact, although scour and deterioration present at outfall

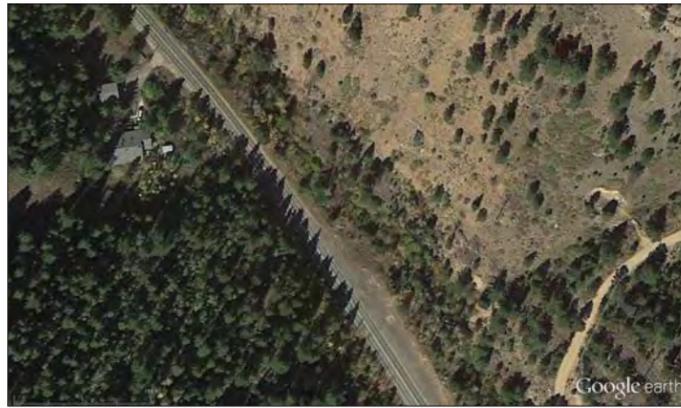
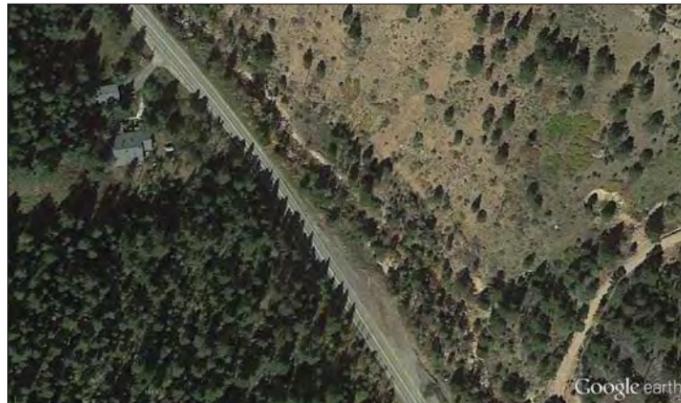
Project No.: 1005-1401	Date: July 2014
Scale: Shown on Images	Drawing No.: 14 of 55

Coal Creek  
 Top: Aerial imagery from 10/7/12  
 Bottom: Aerial imagery from 10/6/13  
 Comments: Noticeable scour and vegetation loss at channel banks, deterioration of highway shoulder on the side adjacent to the creek

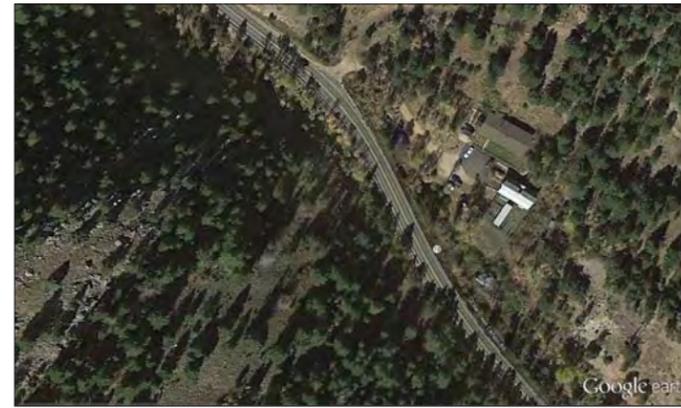
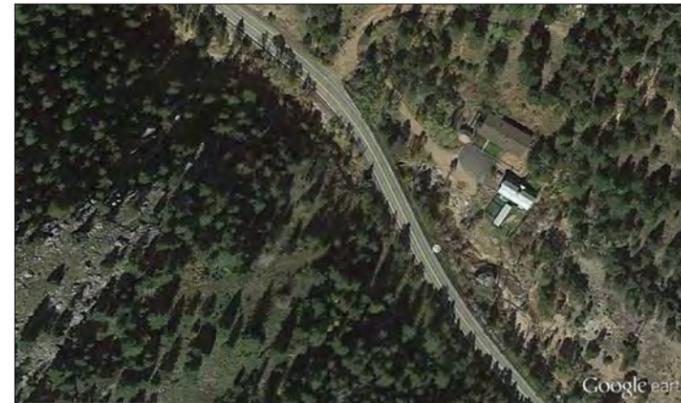
Project No.: 1005-1401	Date: July 2014
Scale: Shown on Images	Drawing No.: 15 of 55

Coal Creek  
 Top: Aerial imagery from 10/7/12  
 Bottom: Aerial imagery from 10/6/13  
 Comments: Noticeable scour and vegetation loss at channel banks, no apparent damage to highway crossing over the creek

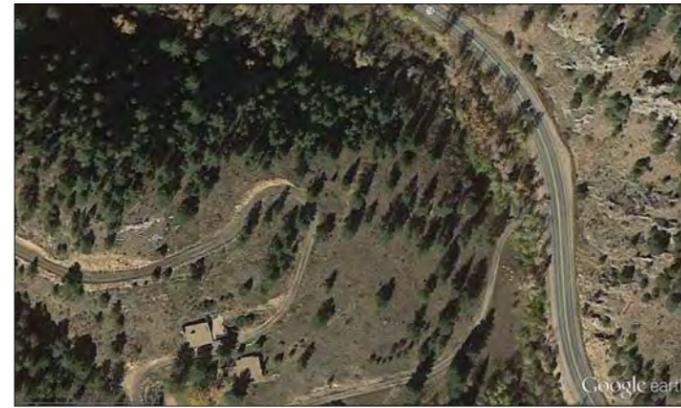
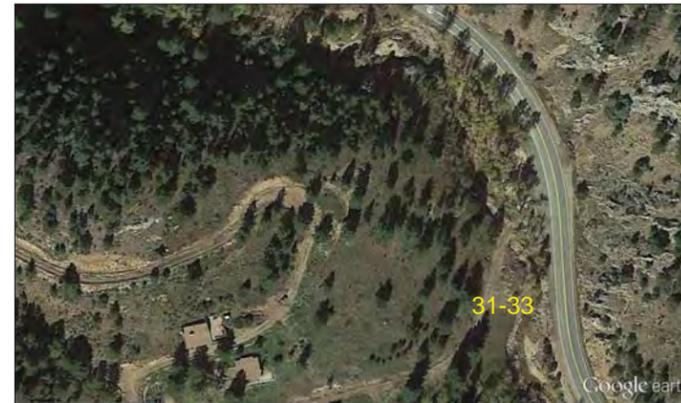
Project No.: 1005-1401	Date: July 2014
Scale: Shown on Images	Drawing No.: 17 of 55

Top: Aerial imagery from 10/7/12  
 Bottom: Aerial imagery from 10/6/13

Comments: Noticeable scour and vegetation loss along channel banks, roadway crossing the creek west of the highway destroyed, deterioration of roadways up on the hill west of the creek potentially may have impacted the stream

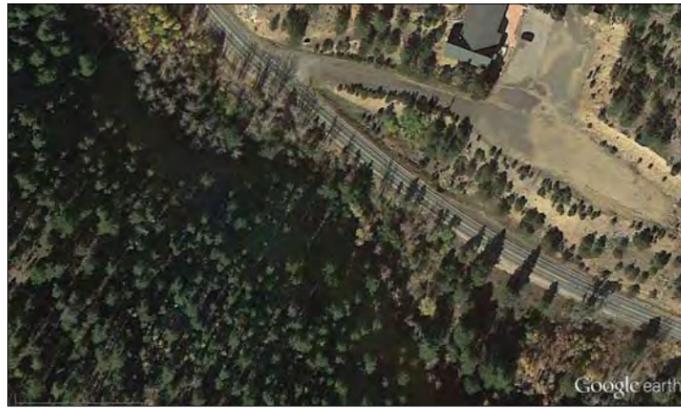
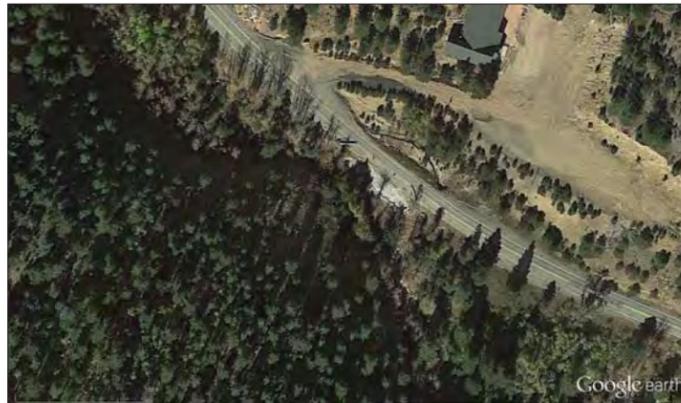
Project No.: 1005-1401	Date: July 2014
Scale: Shown on Images	Drawing No.: 18 of 55

Coal Creek  
 Top: Aerial imagery from 10/7/12  
 Bottom: Aerial imagery from 10/6/13  
 Comments: Scour and deterioration evident on driveway and surrounding land on the opposite side of the highway from the stream. Noticeable damage to left bank of the creek where it abuts against the highway

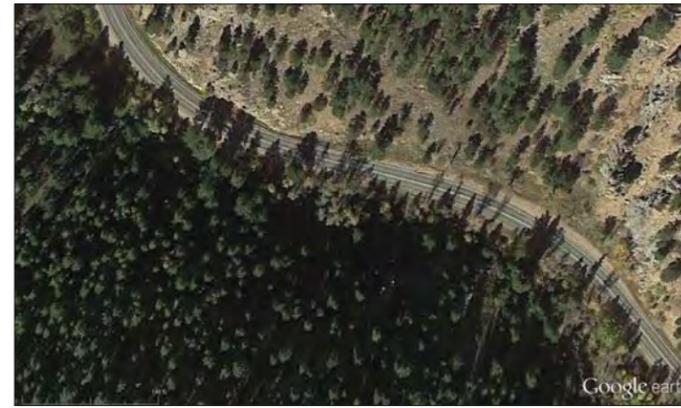
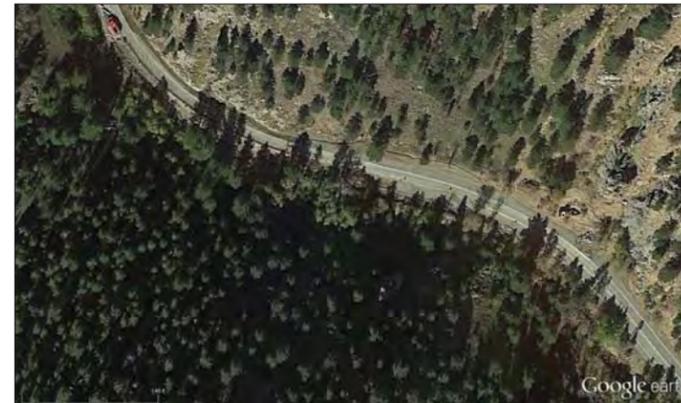
Project No.: 1005-1401	Date: July 2014
Scale: Shown on Images	Drawing No.: 19 of 55

Coal Creek  
 Top: Aerial imagery from 10/7/12  
 Bottom: Aerial imagery from 10/6/13  
 Comments: Deterioration evident on both shoulders of the highway

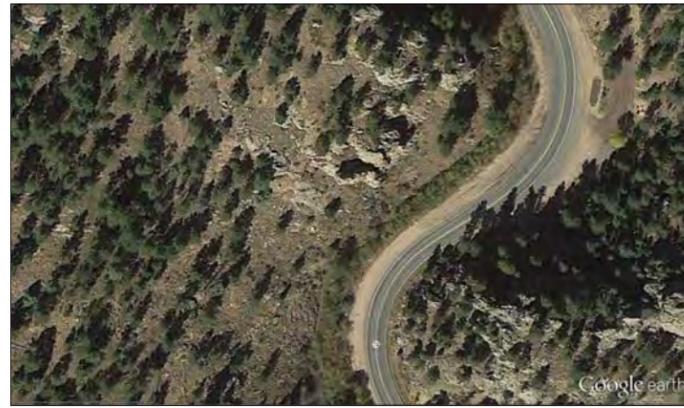
Coal Creek  
 Top: Aerial imagery from 10/7/12  
 Bottom: Aerial imagery from 10/6/13  
 Comments: Some scour and vegetation loss present, deterioration of highway shoulder on the side of the creek potentially impacted the stream  
 Photos Present: 34 and 35

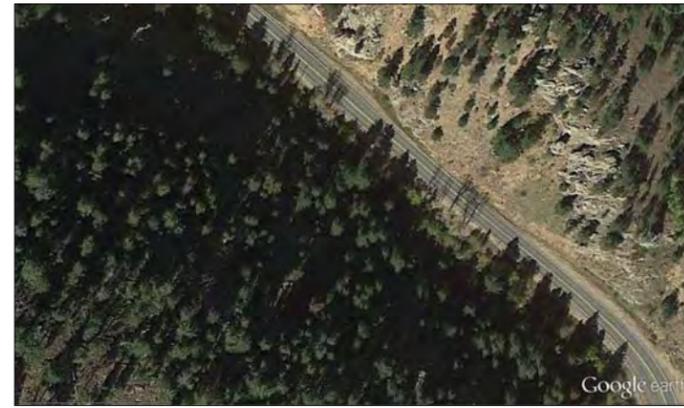
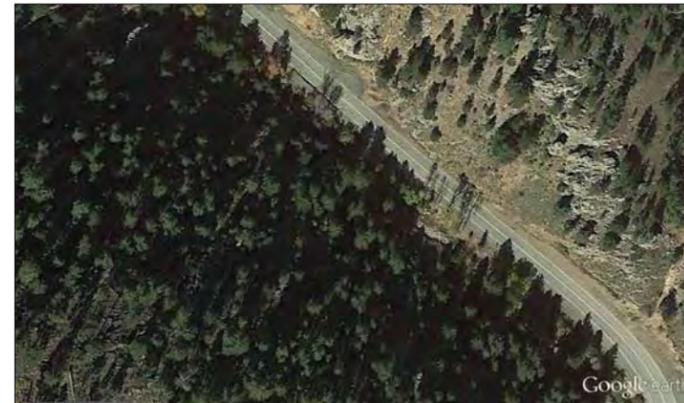
Project No.: 1005-1401	Date: July 2014
Scale: Shown on Images	Drawing No.: 21 of 55

Coal Creek  
 Top: Aerial imagery from 10/7/12  
 Bottom: Aerial imagery from 10/6/13  
 Comments: Some scour evident at channel banks, difficult to observe deterioration at creek due to vegetation and shadows obscuring imagery
