# Upper Coal Creek Watershed Restoration Master Plan

November 2014

Jefferson and Boulder Counties

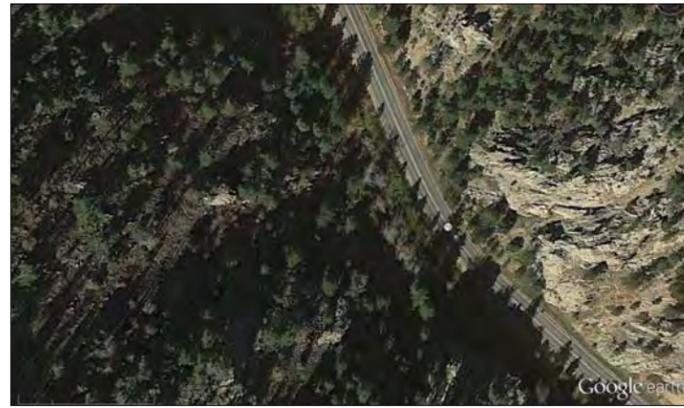
Coal Creek  
 Top: Aerial imagery from 10/7/12  
 Bottom: Aerial imagery from 10/6/13  
 Comments: Damage to highway seen on side opposite of the creek

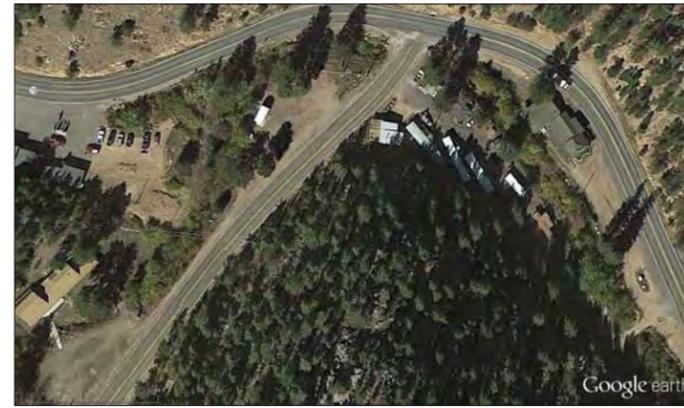
Coal Creek  
 Top: Aerial imagery from 10/7/12  
 Bottom: Aerial imagery from 10/6/13  
 Comments: Scour observed at channel banks, deterioration of highway and side roads leading to possible change in creek flow path at time of flooding, although if that occurred, it has already been repaired

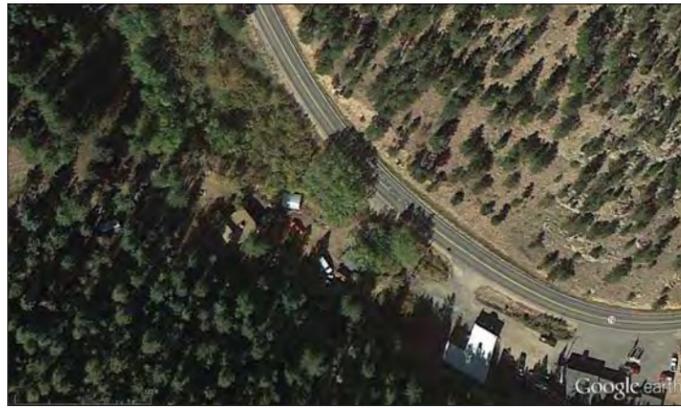
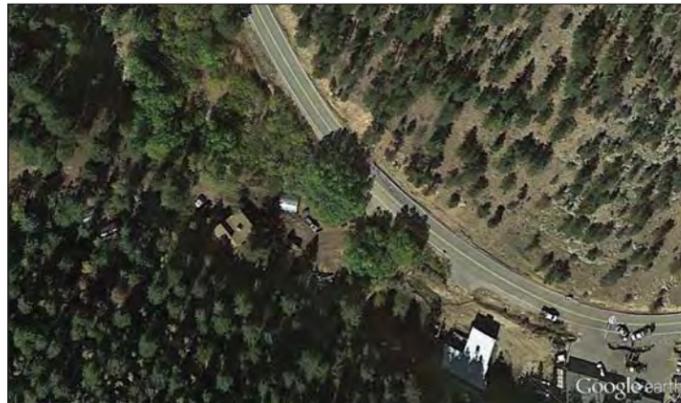
Project No.: 1005-1401	Date: July 2014
Scale: Shown on Images	Drawing No.: 24 of 55

Top: Aerial imagery from 10/7/12  
 Bottom: Aerial imagery from 10/6/13

Comments: Noticeable scour along the highway, smaller driveway destroyed, failure observed to culvert under larger driveway, exposing the creek to the surface

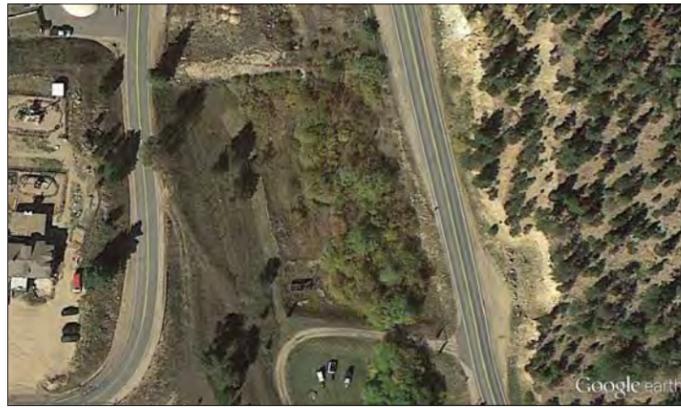
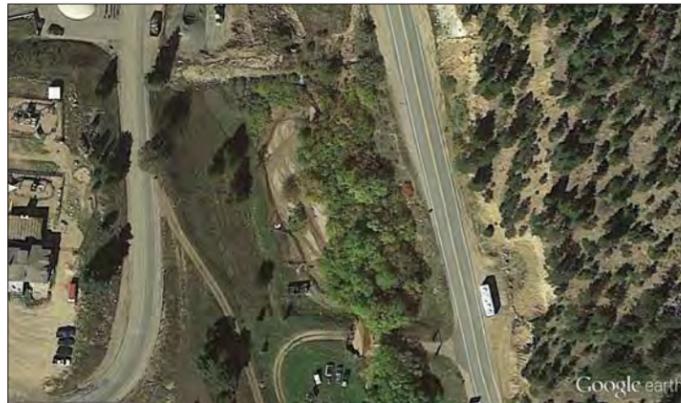
Project No.: 1005-1401	Date: July 2014
Scale: Shown on Images	Drawing No.: 26 of 55

Coal Creek  
 Top: Aerial imagery from 10/7/12  
 Bottom: Aerial imagery from 10/6/13  
 Comments: Dirt road crossing the creek has failed, sediment deposition has occurred at this location  
 Photos Present: 36 and 37

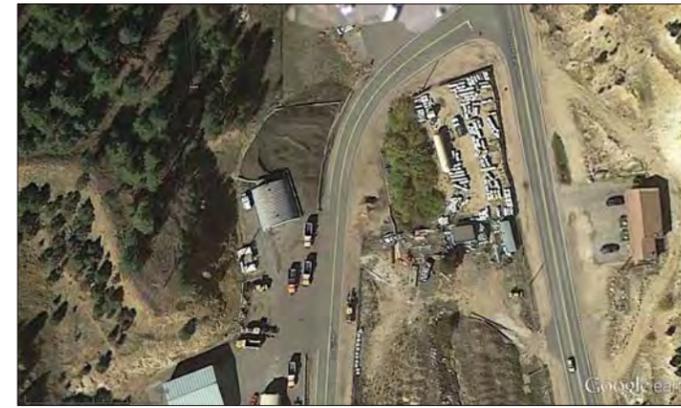
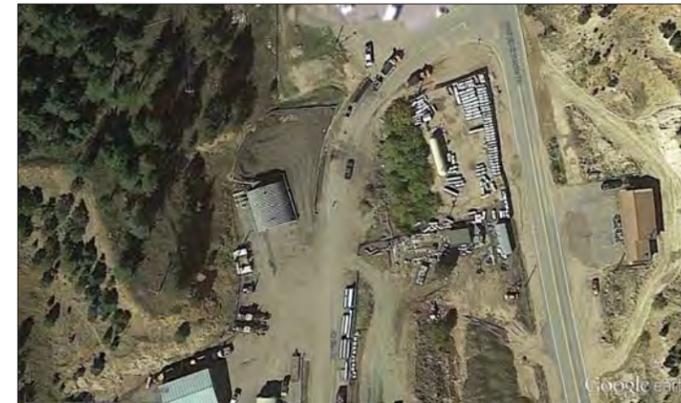
Project No.: 1005-1401	Date: July 2014
Scale: Shown on Images	Drawing No.: 27 of 55

Coal Creek  
 Top: Aerial imagery from 10/7/12  
 Bottom: Aerial imagery from 10/6/13  
 Comments: Scour present at culvert outfall, no apparent damage upstream of culverts

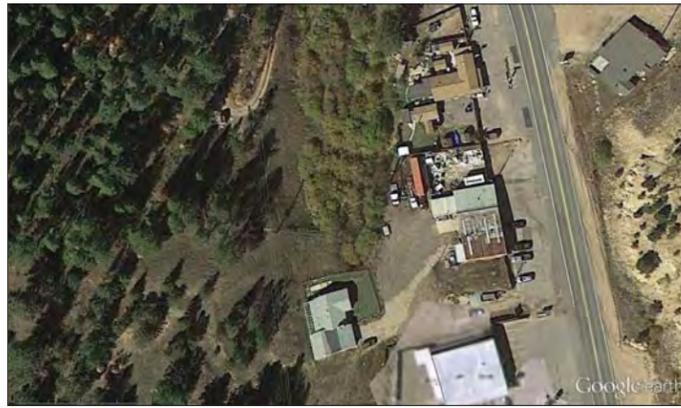
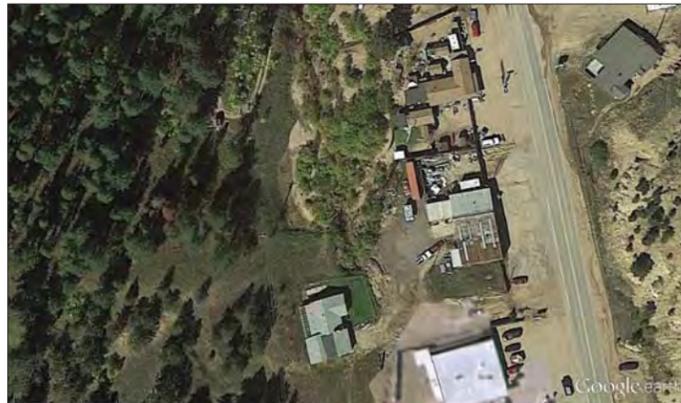
Project No.: 1005-1401	Date: July 2014
Scale: Shown on Images	Drawing No.: 28 of 55

Coal Creek  
 Top: Aerial imagery from 10/7/12  
 Bottom: Aerial imagery from 10/6/13  
 Comments: Noticeable scour and vegetation loss along channel banks and in overbanks on both sides of the creek

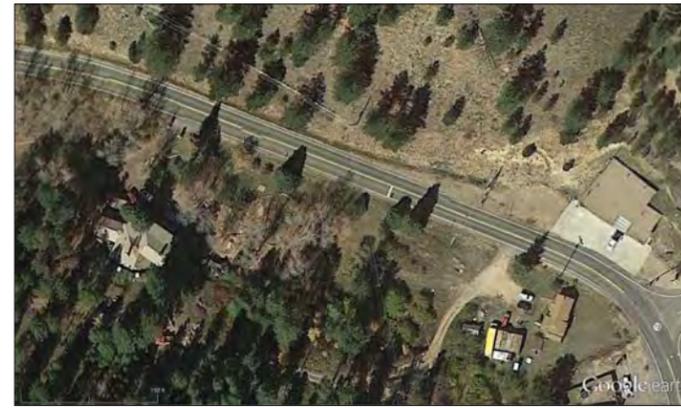
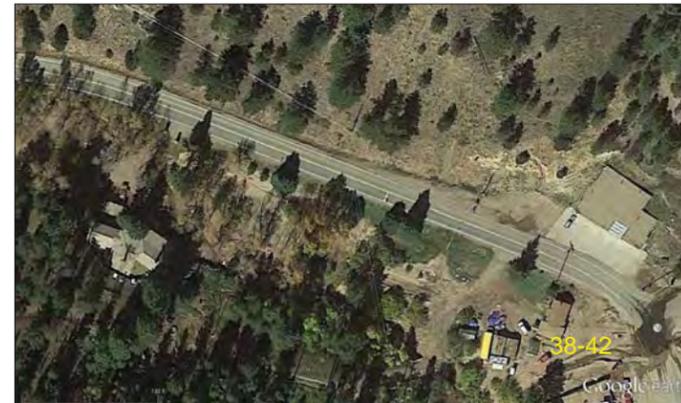
Project No.: 1005-1401	Date: July 2014
Scale: Shown on Images	Drawing No.: 29 of 55

Coal Creek  
 Top: Aerial imagery from 10/7/12  
 Bottom: Aerial imagery from 10/6/13  
 Comments: Low visibility of creek itself, although scouring of the overbanks is evident. Large failure of the highway where it crosses a side channel (since repaired), potentially impacting the main creek as flows from this side channel entered the creek  
 Photos Present: 38-42

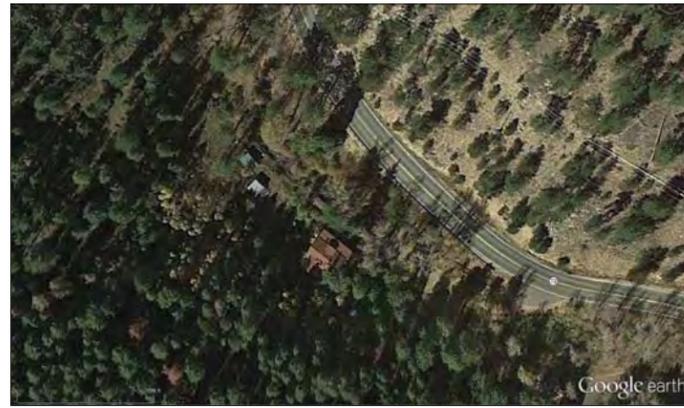
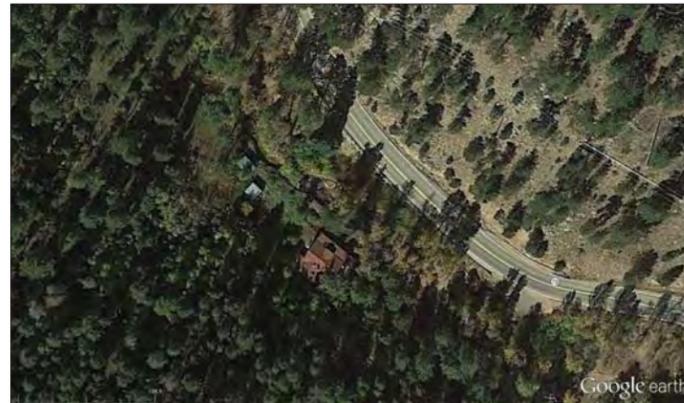
Project No.: 1005-1401	Date: July 2014
Scale: Shown on Images	Drawing No.: 30 of 55

Coal Creek  
 Top: Aerial imagery from 10/7/12  
 Bottom: Aerial imagery from 10/6/13  
 Comments: Possible scour of channel banks, no apparent deterioration of overbanks

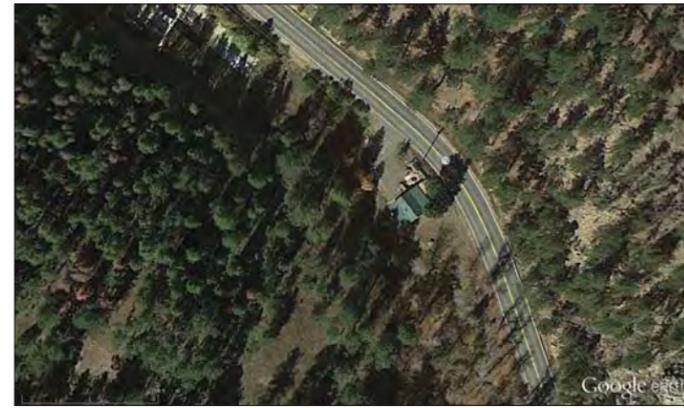
Coal Creek  
 Top: Aerial imagery from 10/7/12  
 Bottom: Aerial imagery from 10/6/13  
 Comments: Possible scour of channel banks, noticeable deterioration of both highway shoulders

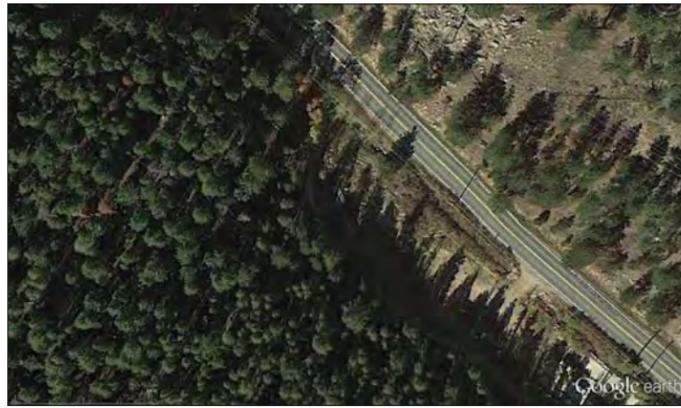
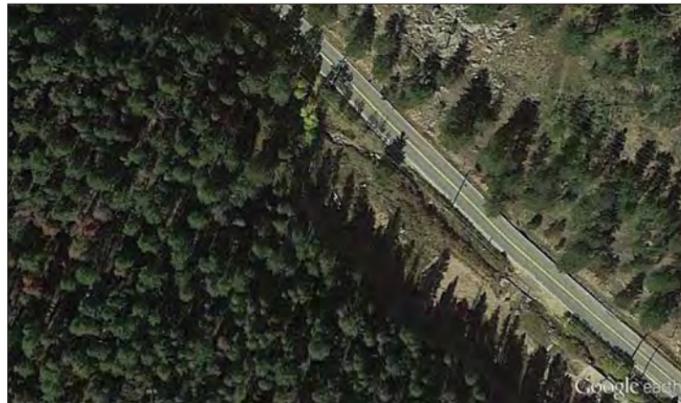
Project No.: 1005-1401	Date: July 2014
Scale: Shown on Images	Drawing No.: 32 of 55

Coal Creek  
 Top: Aerial imagery from 10/7/12  
 Bottom: Aerial imagery from 10/6/13  
 Comments: Scour along channel banks, failure of driveway crossing the creek southwest of the highway

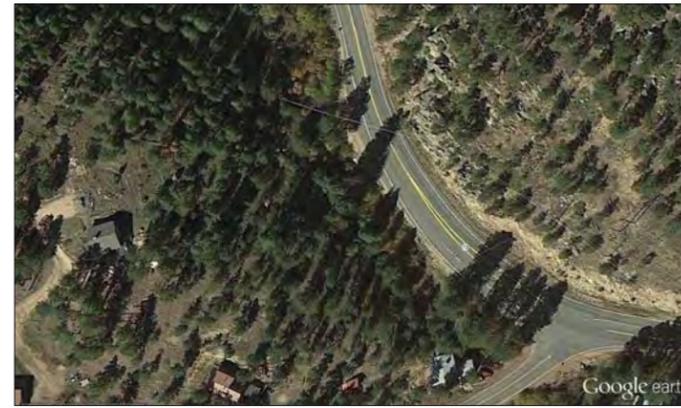
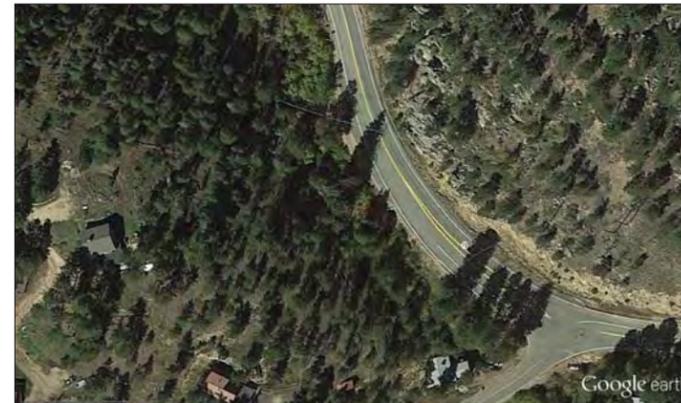
Project No.: 1005-1401	Date: July 2014
Scale: Shown on Images	Drawing No.: 33 of 55

Coal Creek  
 Top: Aerial imagery from 10/7/12  
 Bottom: Aerial imagery from 10/6/13  
 Comments: Some scouring around culvert under road crossing, but culvert appears to have remained intact

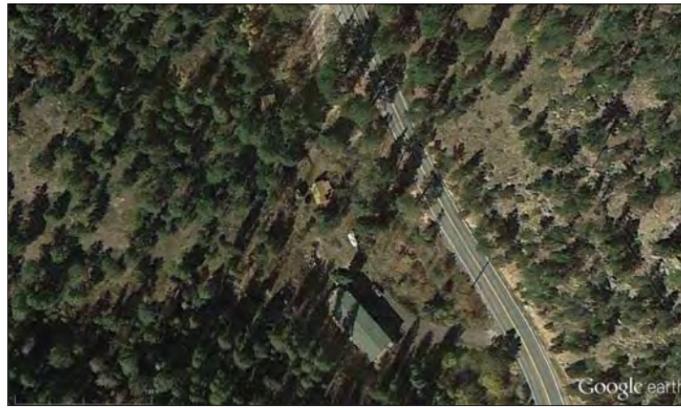
Project No.: 1005-1401	Date: July 2014
Scale: Shown on Images	Drawing No.: 34 of 55

Coal Creek  
 Top: Aerial imagery from 10/7/12  
 Bottom: Aerial imagery from 10/6/13  
 Comments: Little apparent damage present, driveway crossing creek remains intact

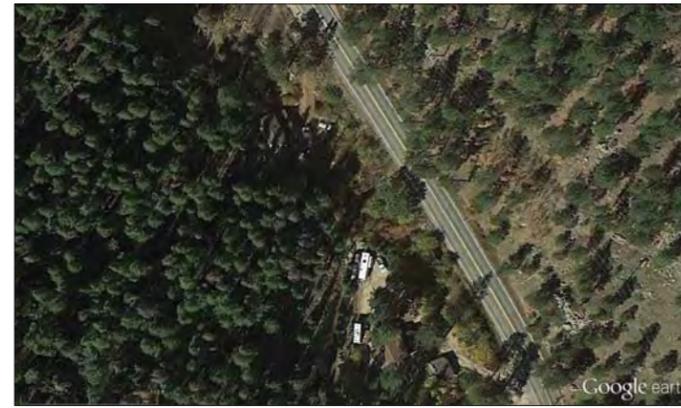
Project No.: 1005-1401	Date: July 2014
Scale: Shown on Images	Drawing No.: 35 of 55

Coal Creek  
 Top: Aerial imagery from 10/7/12  
 Bottom: Aerial imagery from 10/6/13  
 Comments: Some deterioration around driveways possible, little other changes observable

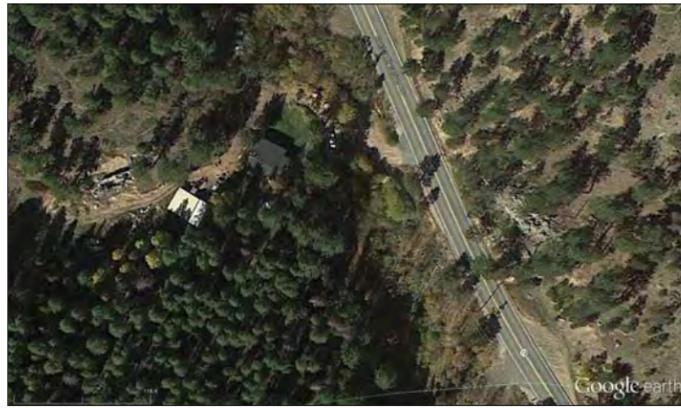
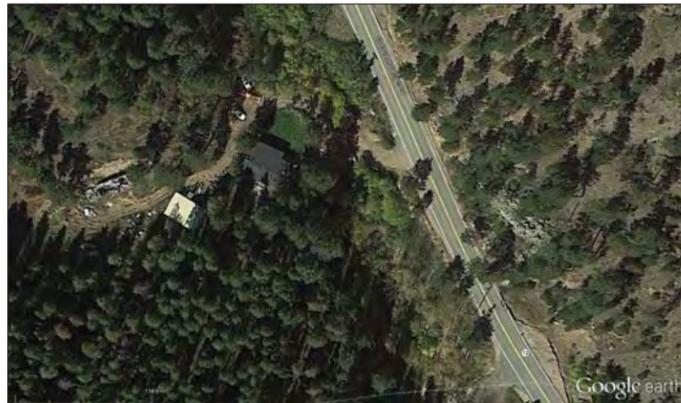
Project No.: 1005-1401	Date: July 2014
Scale: Shown on Images	Drawing No.: 36 of 55

Coal Creek  
 Top: Aerial imagery from 10/7/12  
 Bottom: Aerial imagery from 10/6/13  
 Comments: Scouring along the highway on the opposite side from the creek

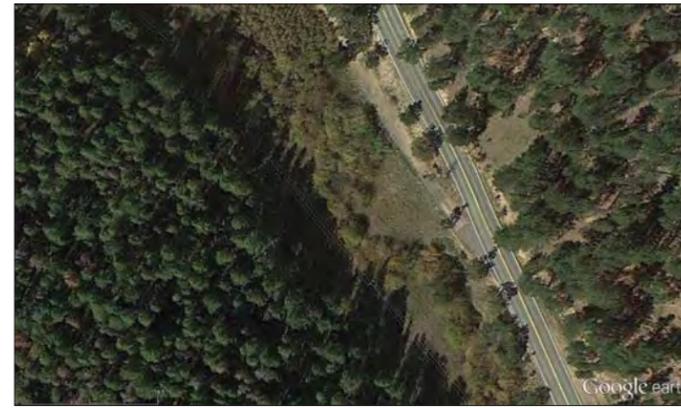
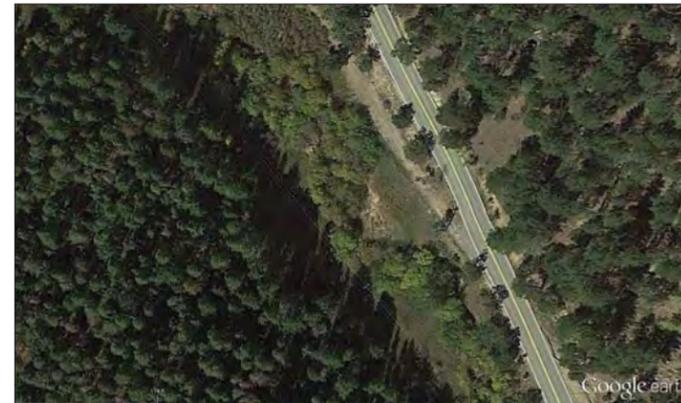
Project No.: 1005-1401	Date: July 2014
Scale: Shown on Images	Drawing No.: 37 of 55

Coal Creek  
 Top: Aerial imagery from 10/7/12  
 Bottom: Aerial imagery from 10/6/13  
 Comments: Scouring along the highway on the opposite side from the creek, some erosion on the left overbank between the creek and the highway

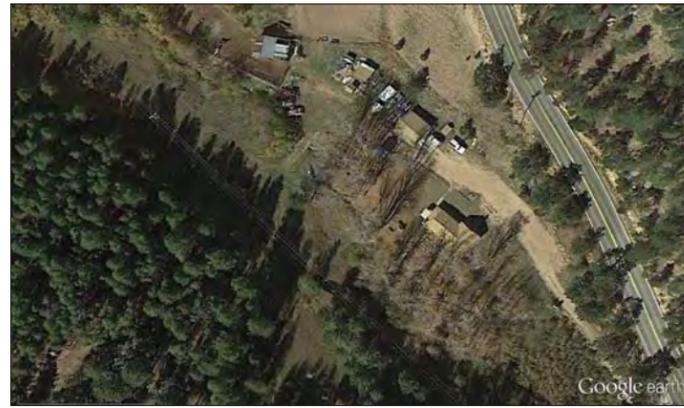
Coal Creek  
 Top: Aerial imagery from 10/7/12  
 Bottom: Aerial imagery from 10/6/13  
 Comments: Scouring along the channel banks at some locations, failure of small bridge crossing creek behind houses

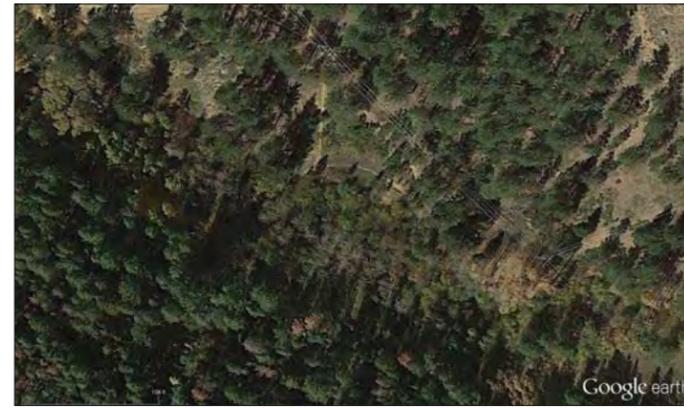
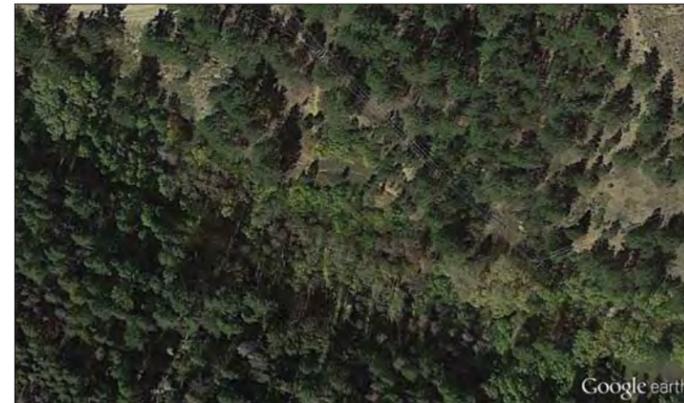
Project No.: 1005-1401	Date: July 2014
Scale: Shown on Images	Drawing No.: 39 of 55

Coal Creek  
 Top: Aerial imagery from 10/7/12  
 Bottom: Aerial imagery from 10/6/13  
 Comments: No apparent deterioration of the creek

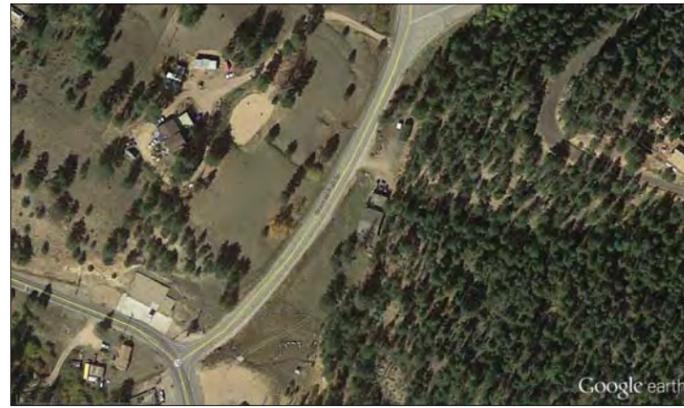
Tributary along Crescent Park Drive  
 Top: Aerial imagery from 10/7/12  
 Bottom: Aerial imagery from 10/6/13  
 Comments: Severe scouring along Crescent Park Drive, damage to Highway 72

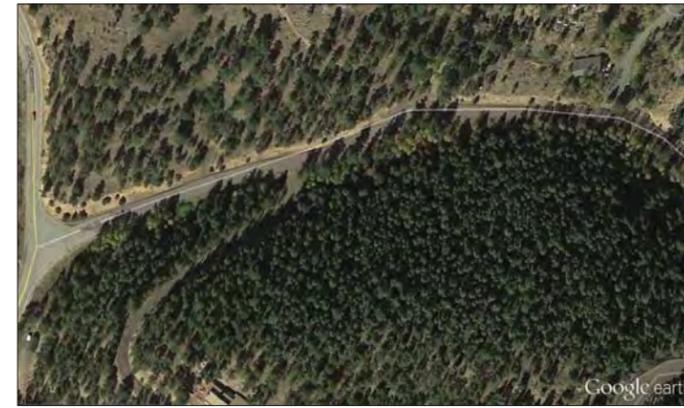
Tributary along Butte Drive  
 Top: Aerial imagery from 10/7/12  
 Bottom: Aerial imagery from 10/6/13  
 Comments: Scouring evident upstream and downstream of driveway to the south of the road  
 Photos Present: 50 and 51

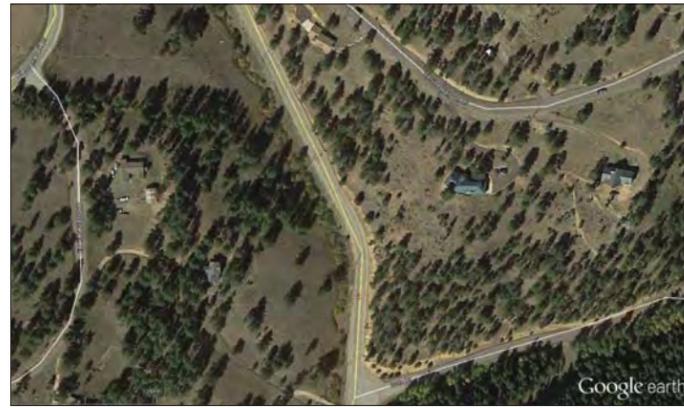
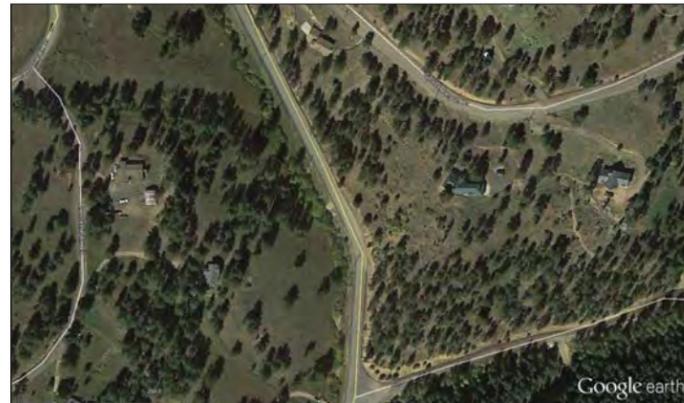
Project No.: 1005-1401	Date: July 2014
Scale: Shown on Images	Drawing No.: 42 of 55

Tributary along Crescent Park Drive  
 Top: Aerial imagery from 10/7/12  
 Bottom: Aerial imagery from 10/6/13  
 Comments: Minor scouring evident along road. No significant vegetation loss noticeable.

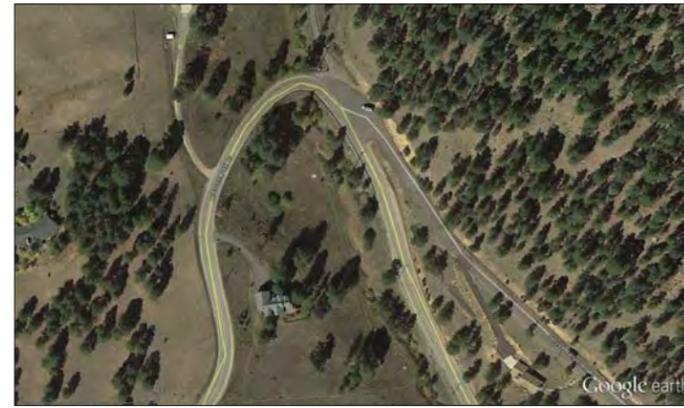
Tributary along Crescent Park Drive  
 Top: Aerial imagery from 10/7/12  
 Bottom: Aerial imagery from 10/6/13  
 Comments: Some scouring has occurred below the culvert crossing under Crescent Park Drive  
 Photos Present: 52

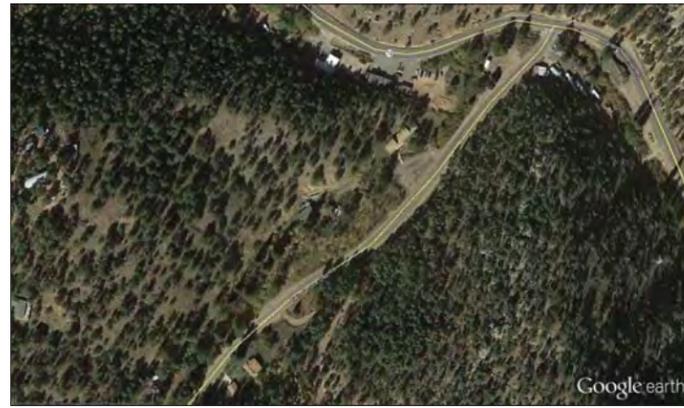
Beaver Creek  
 Top: Aerial imagery from 10/7/12  
 Bottom: Aerial imagery from 10/6/13  
 Comments: Driveways crossing over the tributary were destroyed by the flooding  
 Photos Present: 48

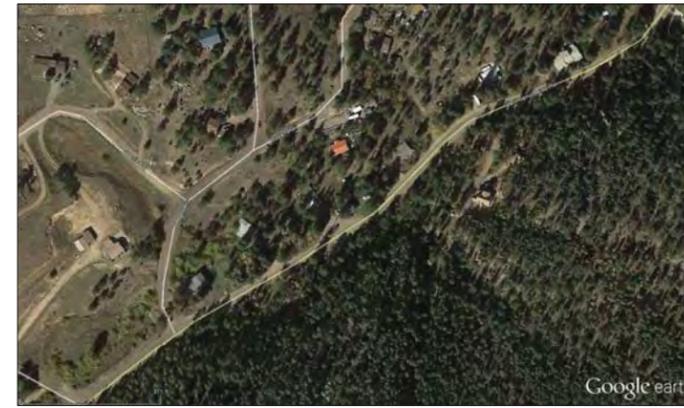
Beaver Creek  
 Top: Aerial imagery from 10/7/12  
 Bottom: Aerial imagery from 10/6/13  
 Comments: Scouring and vegetation loss apparent upstream of Burland Drive  
 Photos Present: 49

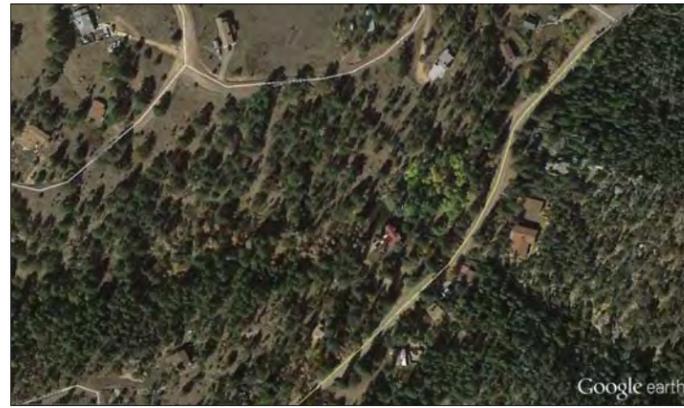
Beaver Creek and S. Beaver Creek  
 Top: Aerial imagery from 10/7/12  
 Bottom: Aerial imagery from 10/6/13  
 Comments: Backyard pond of residential structure north of road has been washed away

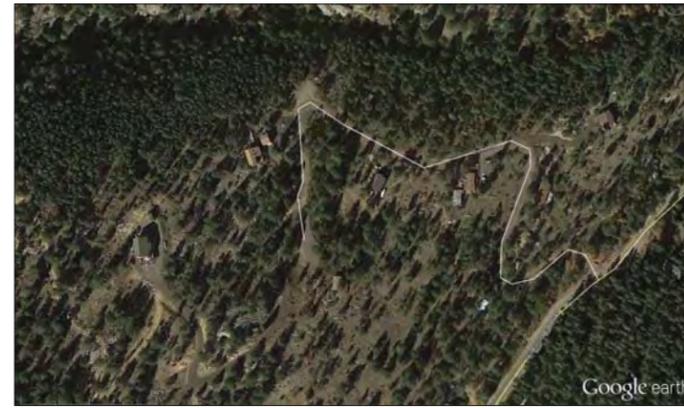
Beaver Creek and S. Beaver Creek  
 Top: Aerial imagery from 10/7/12  
 Bottom: Aerial imagery from 10/6/13  
 Comments: Degradation present at residential driveways crossing the stream

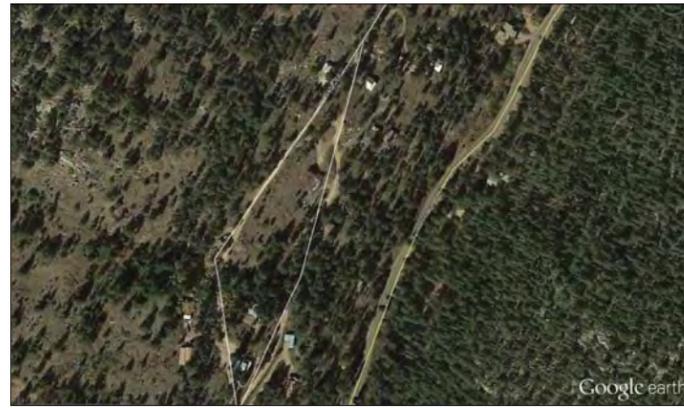
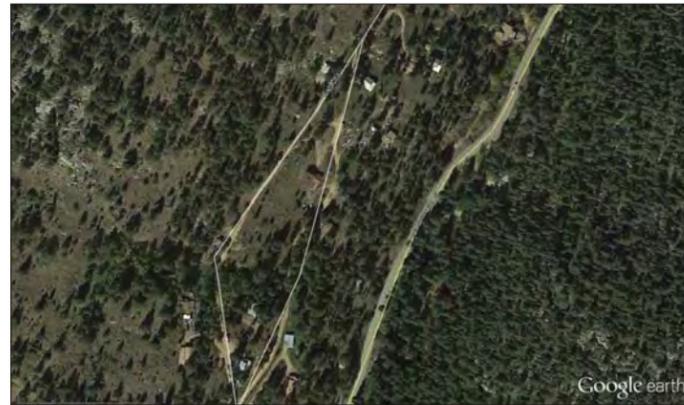
Project No.: 1005-1401	Date: July 2014
Scale: Shown on Images	Drawing No.: 48 of 55

S. Beaver Creek  
 Top: Aerial imagery from 10/7/12  
 Bottom: Aerial imagery from 10/6/13  
 Comments: Apparent scouring to the channel is present.  
 No significant loss of vegetation evident

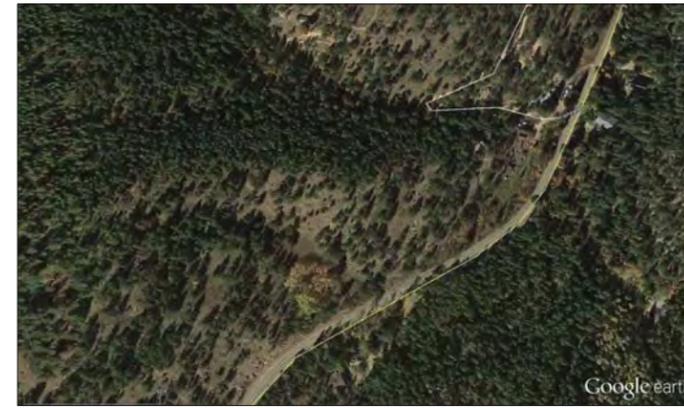
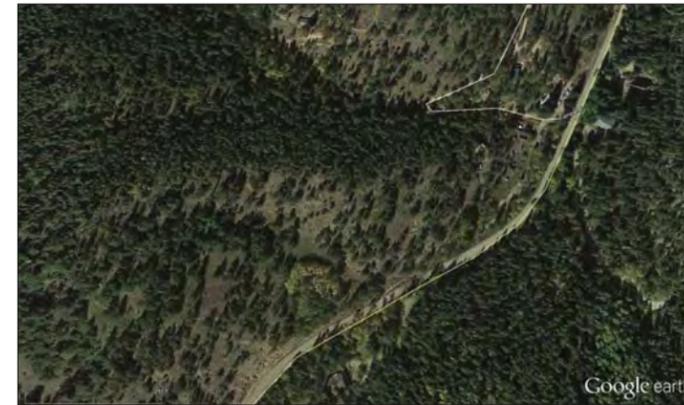
Project No.: 1005-1401	Date: July 2014
Scale: Shown on Images	Drawing No.: 49 of 55

S. Beaver Creek  
 Top: Aerial imagery from 10/7/12  
 Bottom: Aerial imagery from 10/6/13  
 Comments: Scouring to channel is evident along the left bend the stream makes along the road

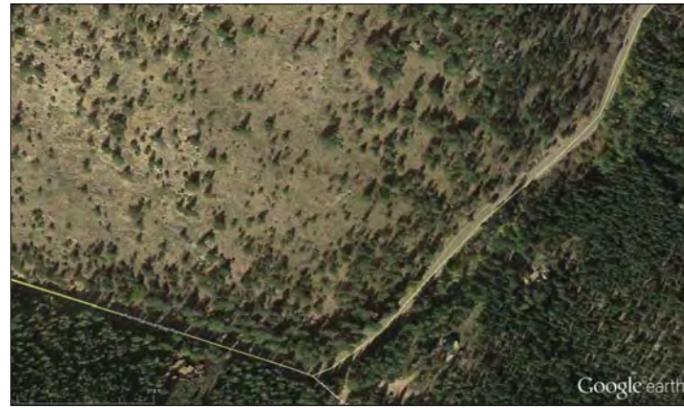
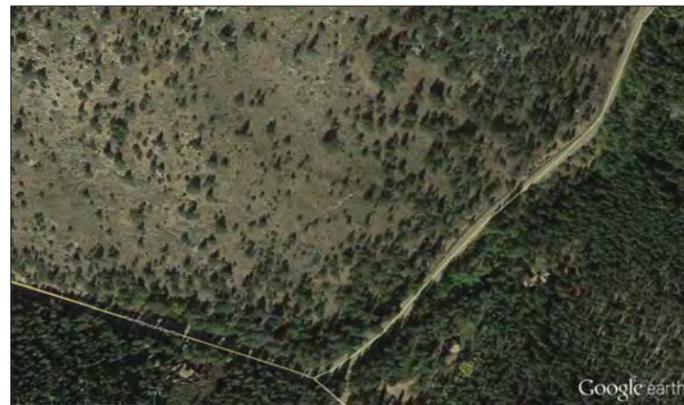
Project No.: 1005-1401	Date: July 2014
Scale: Shown on Images	Drawing No.: 50 of 55

S. Beaver Creek  
 Top: Aerial imagery from 10/7/12  
 Bottom: Aerial imagery from 10/6/13  
 Comments: Road appears to have deteriorated along the stream

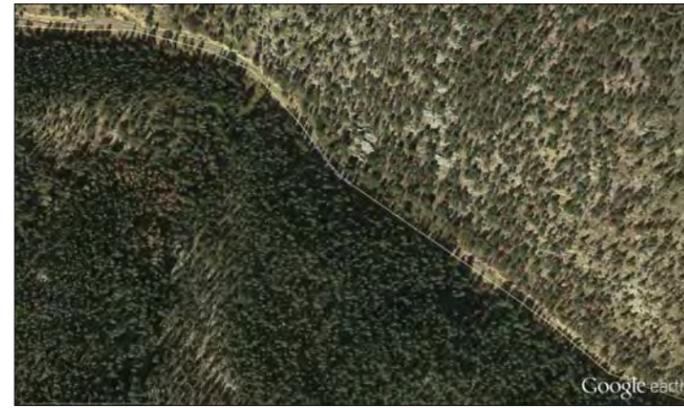
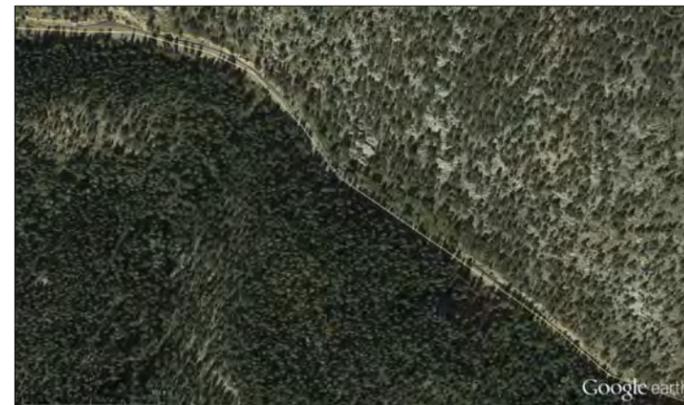
Project No.: 1005-1401	Date: July 2014
Scale: Shown on Images	Drawing No.: 51 of 55

S. Beaver Creek  
 Top: Aerial imagery from 10/7/12  
 Bottom: Aerial imagery from 10/6/13  
 Comments: No noticeable degradation to road, channel, or vegetation

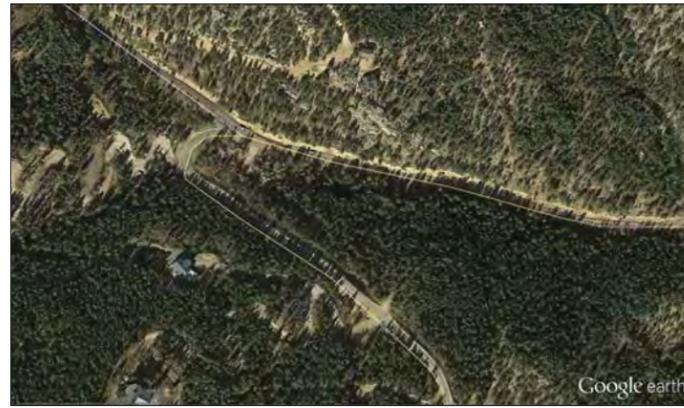
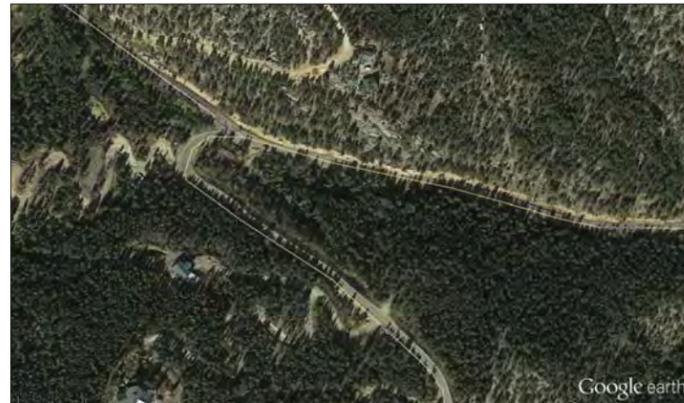
Project No.: 1005-1401	Date: July 2014
Scale: Shown on Images	Drawing No.: 52 of 55

S. Beaver Creek  
 Top: Aerial imagery from 10/7/12  
 Bottom: Aerial imagery from 10/6/13  
 Comments: No noticeable degradation to road, channel, or vegetation

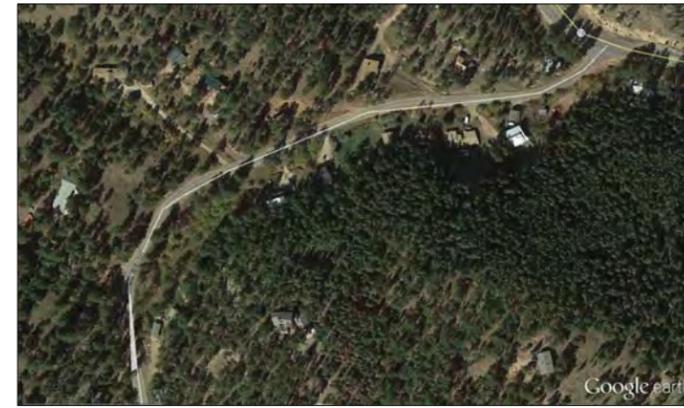
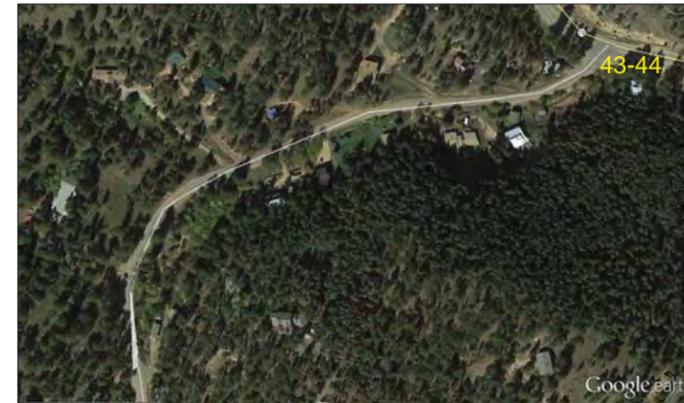
Project No.: 1005-1401	Date: July 2014
Scale: Shown on Images	Drawing No.: 53 of 55

Tributary along Ranch Elsie Road  
 Top: Aerial imagery from 10/7/12  
 Bottom: Aerial imagery from 10/6/13  
 Comments: Scouring evident in channel, residential driveways crossing tributary were damaged or destroyed  
 Photos Present: 43 and 44

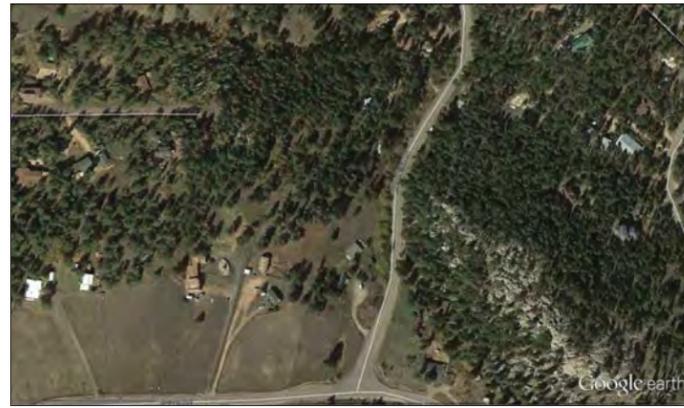
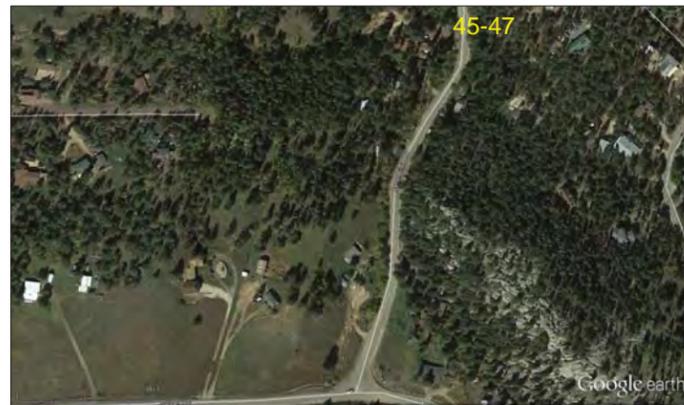
Tributary along Ranch Elsie Road  
Top: Aerial imagery from 10/7/12  
Bottom: Aerial imagery from 10/6/13  
Comments: Scouring evident in channel, residential driveways crossing tributary were damaged or destroyed  
Photos Present: 45-47

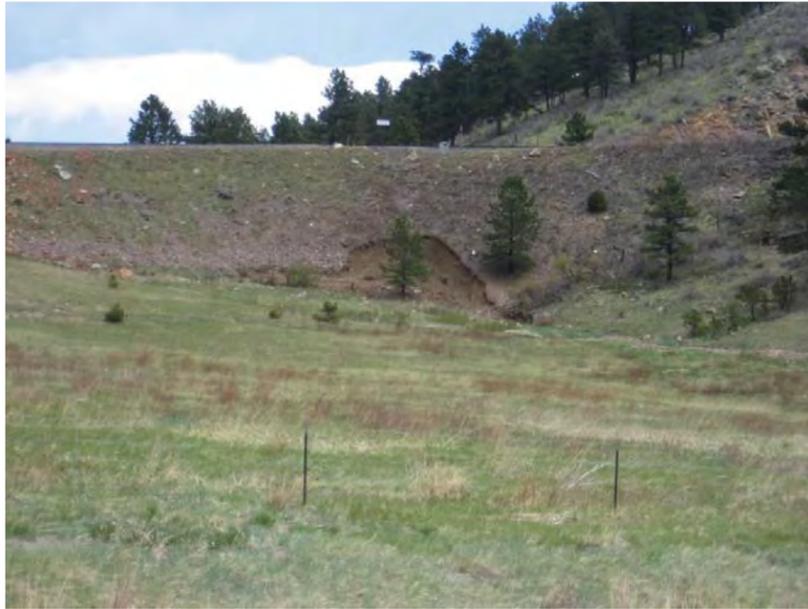
**Photos 1 and 2** – The south slope of the railroad existing north of Coal Creek (the creek) and Highway 72 (the highway) showed locations of severe scour and erosion, cutting a new flowpath running to the south from the base of the railroad slope down to the highway. During the flood event, it is likely that the material eroded away to create this flowpath was transported to Coal Creek and deposited somewhere in the channel.

Photo 1 – Scouring of the railroad's south bank

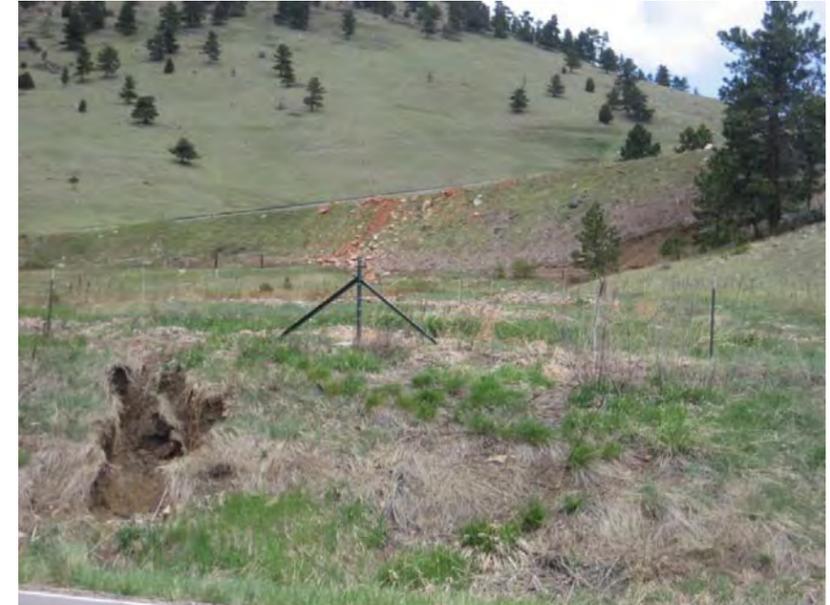
Photo 2 – New flowpath created by erosion, shown where it reaches the highway

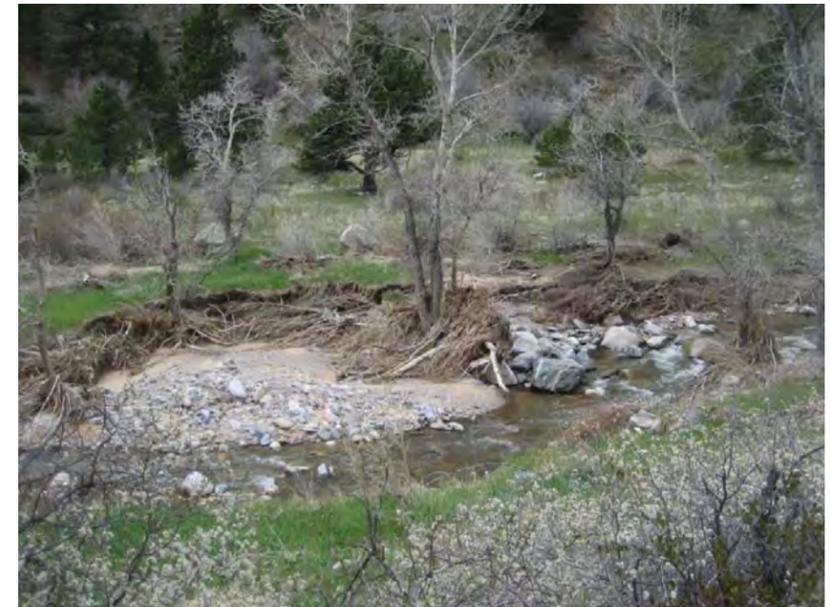
**Photos 3 and 4** – Large amounts of debris are present in the creek and its floodplain. Scouring has occurred at the channel banks, while the deposition of larger sized material appears to have taken place within the channel.

Photo 3 – Scouring of the creek's right bank

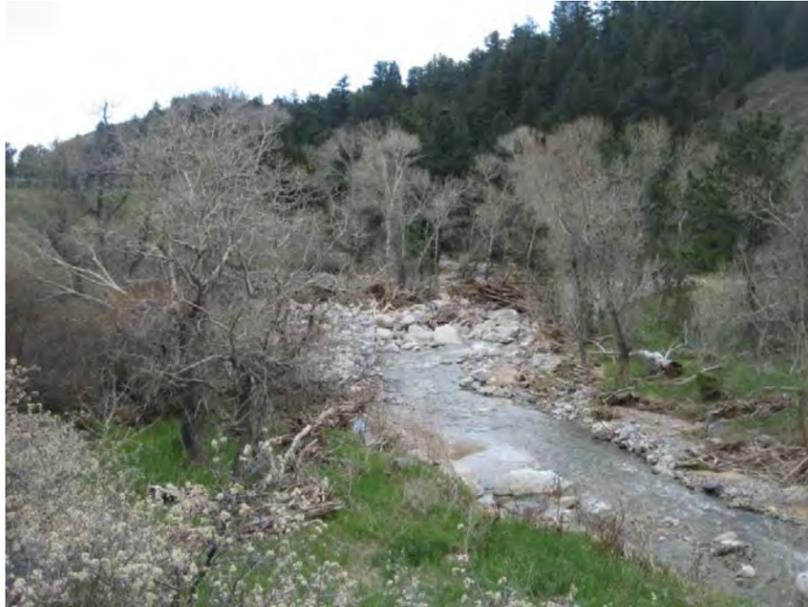
Photo 4 – View of debris and deposited material looking downstream

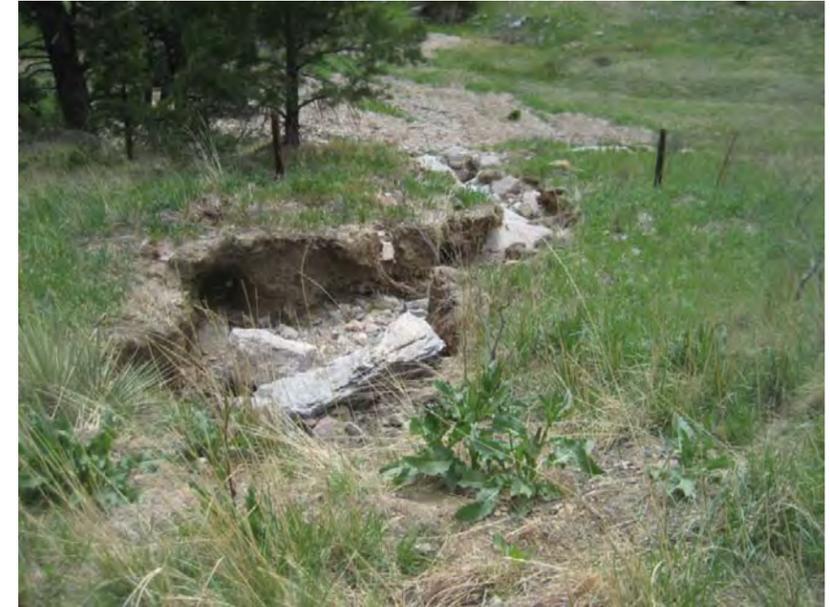
Photo 5 – Scour at culvert outfall

**Photos 5 and 6** – Extreme scouring took place at the outfall of a culvert crossing under the highway. A new flowpath about 1-2 feet deep was created down the steep highway bank, and eroded material was deposited along the hillside as the slope becomes less steep. The new flowpath does not currently reach the creek, however the large flows of the flood event likely did run all the way from the culvert to the creek, potentially carrying eroded material with it.

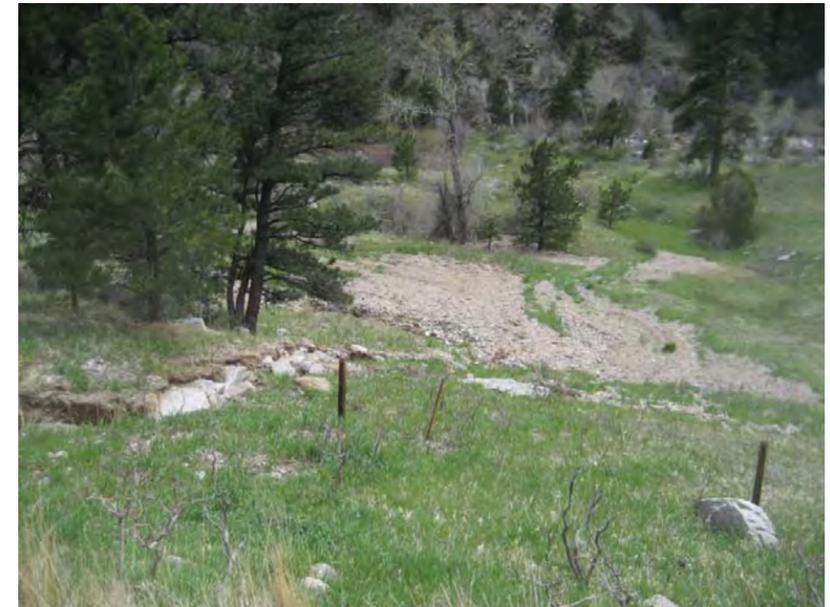
Photo 6 – Eroded material deposited on hillside

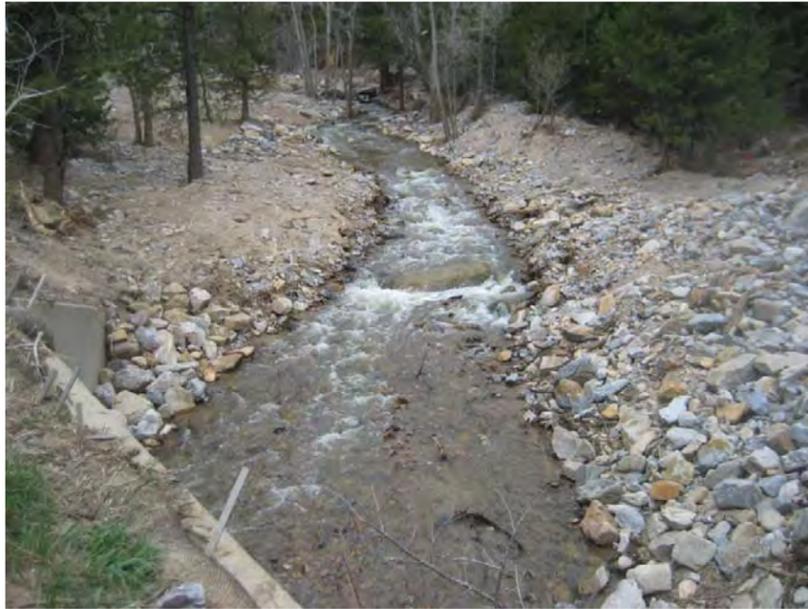
**Photos 7 and 8** – The creek at this location has been reconstructed, with banks rebuilt out of cobble and boulder material. Vegetation loss in the overbanks is apparent, however most of the debris was either transported downstream or has been removed. The concrete box culvert allowing the creek to pass under the highway appears to have withstood the impacts of the flooding, and is still functioning adequately.

Photo 7 – Reconstructed channel as it approaches the highway crossing

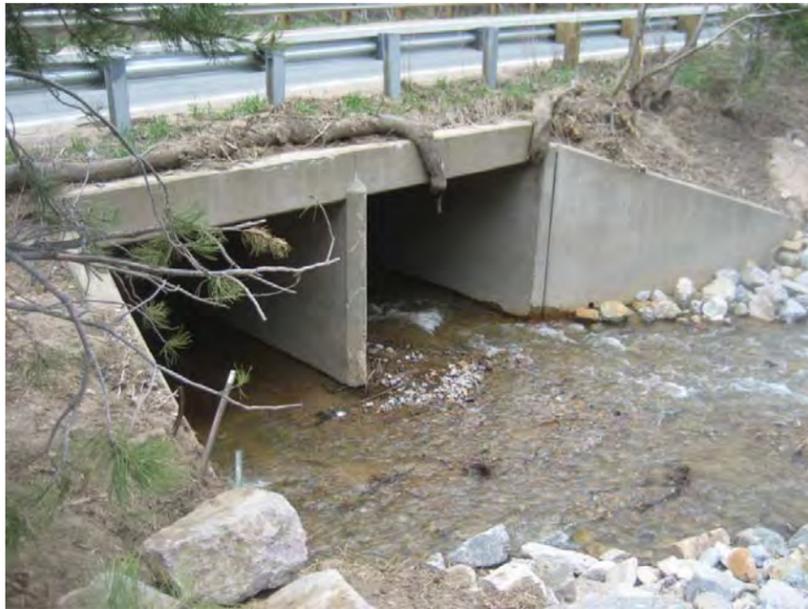
Photo 8 – Upstream entrance to box culvert under highway

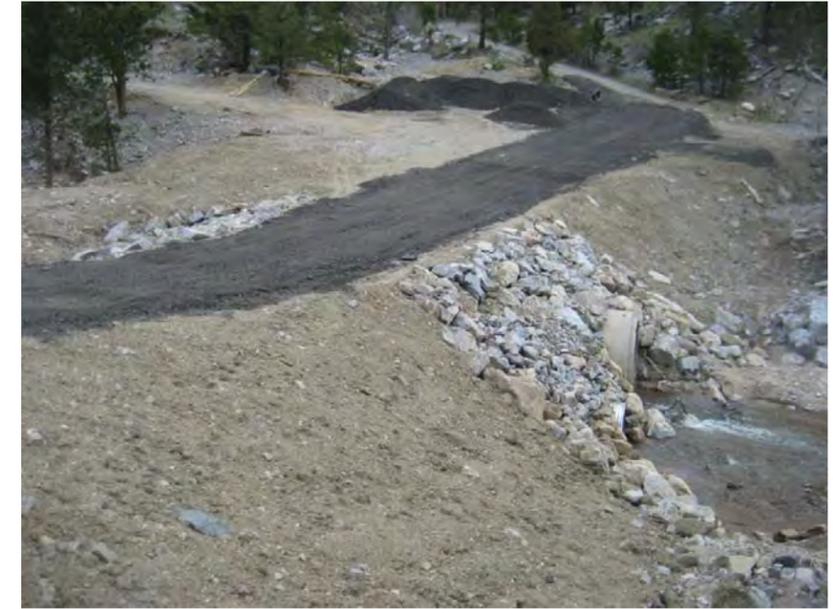
**Photos 9-11** – A new roadway and culverts have been implemented where the creek crossing to the residential structures had been destroyed by the flood event. The channel has been reconstructed both upstream and downstream of the culverts, and both overbanks are mostly devoid of vegetation.

Photo 9 – New roadway and culverts

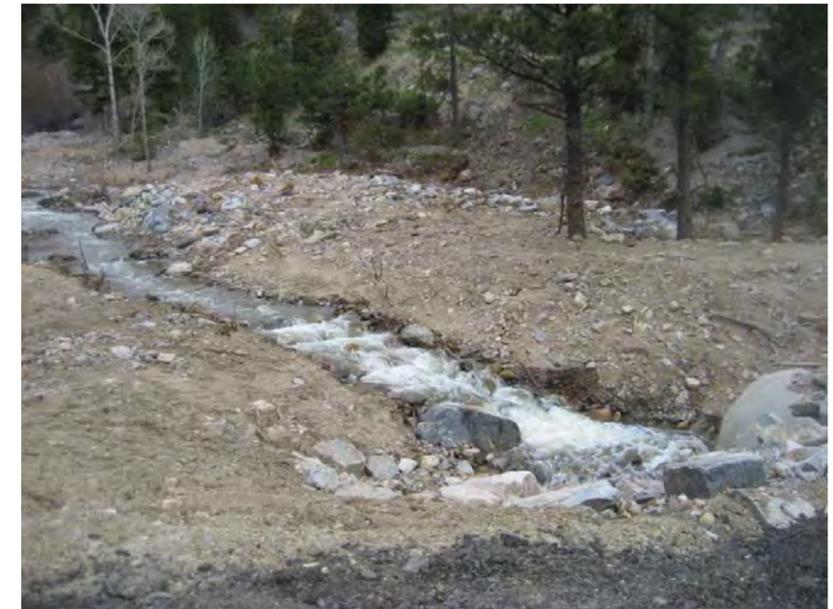
Photo 10 – Reconstructed creek upstream of culverts

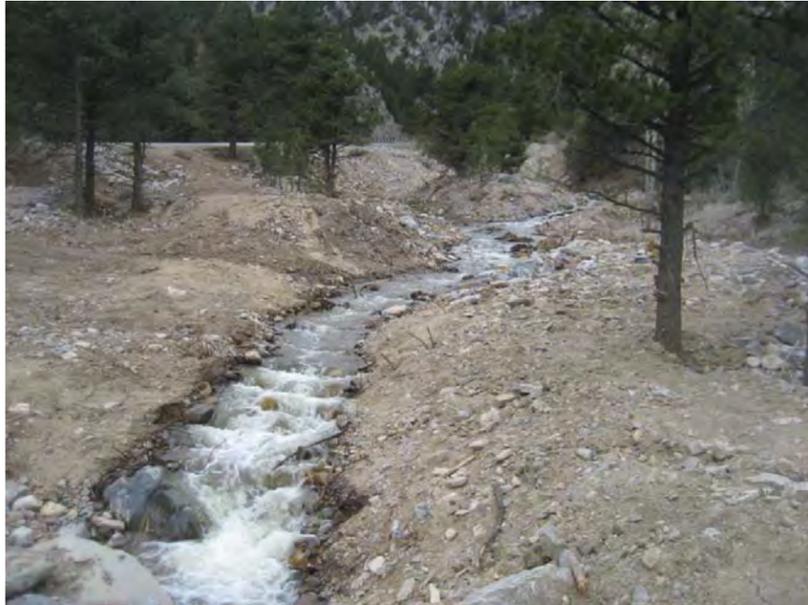
Photo 12 – Freshly installed grouted riprap between creek and highway

Photo 12 – A new right channel bank has been constructed, abutting the highway. Grouted riprap has been installed to stabilize the bank. Scour and vegetation loss is evident along the creek.
