# Upper Coal Creek Watershed Restoration Master Plan

November 2014

Jefferson and Boulder Counties

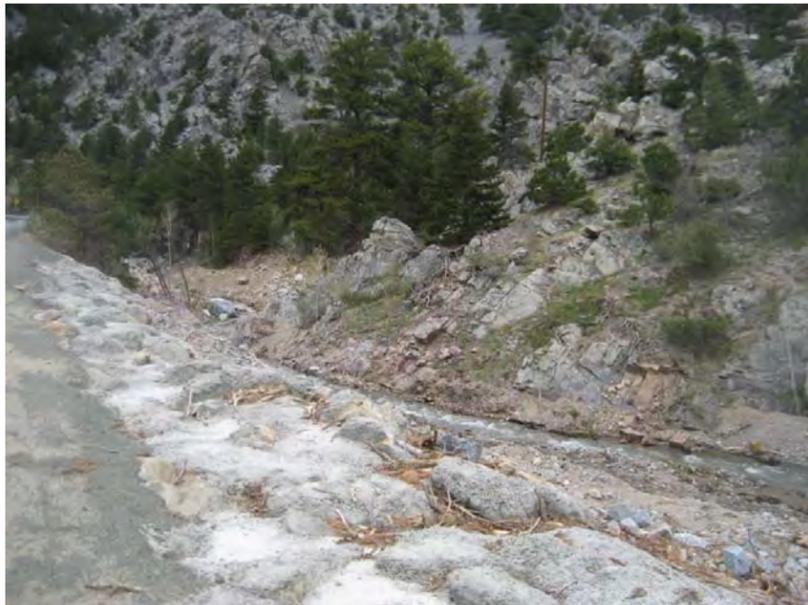
Photo 13 – Severely scoured left channel bank, and newly constructed right channel bank

Photo 13 – The left channel bank has been severely scoured by the flood event. Vegetation along the slope of the bank has mostly been removed, and vegetation at the top of the bank has been undercut, with roots now exposed. New boulder riprap has been installed along the highway abutment which makes up the right bank of the creek.

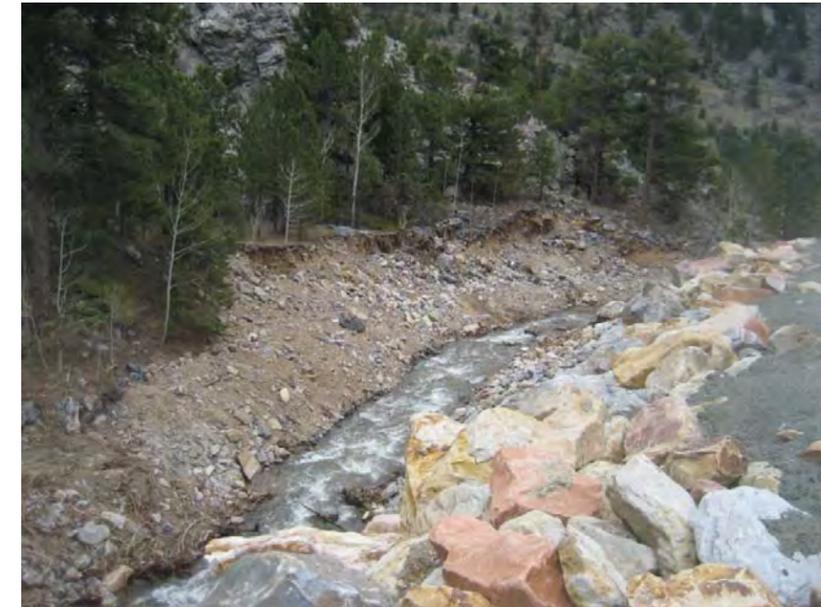
Photo 14 – Scoured channel banks with undercut vegetation; boulders present in channel

Photos 14-16 – Channel banks have been scoured, with vegetation removed or undercut. Large boulders are present in the channel at this location, which appear to have entered the channel via the small canyon adjacent to the creek to the west. The right channel bank adjacent to the highway consists mostly of exposed dirt, with little to no vegetation or rock material to stabilize it.

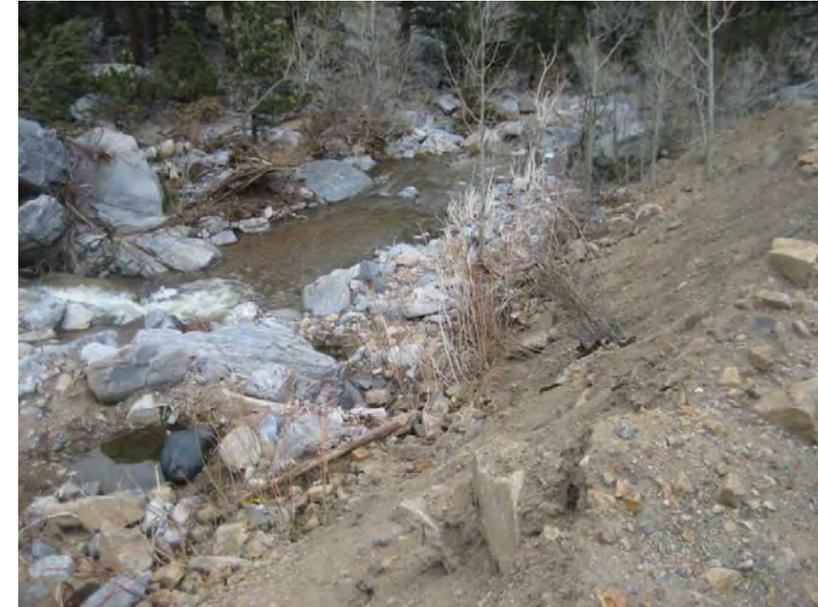
Photo 17 – New driveway and culverts installed after the flood event

**Photos 17 and 18** – A new driveway has been constructed to allow access to residential northwest of the creek. The driveway contains two culverts conveying flow from the creek. The channel has been rebuilt at this location upstream of the culverts, with riprap stabilizing the bank in front of the structures.

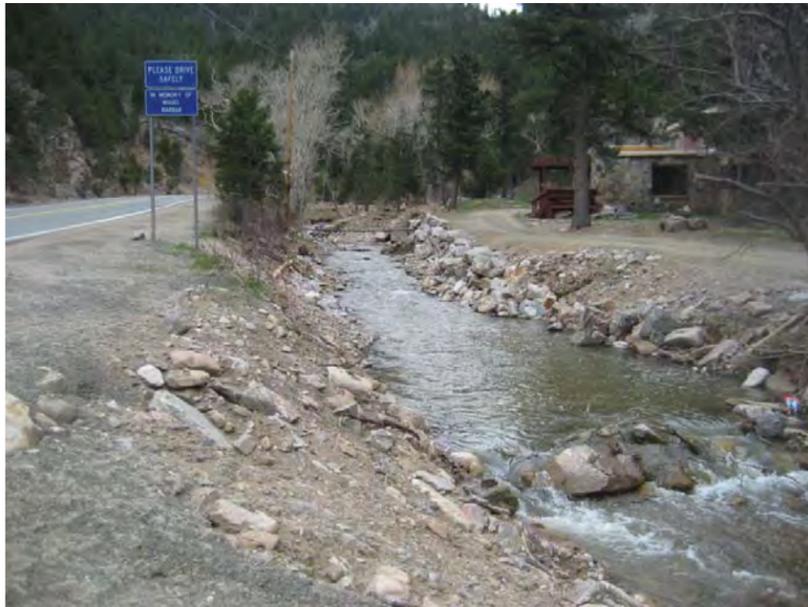
Photo 19 – Scour and undercutting alongside residential structures

Photos 19-20 – Severe scouring has taken place alongside the highway in front of residential structures, undercutting the structures themselves. The water that accumulates at this location enters the creek via a culvert, which likely plugged up during the flood event due to debris, and had plenty of debris present in it still at the time of these photos.

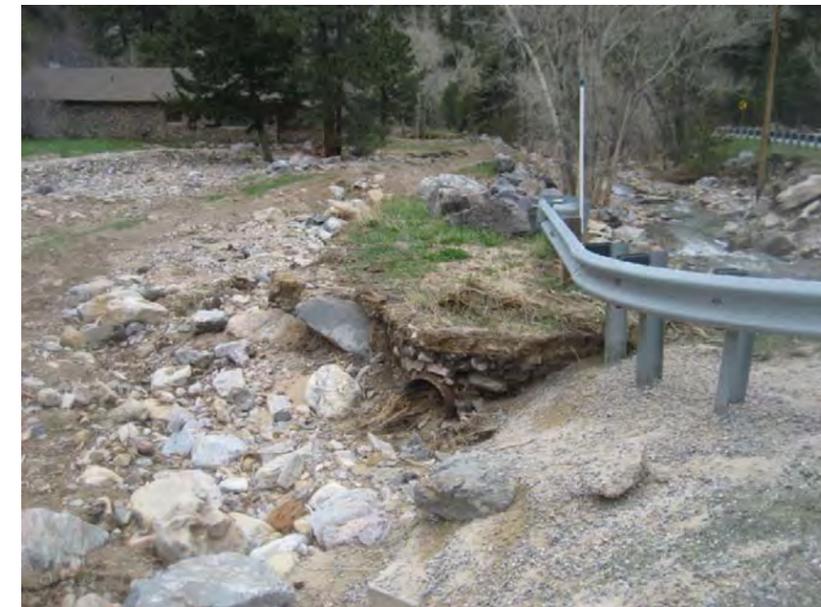
**Photo 21** – Downstream outlets of the concrete box culvert and the culvert pipe from **Photo 20**

**Photos 21-24** – The creek crosses the highway at this location via a concrete box culvert. The culvert itself appears to still be structurally sound, although it has been reinforced with grouted riprap on its upstream end. **Photo 21** shows the outlet of the culvert pipe shown previously in **Photo 20**. Vegetation loss and scouring of the banks has occurred both upstream and downstream of the box culvert, but most of the debris in the channel appears to have been removed.

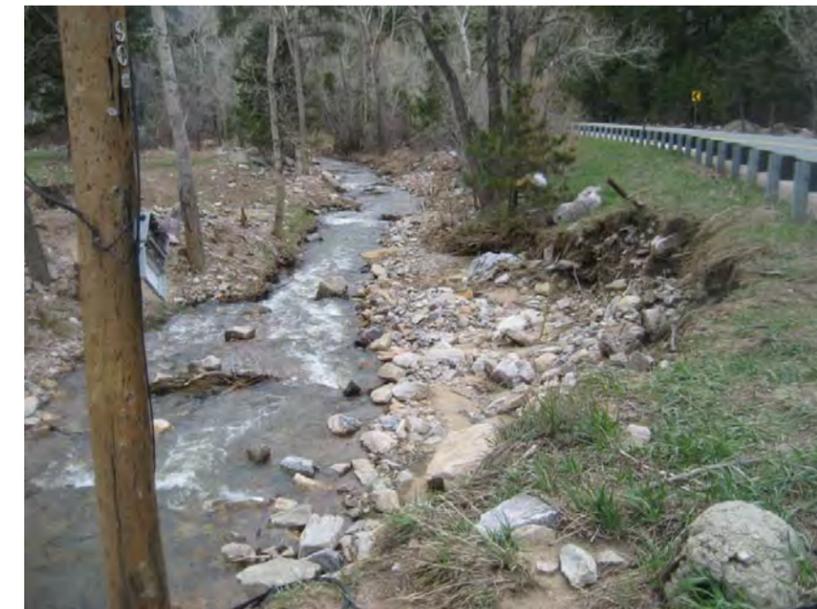
**Photo 25** – Destroyed driveway which has not been reconstructed

**Photos 25-28** – Several residential driveways along the highway were destroyed by the flooding. Some of the driveways have been reconstructed with new culvert pipes, while others have not. Also present in these images is the scouring and vegetation loss which occurred along the creek at this location, as well as the amount of debris which is still present in the channel.

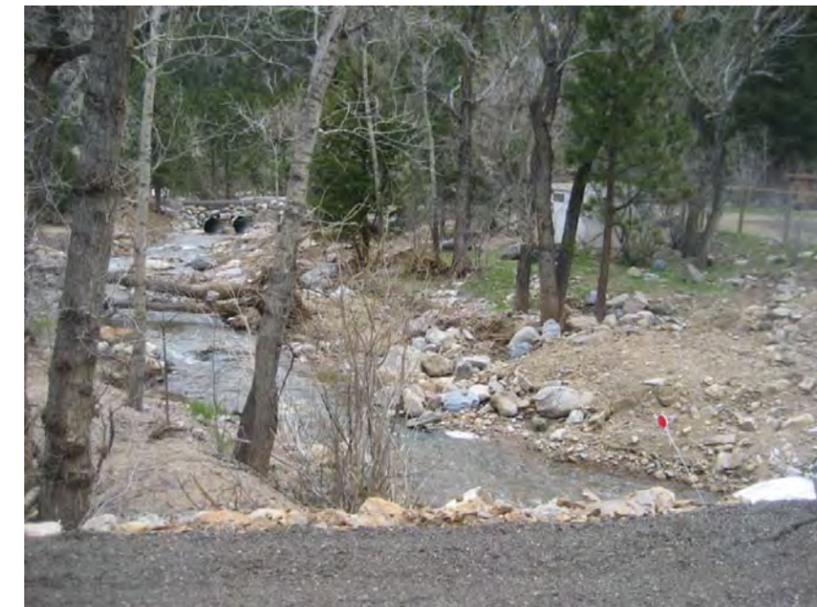
**Photos 29-30** – Many locations along the creek showed significant scour at places where roads coming down the hillside intersected the stream. This is possibly due to large amounts of runoff traveling down the roadway unimpeded, and entering the channel at high velocities. **Photo 29** shows one such instance of this. **Photo 30** demonstrates the extreme vegetation loss and debris observed on the floodplain between the highway and the creek, just downstream from where this side road crosses the stream.

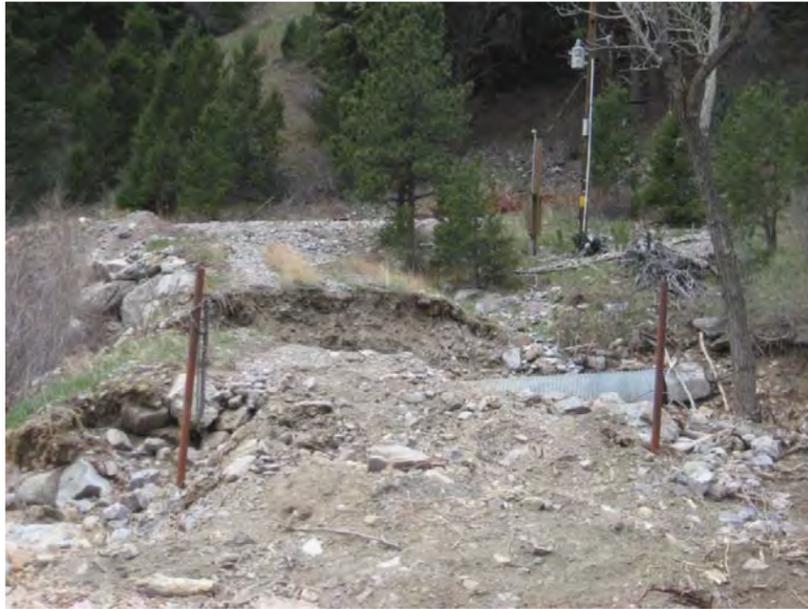
Photo 30 – Vegetation loss and debris in floodplain

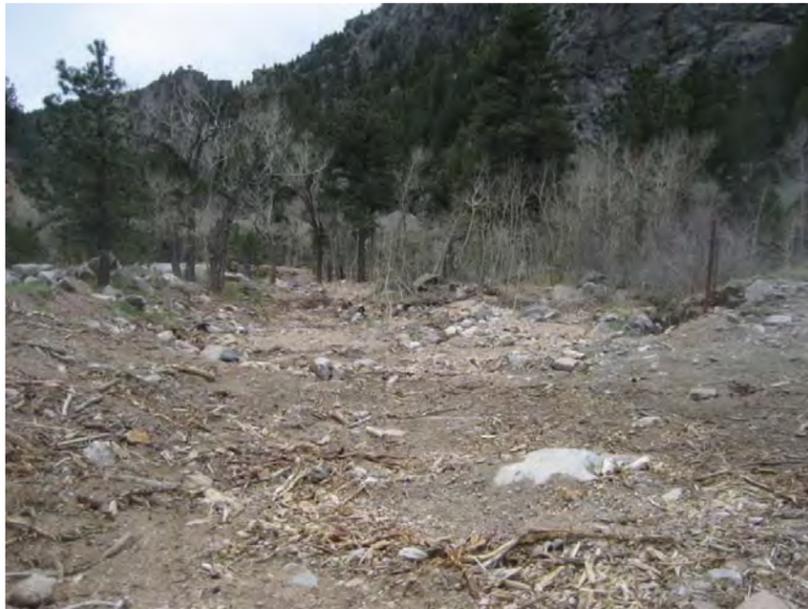
Photo 31 – Eroded banks and accumulated debris

**Photos 31-33** – Channel bank slopes have been severely undermined on the outside of the creek's bend. Vegetation has been uprooted from the overbanks, and large amounts of debris have piled up outside of the creek's low flow channel.

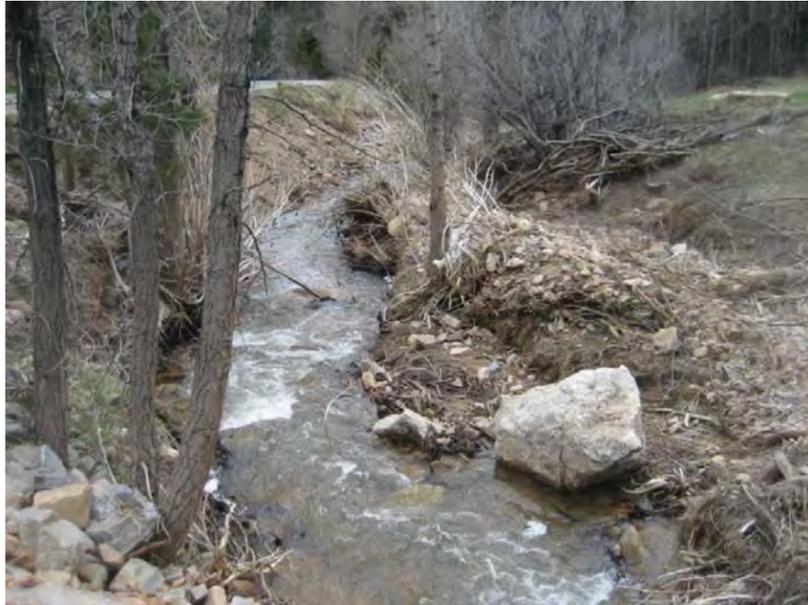
Photo 35 – Undermined banks; debris accumulated in stream

**Photos 34 and 35** – Channel banks have been significantly undermined at this location. More vegetation is still present in the overbanks than at farther downstream locations, however tree roots have been exposed along the banks, and the higher right bank appears unstable. Debris has covered the overbanks, and has also accumulated at various spots in the stream itself.

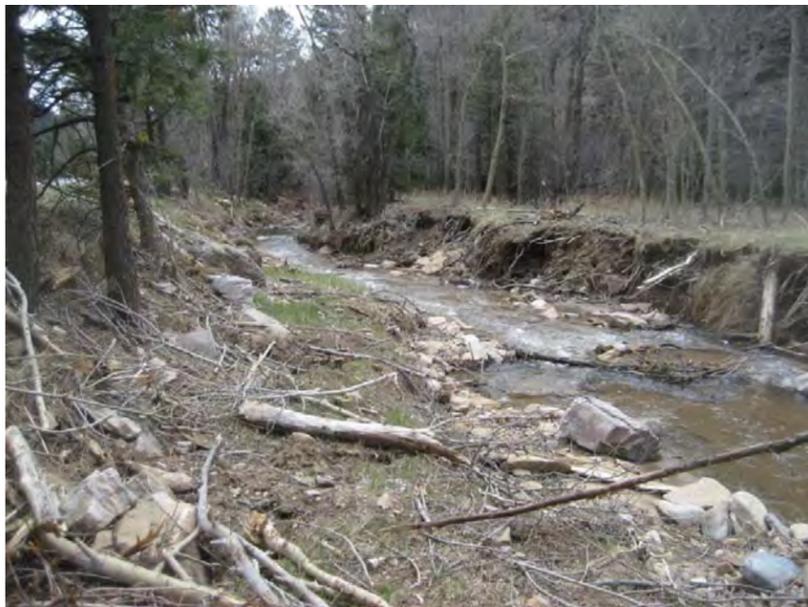
Photo 36 – Destroyed roadway formerly crossing the creek

**Photos 36 and 37** – The dirt road crossing the creek to the east of the highway has been destroyed. This is the first location since the extreme downstream sections of stream where significant sediment deposition has occurred. Large amounts of sand are present in the channel and overbanks, and the culvert between the main channel and the highway is mostly filled with sediment.

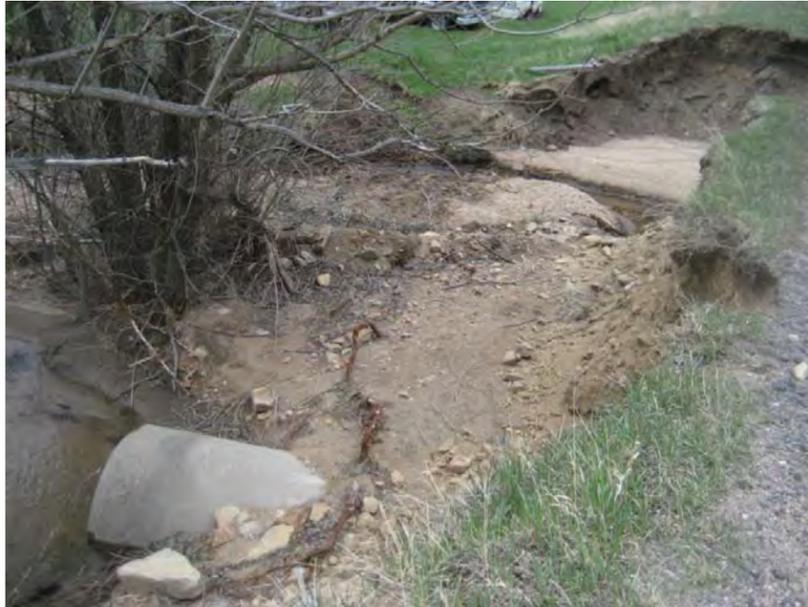
Photo 38 – New patch of road on Highway 72 where it intersects with Crescent Park Drive

**Photos 38-42** – The section of highway that was destroyed by the flood event has since been replaced. New culverts were installed under the highway, and the channel conveying the tributary flow to Coal Creek has been re-formed. Large quantities of sand have deposited in the left overbank along the creek. Residential yards existing in the floodplain also accumulated large amounts of sediment.

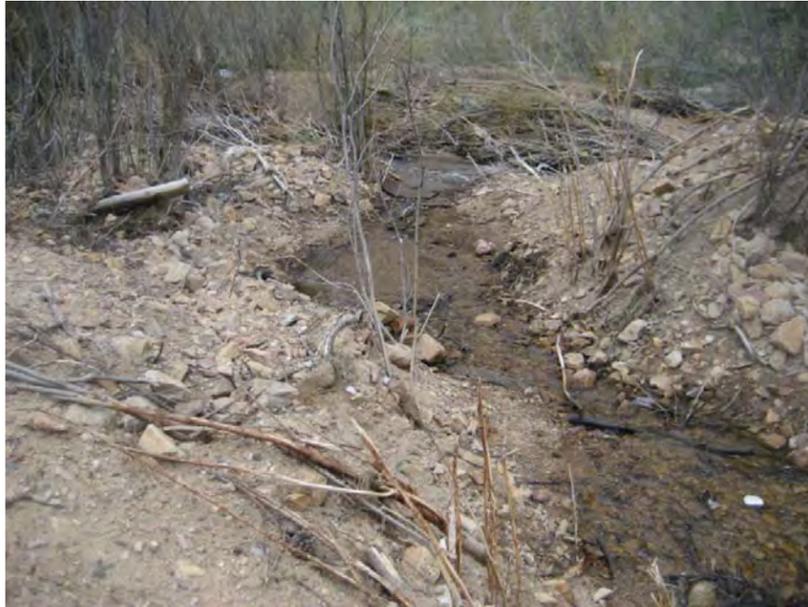
Photo 41 – Deposited sediment along Coal Creek

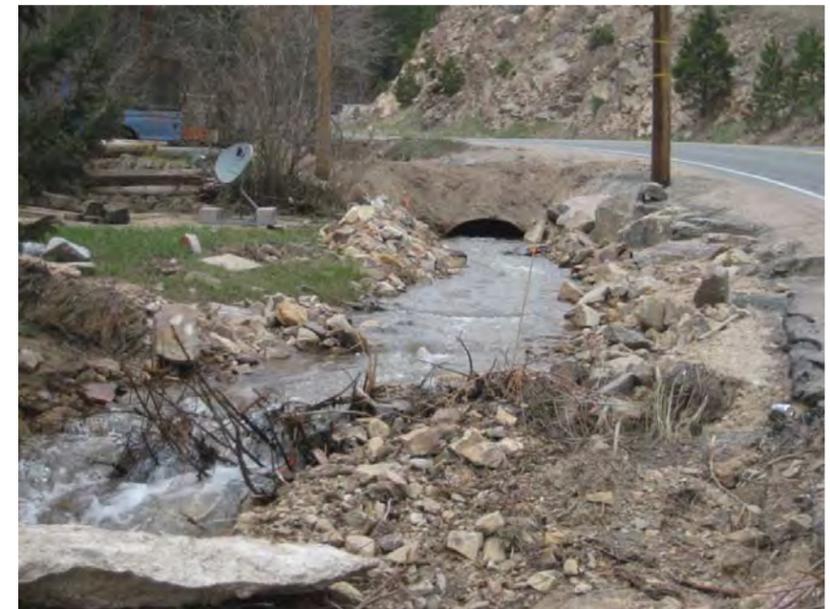
Photo 44 – Culvert already near its capacity, even with relatively low flows

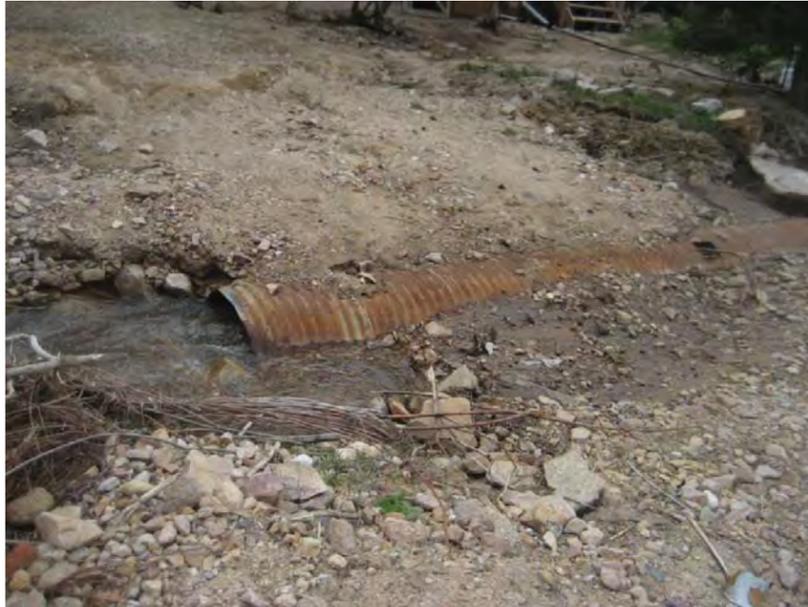
Photo 45 – Upstream end of culvert on Coal Creek tributary alongside Ranch Elsie Road

**Photos 45-47** – The flood event also caused scouring and degradation along Coal Creek’s tributaries. **Photos 45-47** show degradation around a culvert passing under a driveway alongside Ranch Elsie Road. **Photo 45** shows the upstream end of the culvert, where the banks of the channel have been undermined, but the culvert itself appears to still be functional. **Photo 46** shows the downstream end of the culvert, which has been completely undermined. The pipe is still in place, but the driveway bank has eroded around it. **Photo 47** shows the channel just downstream of the culvert, where the banks have been undermined where the channel bends.

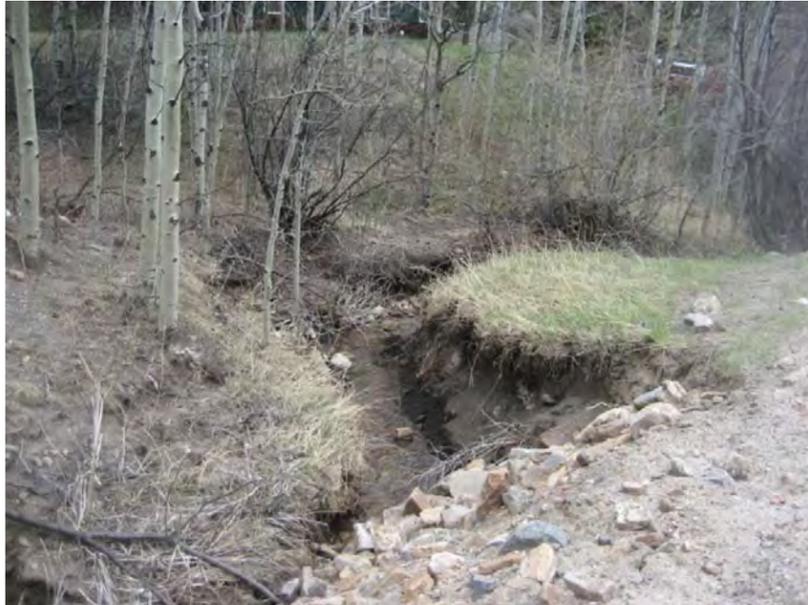
Photo 49 – Farther upstream on Beaver Creek, channel banks are bare of vegetation or armoring and appear unstable. Debris in the floodplain gives an indication of how high the water had been during the flood event.

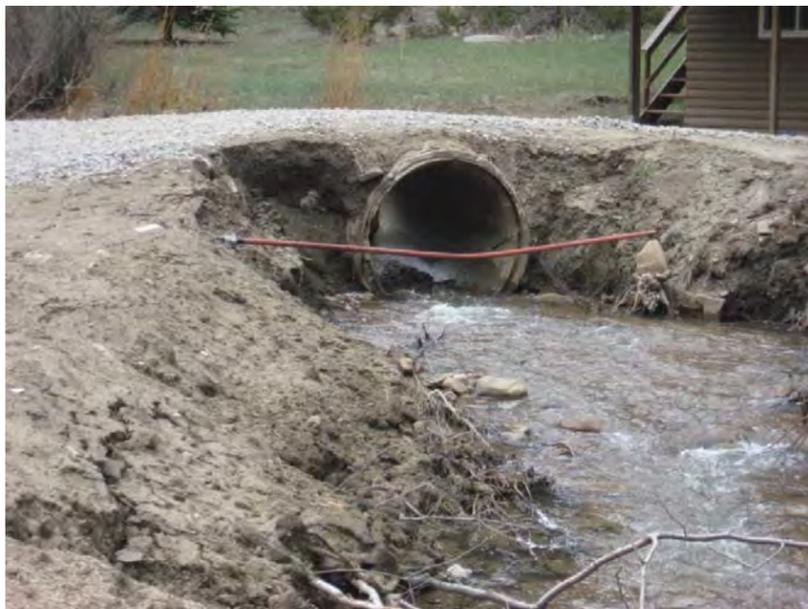
Photo 48 – Undermined culvert on Beaver Creek

Photo 48 – This driveway crossing Beaver Creek, a few hundred feet upstream of its confluence with Coal Creek, has been rebuilt since the flood event. The culvert has been undermined, and the downstream banks appear unstable, as there is little vegetation or armoring present to stabilize them.

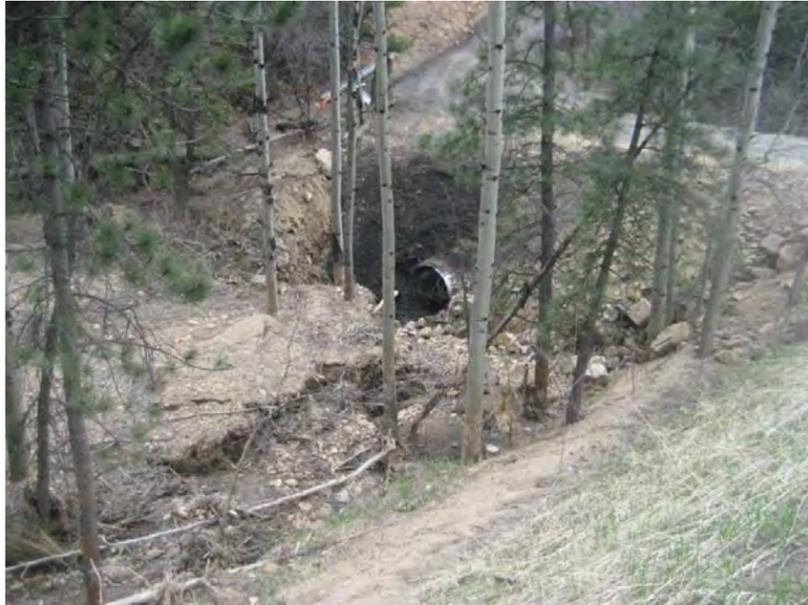
Photo 50 – Upstream view of culvert for tributary alongside Butte Drive

Photos 50 and 51 – These photos show the upstream and downstream ends of a culvert conveying flow from the Coal Creek Tributary running alongside Butte Drive. It is unclear if this culvert was in place before the flood event, or if it was installed after. Channel banks upstream of the culvert have been scoured and undermined, and debris has collected in the channel. Below the culvert outfall, large rock material has settled below the pipe, possibly having fallen down the bank of the road.

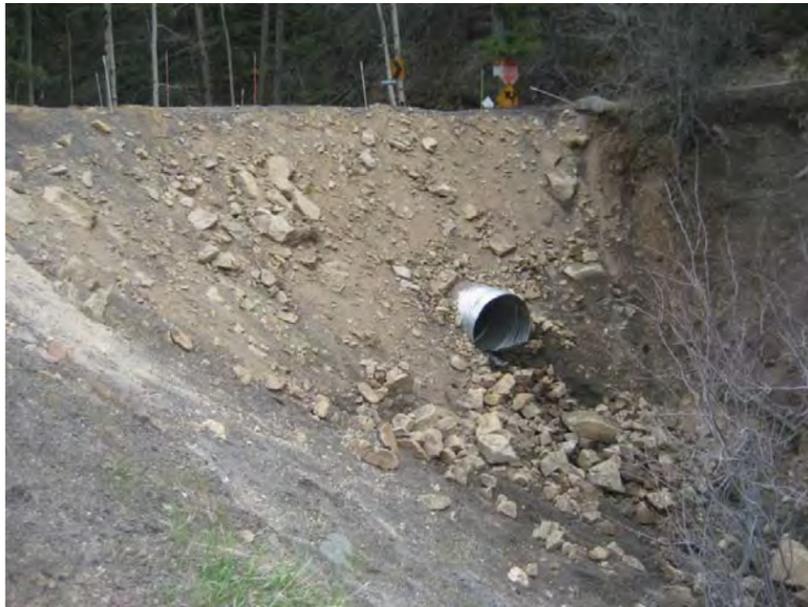
**Photo 52** – This culvert passes under Crescent Park Drive, and conveys flows for the Coal Creek tributary that runs along that road until it reaches the highway and joins with Coal Creek. The culvert pipe appears undamaged from the flood event, and a well-defined flowpath downstream of the culvert is evident, there does not appear to have been significant scouring or deterioration of this channel.

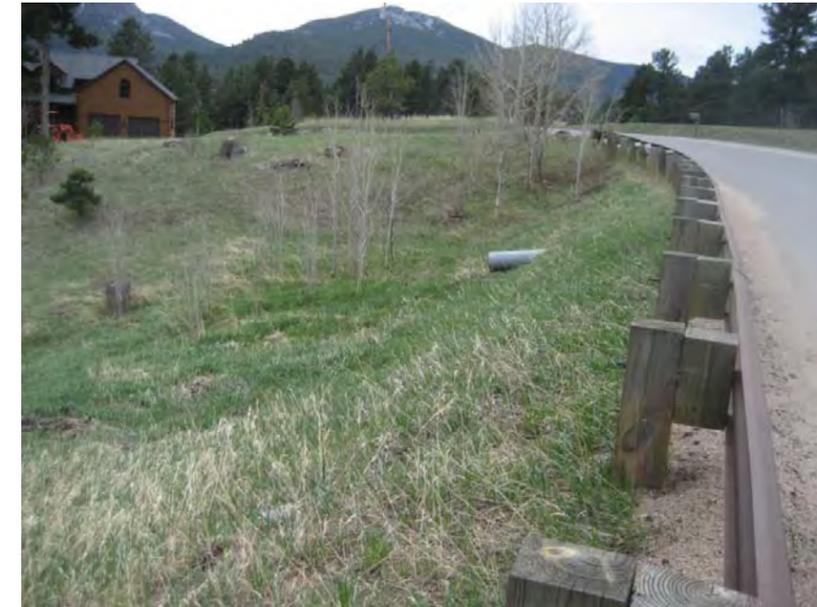
Photo 52 – Culvert passing under Crescent Park Drive

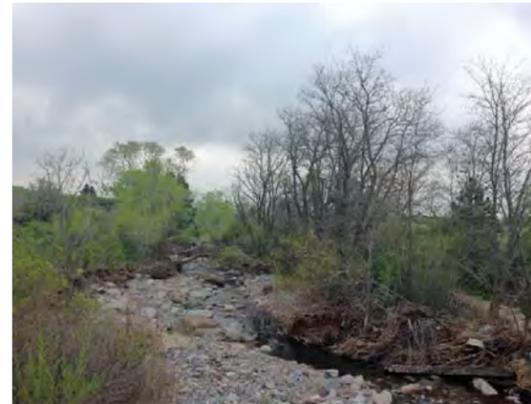
**Photo 1.** Example of low disturbance to the riparian zone. This photo depicts a more ideal riparian zone vegetation community along Coal Creek at the downstream end of project area. In this section, the riparian zone is dominated by an overstory of narrowleaf cottonwood and ponderosa pine tree canopy intermixed with dense shrub understory with native grass species.

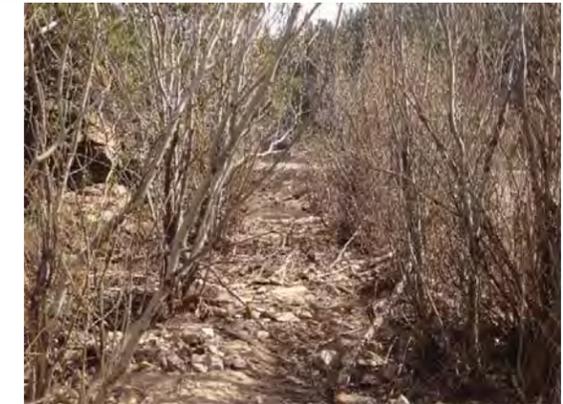
**Photo 2.** Example of moderate disturbance to the riparian zone. This photo depicts a common condition in the middle to lower portions of the project area where scouring has removed herbaceous understory. A dense willow-dominated midstory is present which provides streambank stabilization however the lack of a stable understory can lead to soil erosion or root damage further limiting riparian functions.

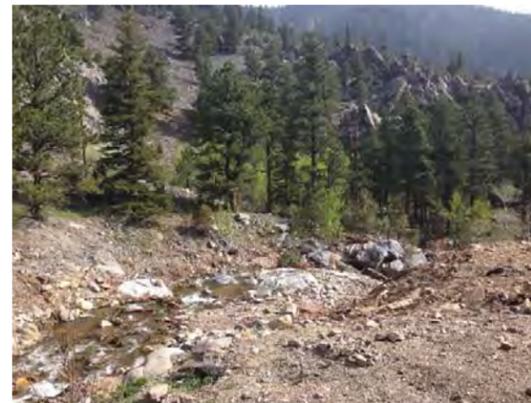
**Photo 3.** Example of high disturbance to the riparian zone. Flood flows and transport of large alluvial material/wood have eroded the channel of Coal Creek, completely removing vegetation within the riparian zone.
