Fall 2015 Review of Selected Boulder County Properties Affected by 2013 Floods

Laura Backus
January 29, 2016

The sections that follow are photographic documentation of conditions in the Ramey and Peschel properties along St. Vrain Creek, the Brewbaker-Sorensen property along Left Hand Creek, and the Alexander Dawson Property west of US 287 along Boulder Creek.

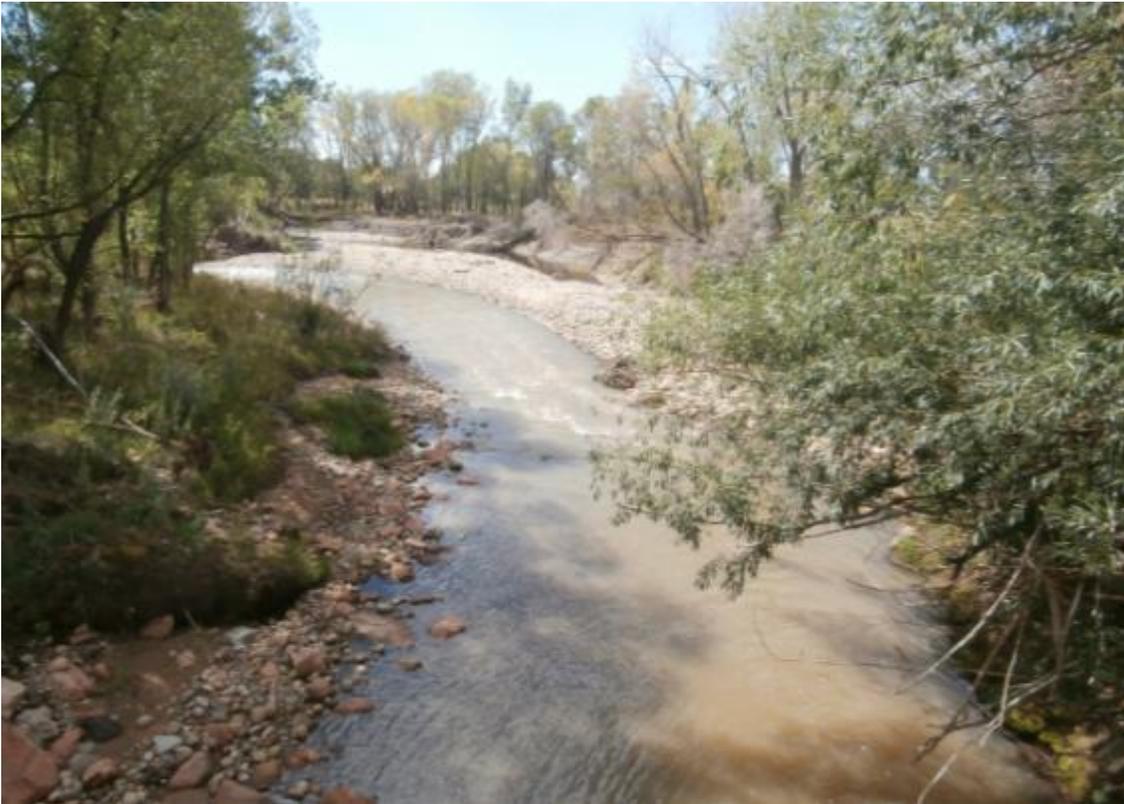
View downstream from North 63rd St. Bridge:

August 29, 2014: Note flow path along river left bank

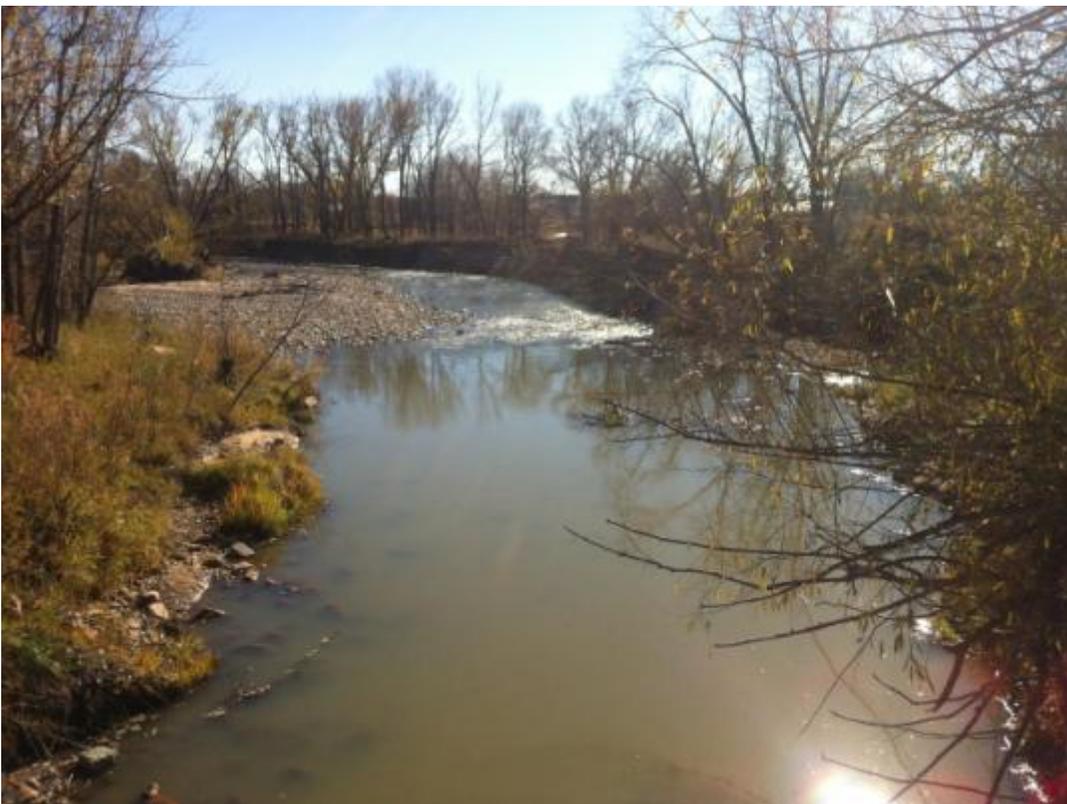
November 10, 2015: The water course change is now more up against right bank leaving an exposed cobble bar on river left.

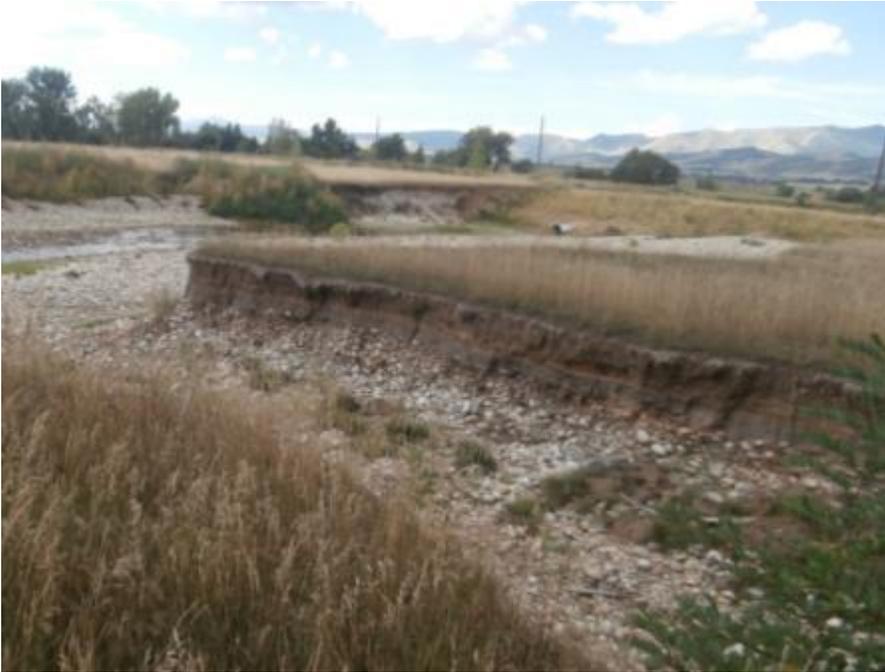
View to south west of new side channels cut into the former meadow area on river right:

August 29, 2014: Note that weedy vegetation is beginning to develop in the foreground overflow channel. This area was upland pasture prior to 2013 floods: shrubs along the new channel in the background likely were washed in when the reservoir to the west breached.

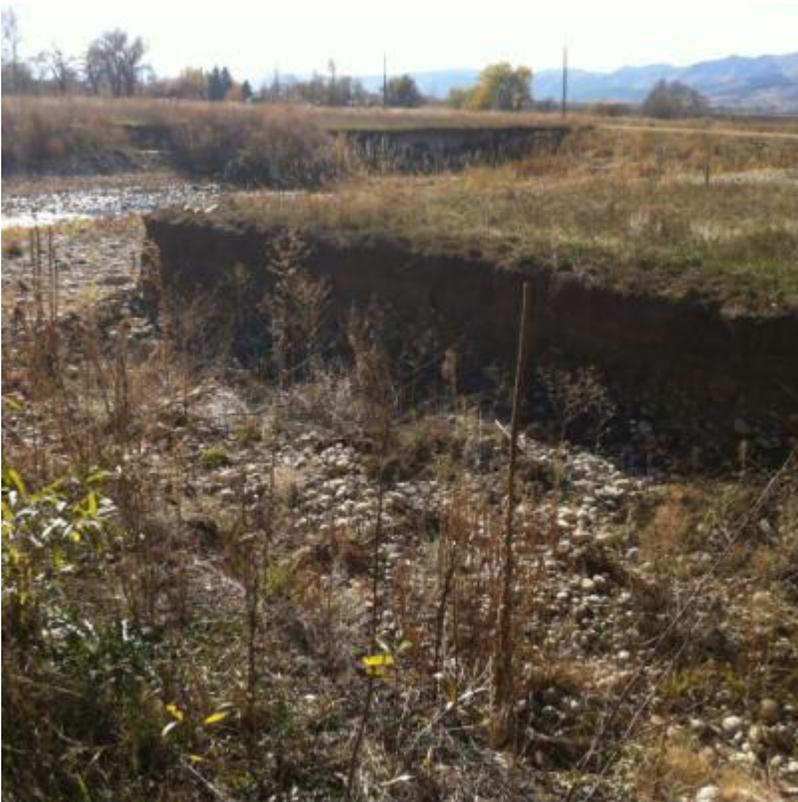
November 10, 2015: Note more weedy development in the foreground channel, increased wetland fringe along the channel in the background, and continued survival of shrubs.

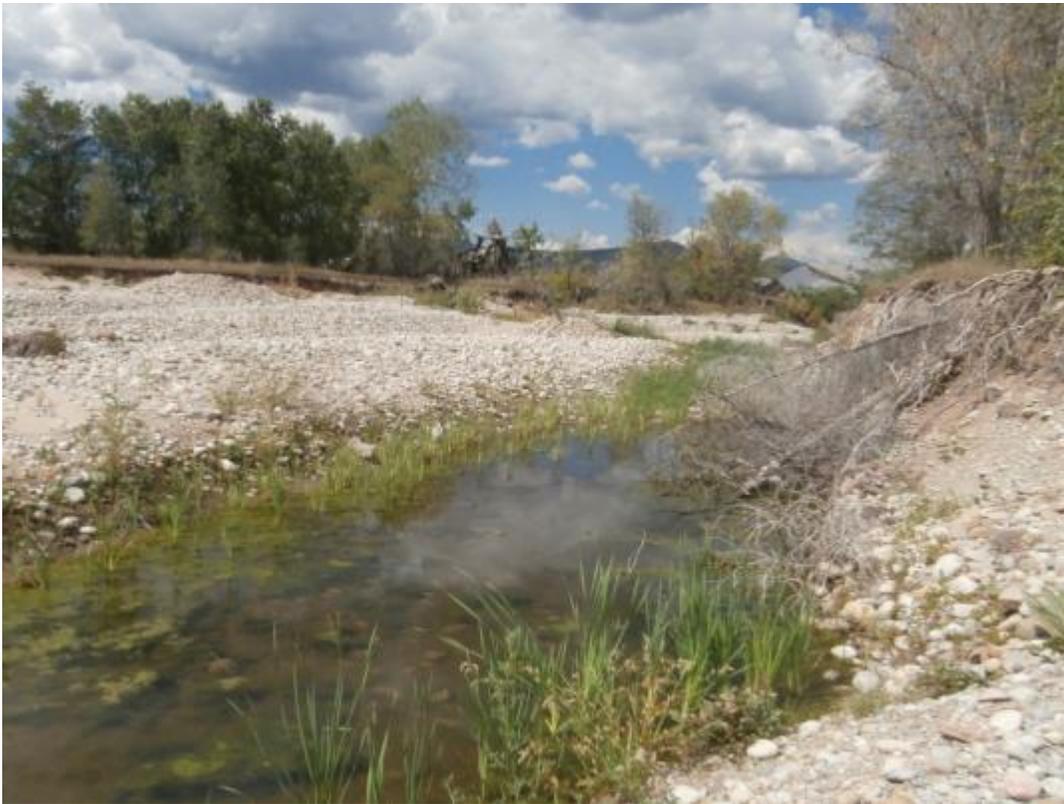
View to west of new side channel cut to east of old farm buildings on east side of North 61st St.:

August 29, 2014: Note beginning development of cattail and other wetland vegetation along flow path, very sparse vegetation cobble deposits in center left of photograph.

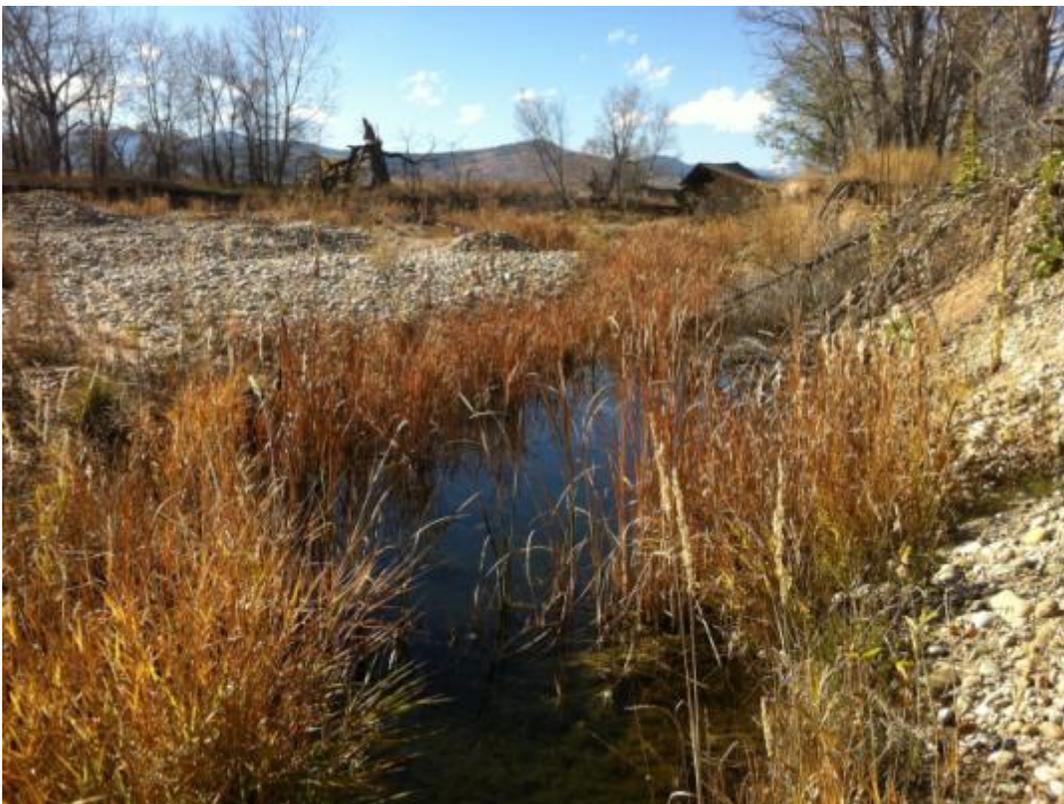
November 10, 2015: Note continued development of wetland vegetation along the flow path and slight development of vegetation in cobble deposits in center left of photograph.

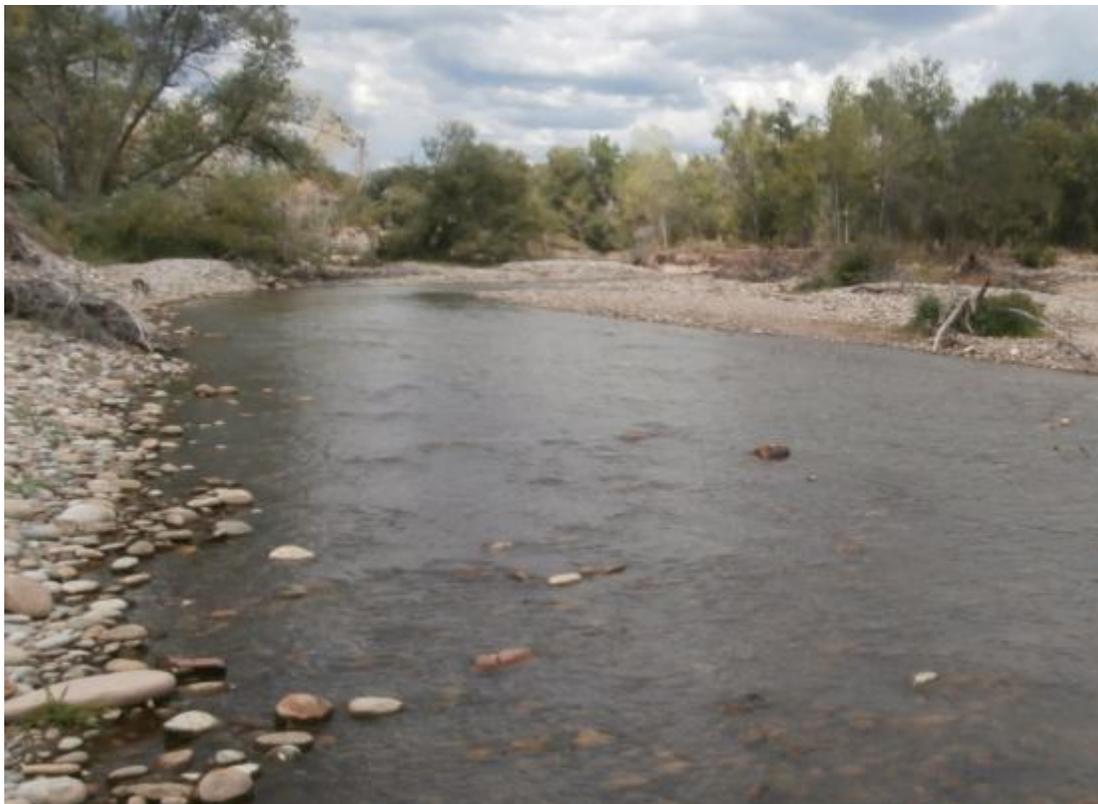
View upstream from downstream property boundary:

August 29, 2014: Note main channel of river is up against the bank on river right. Minor development of vegetation in cobble deposits.

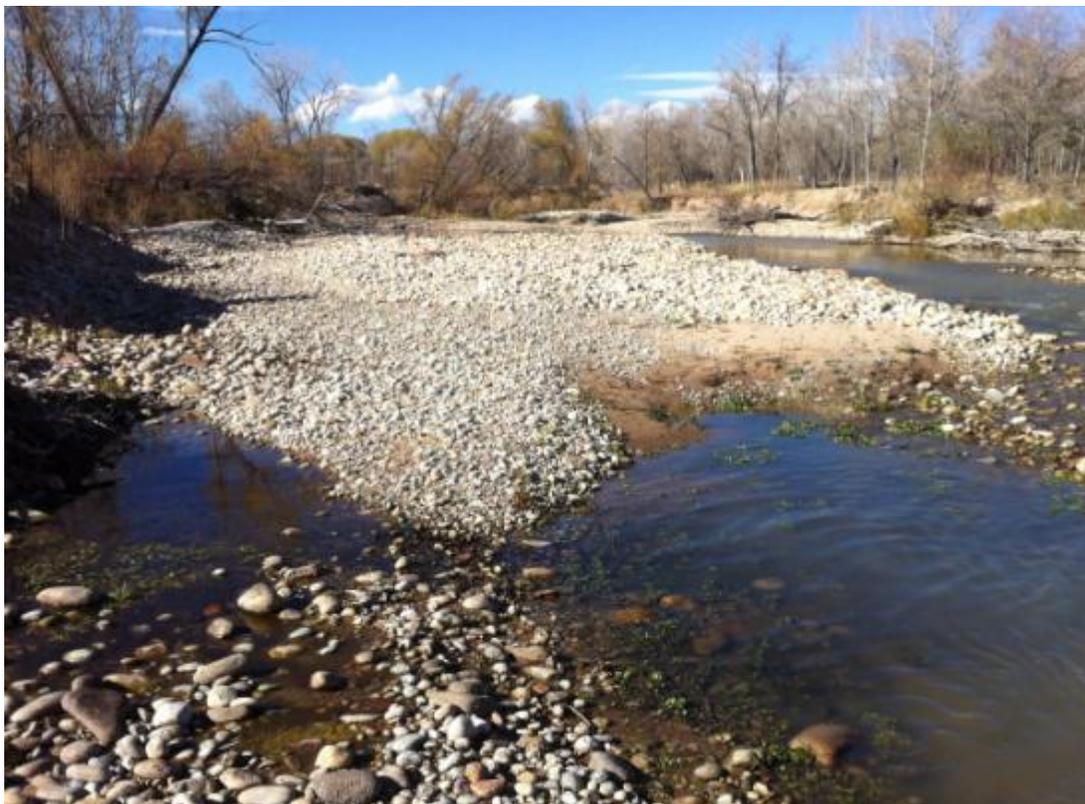
November 10, 2015: Main channel of river now flows further to the east and a large unvegetated cobble bar is exposed. Note vegetation developing in areas of slow flows.

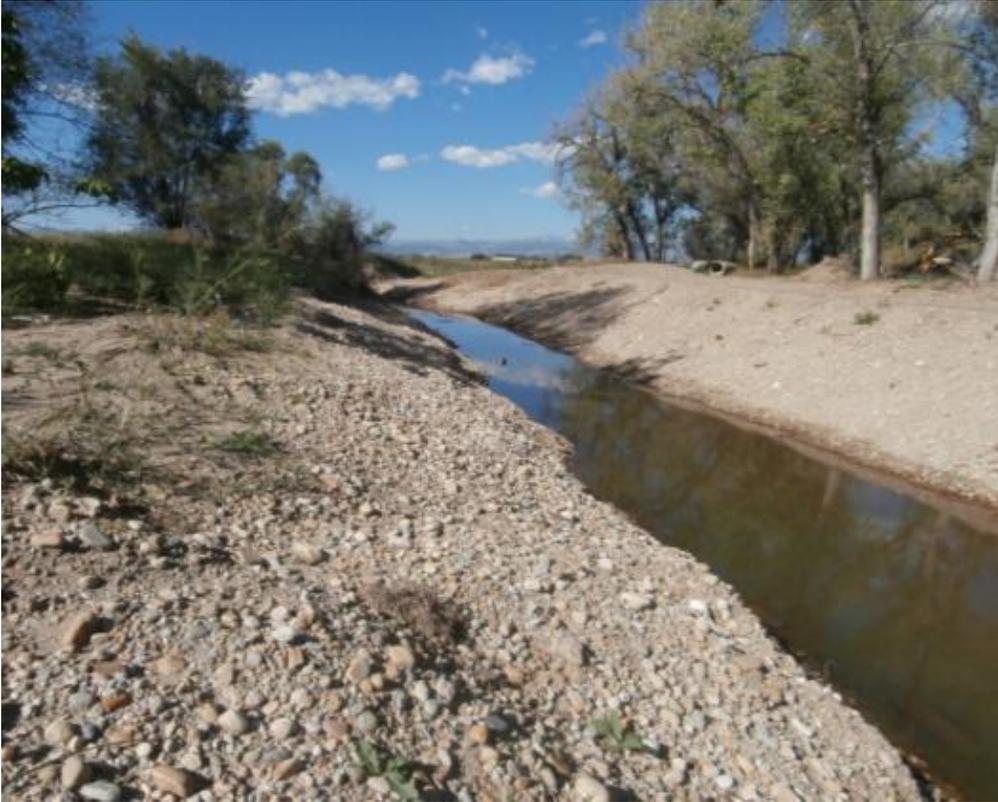
Flow channel prior to 2013 flood, view to west of channel just east of avulsion:

September 3, 2014: Note that banks are almost completely devoid of vegetation. Flows are to west.

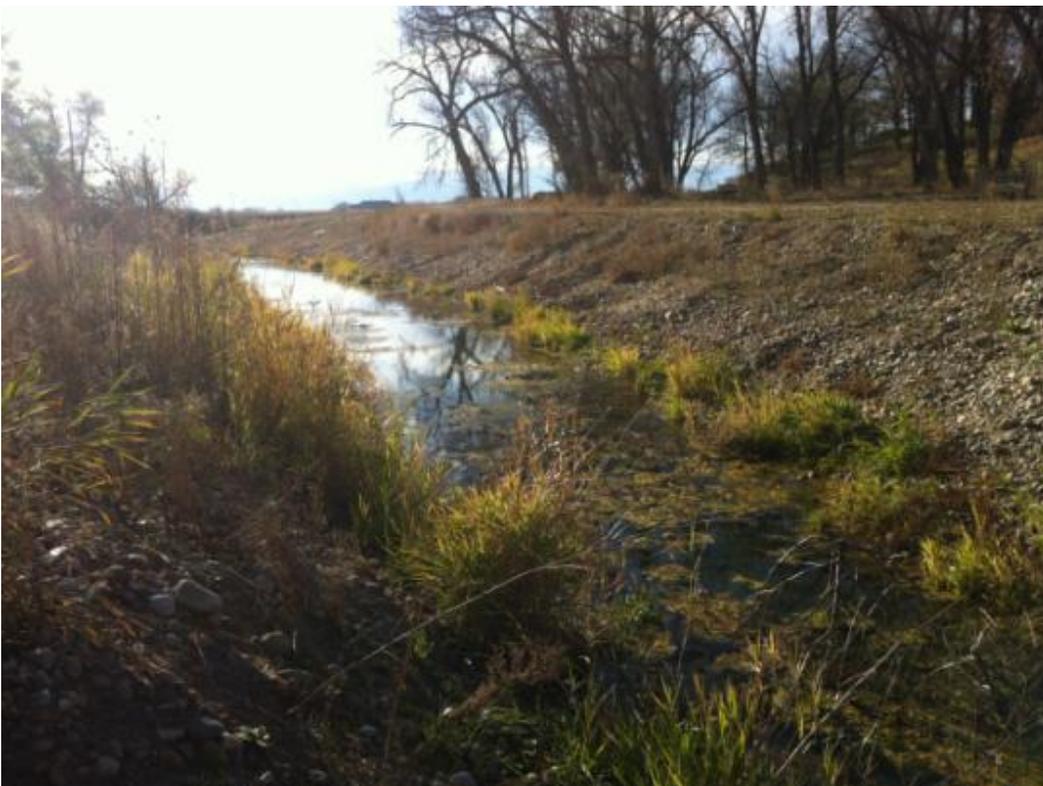
November 10, 2015: Note development of bank vegetation especially adjacent to the channel. Flows are to west.

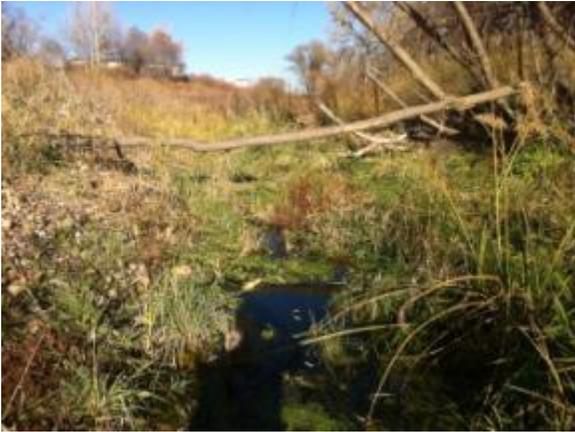
Flow channel prior to 2013 flood, views to east of traverse from west to east:

November 10, 2015: Note wetland vegetation filling much of the former flow channel.

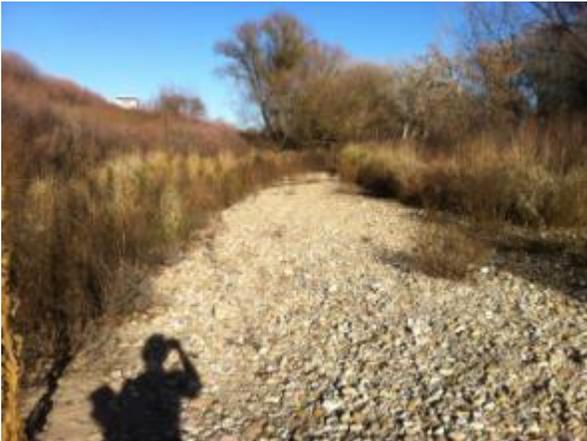
November 10, 2015: Note transition of channel bed to very sparsely vegetated cobble.

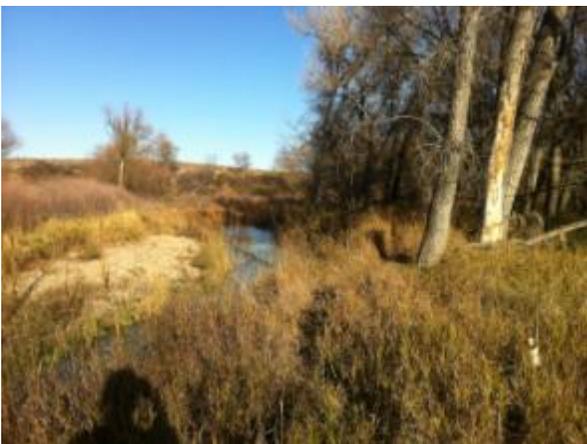
November 10, 2015: Note transition of channel back to carrying flows.

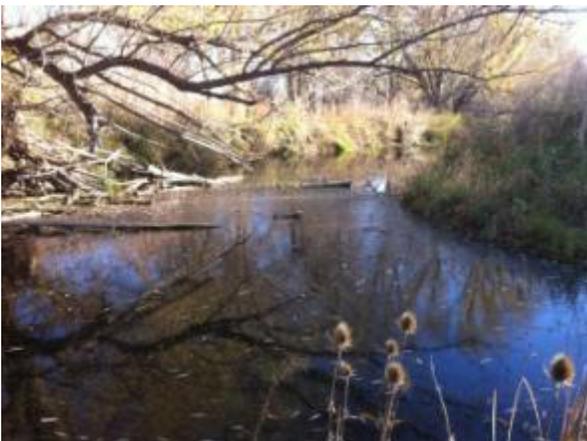
November 10, 2015: Note ponded area at right angle bend where flows transition to the south.

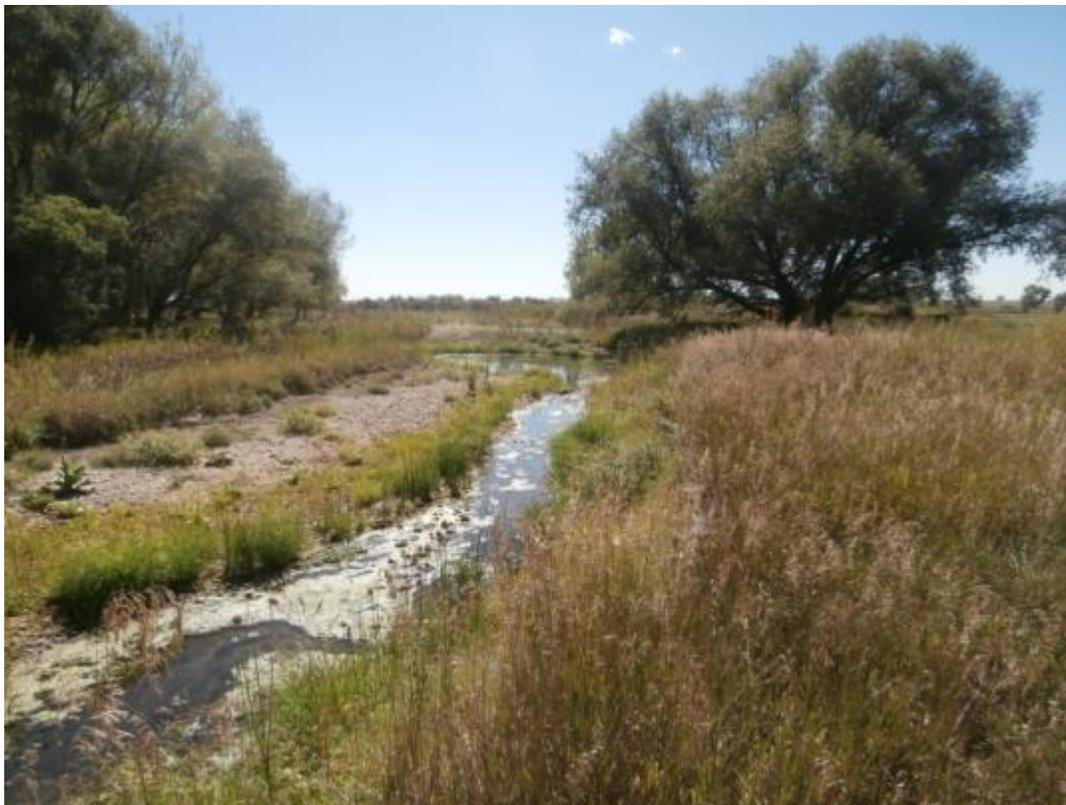
Flow channel prior to 2013 flood, views to south just upstream of lower property boundary:

September 3, 2014: Note presence of flowing water with algae, vegetation development adjacent to flows and sparse vegetation on cobble deposits.

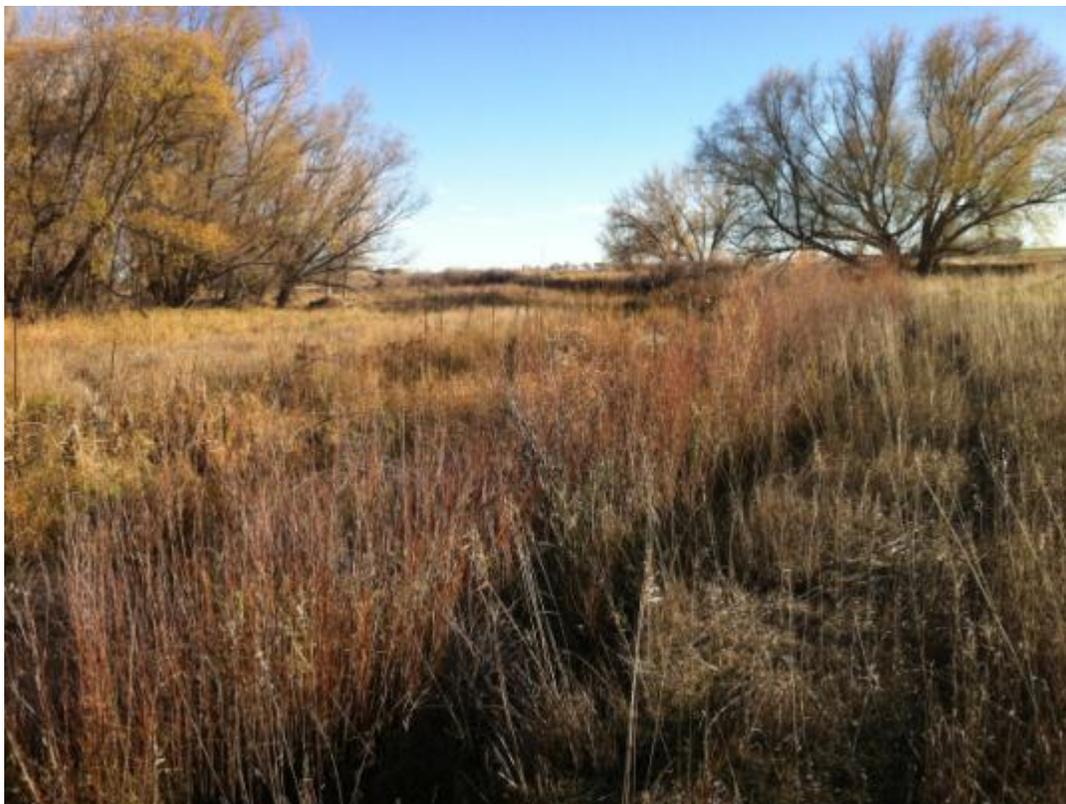
November 10, 2015: Note that channel does not have visible flows and that wetland vegetation has greatly increased.

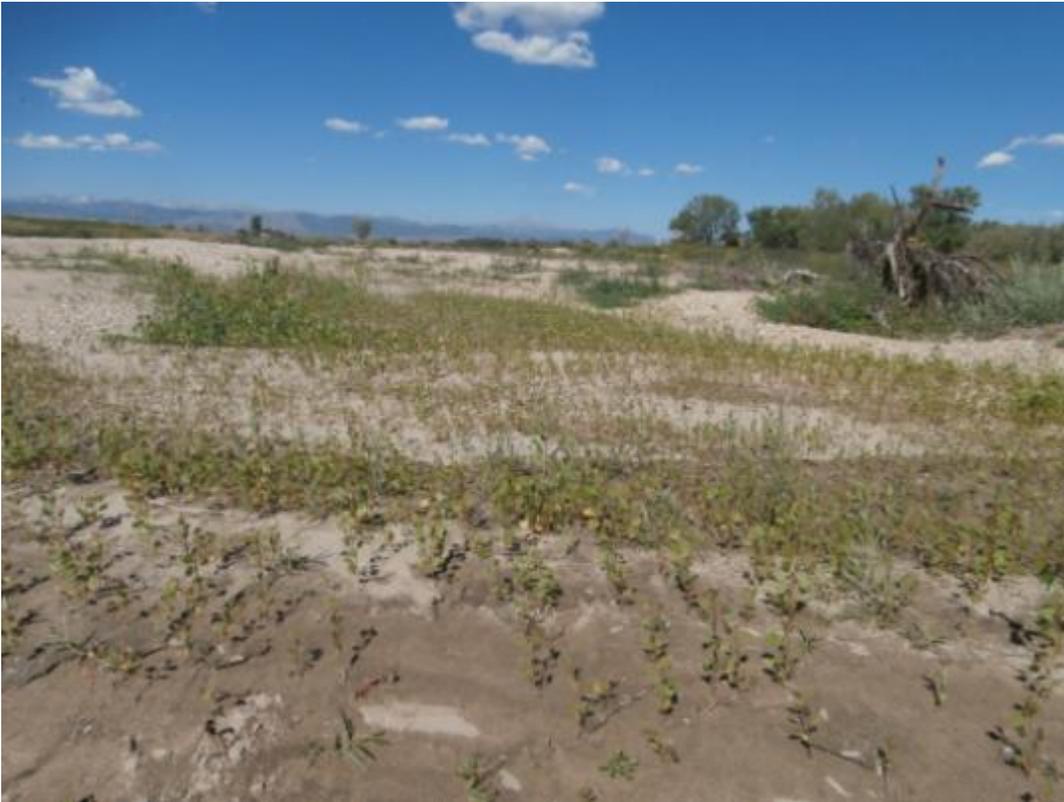
Cobble deposits in new flood channel below stream avulsion, view to west:

September 3, 2014: Note prevalence of woody volunteers, mainly cottonwood.

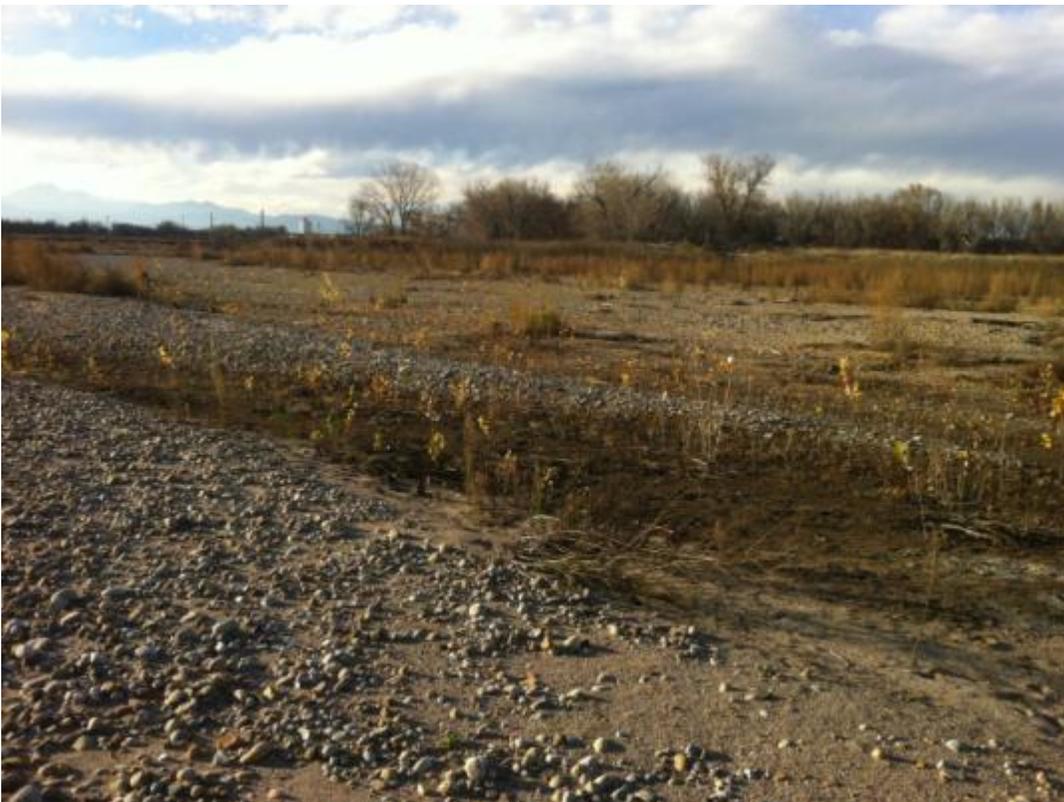
November 10, 2015: Note high mortality of woody volunteers.

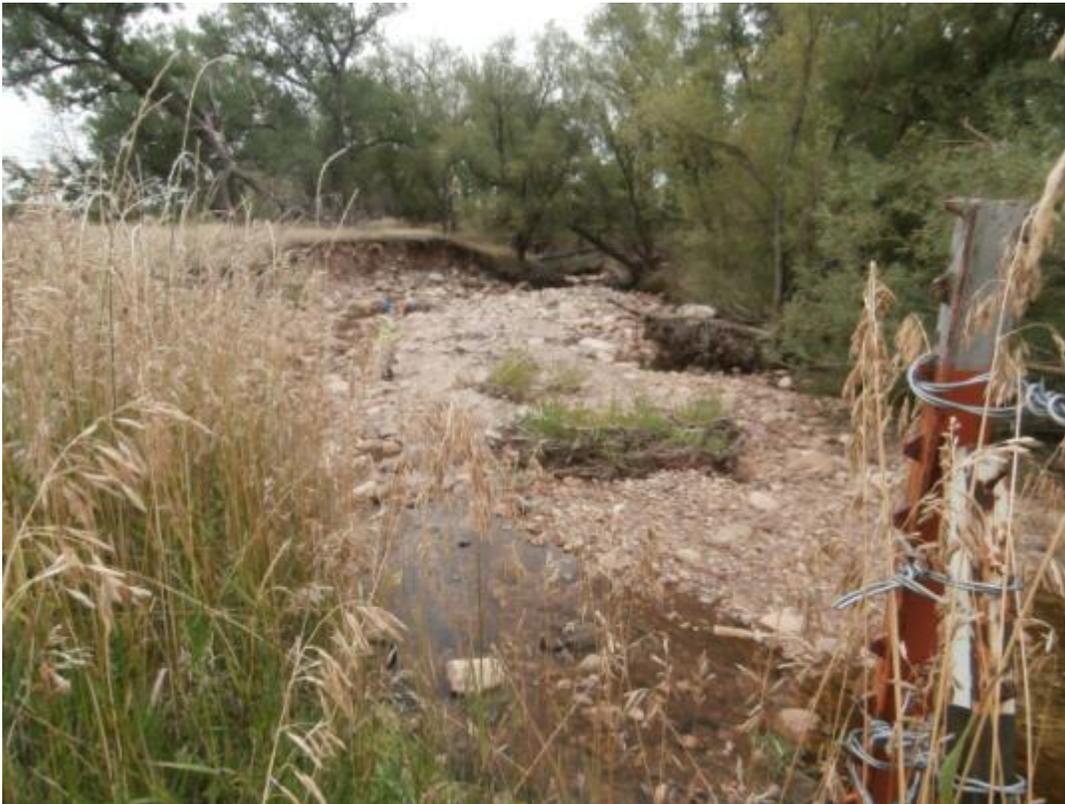
View downstream from western property boundary:

August 22, 2014: Note washed in vegetation growing on river right cobble bar.

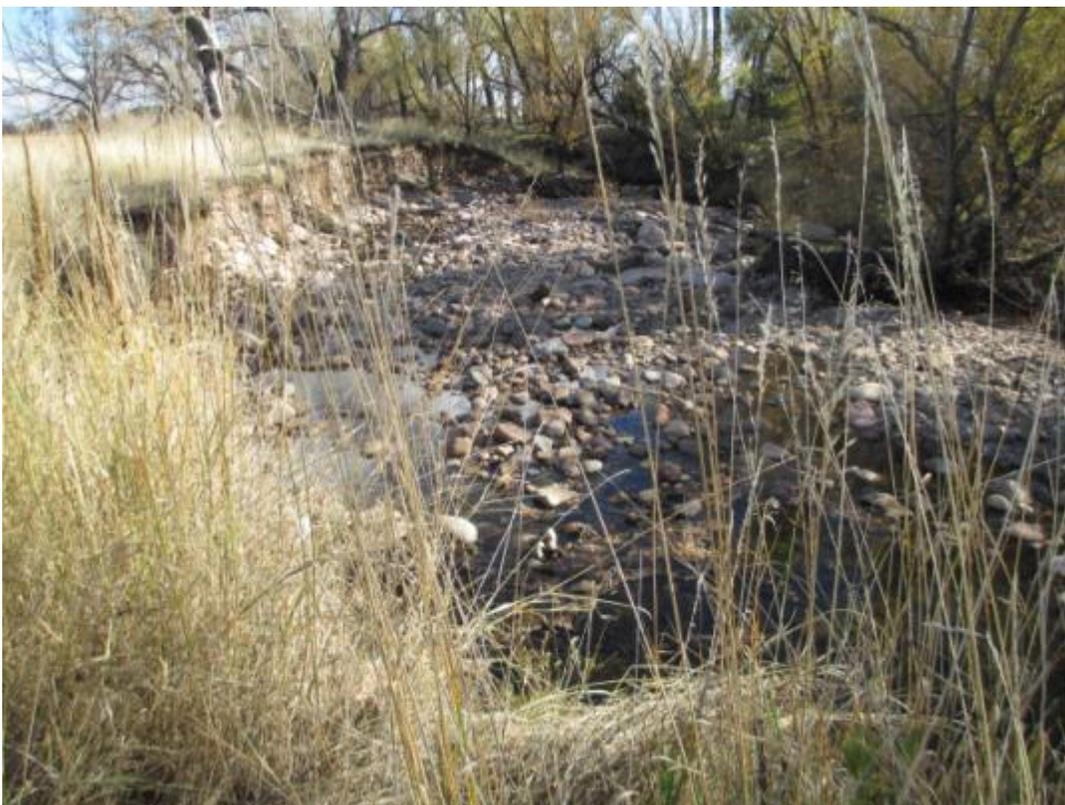
November 5, 2015: Note very little vegetation in cobbles.

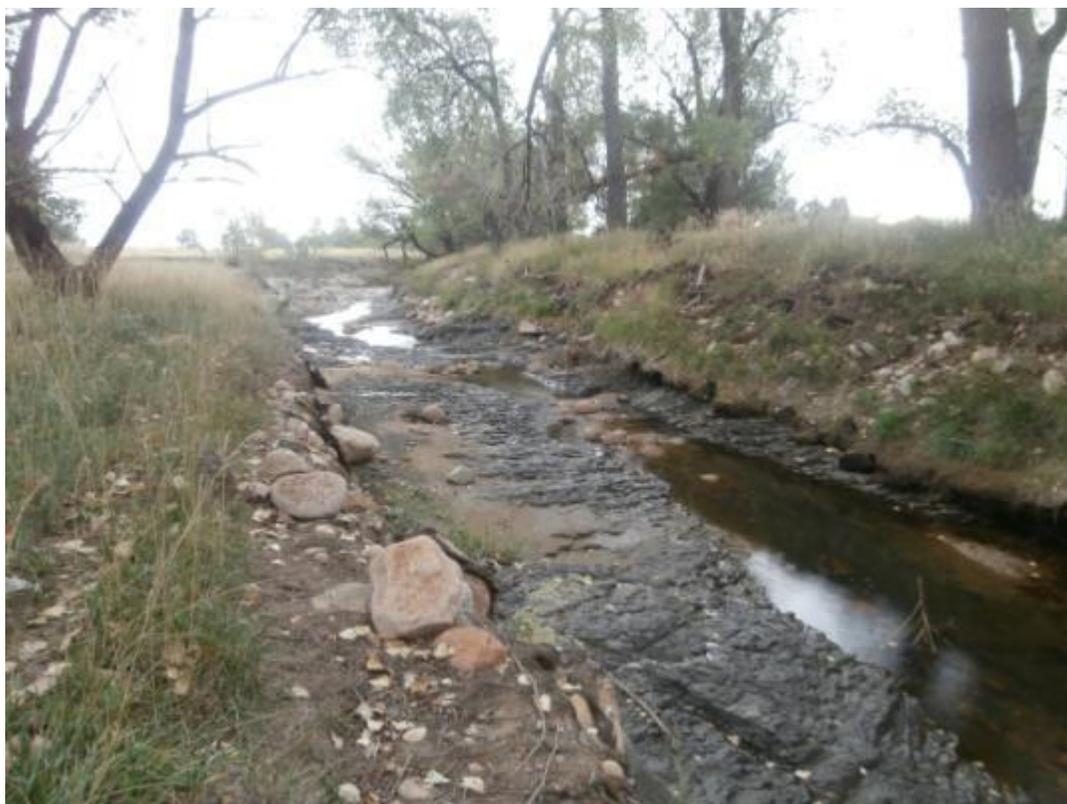
View downstream from approximately 200 feet below western property boundary:

August 22, 2014: Note exposure of shale bedrock, vegetation developing only in sand deposits.

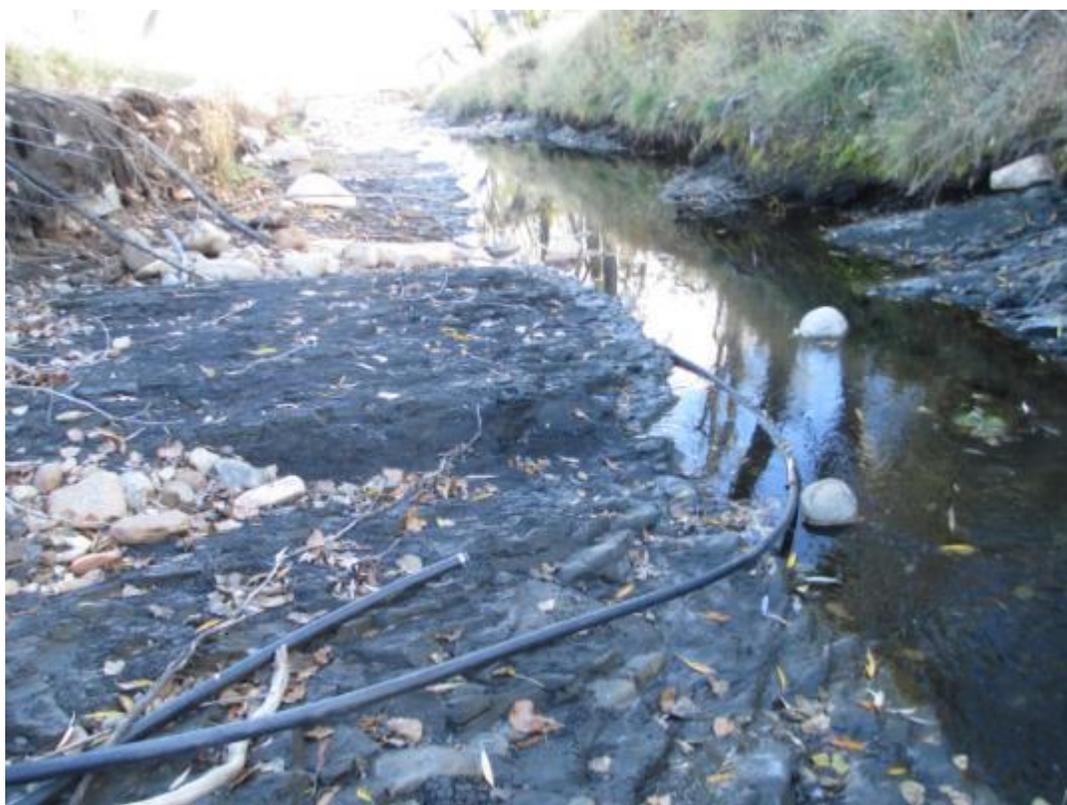
November 5, 2015: Note areas of shale bedrock still lack vegetation, broken pipe in foreground.

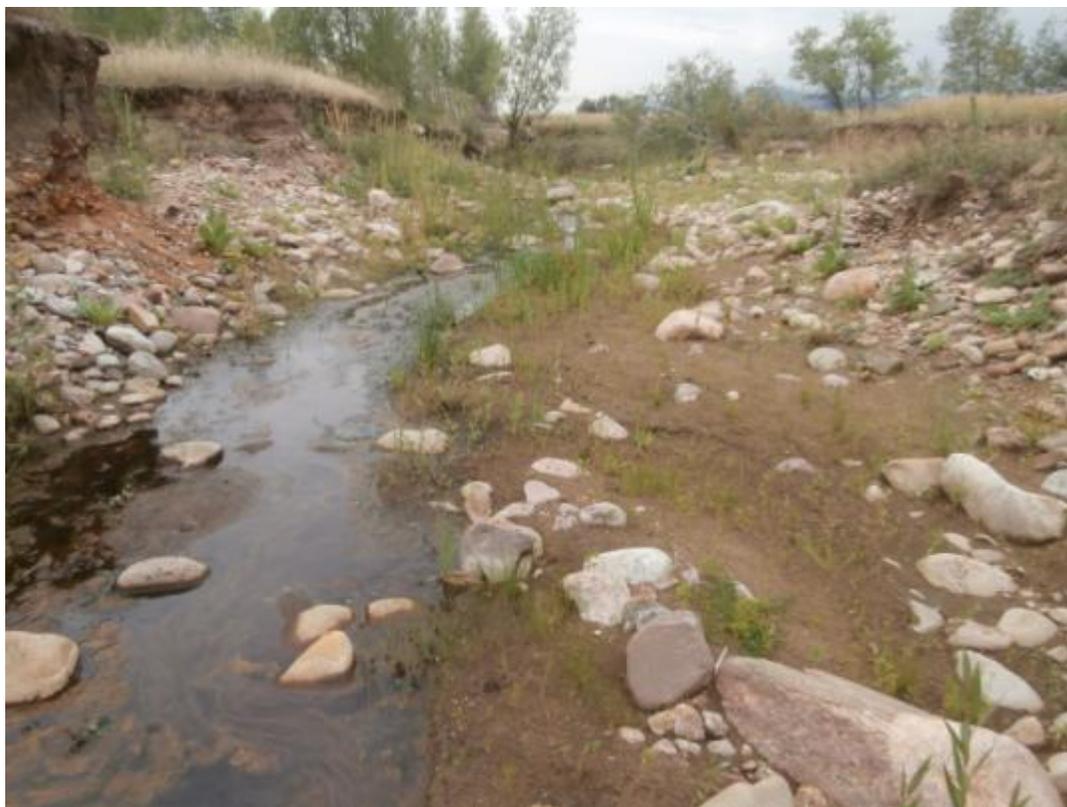
View downstream of flood channel cut into upland pasture, north side near west end of property:

August 22, 2014: Note development of wetlands with variety of vegetation.

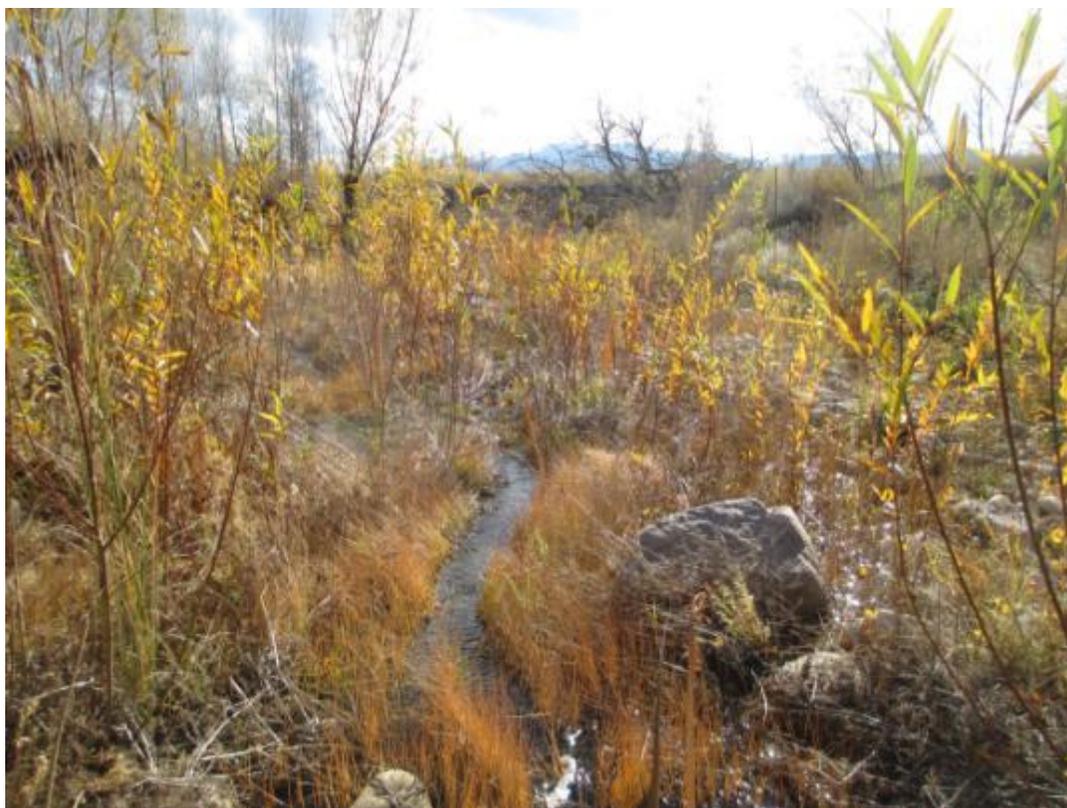
November 5, 2015: Note increased development of diverse wetland vegetation.

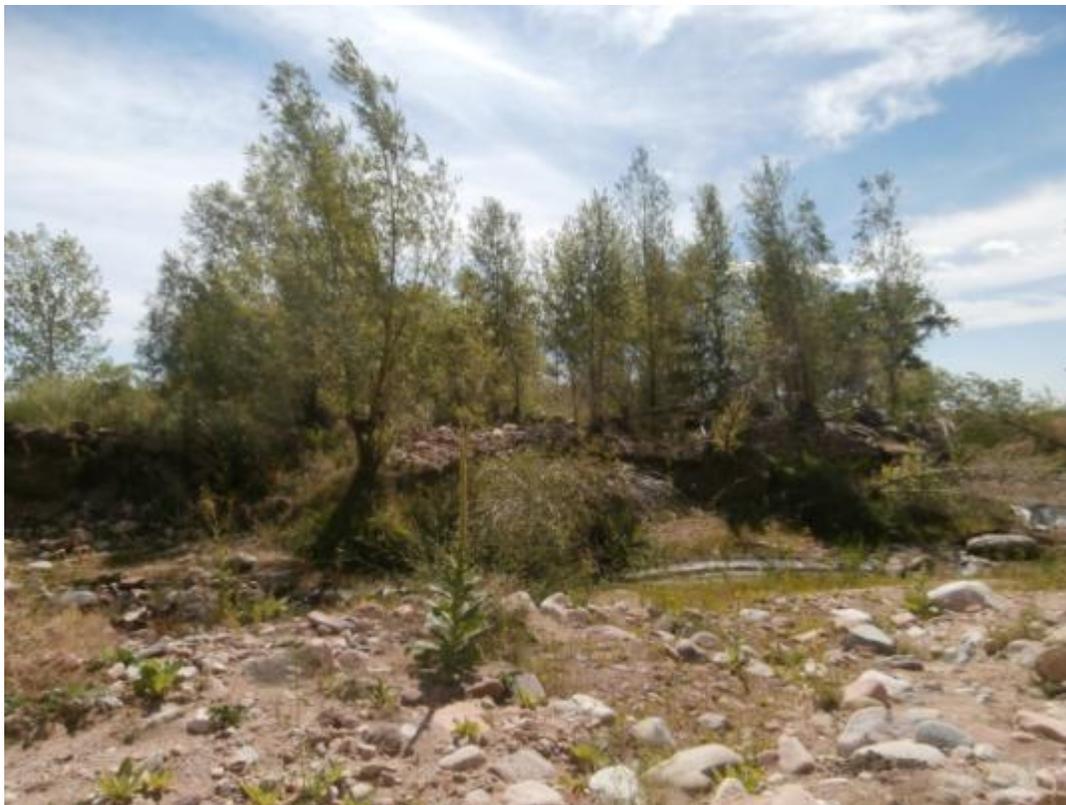
View to north across the stream channel toward restoration planting area:

August 25, 2014: Note survival of tree plantings, development of weedy upland vegetation in cobble deposits.

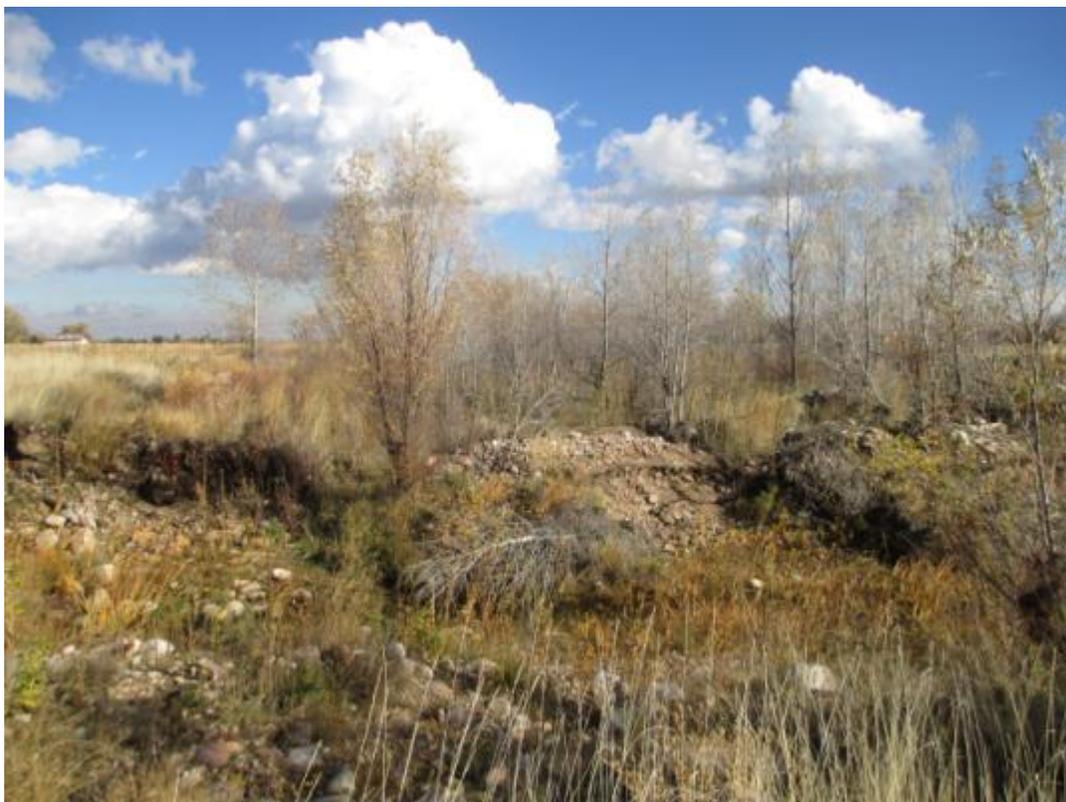
November 5, 2015: Note development of vegetation in cobble deposit area.

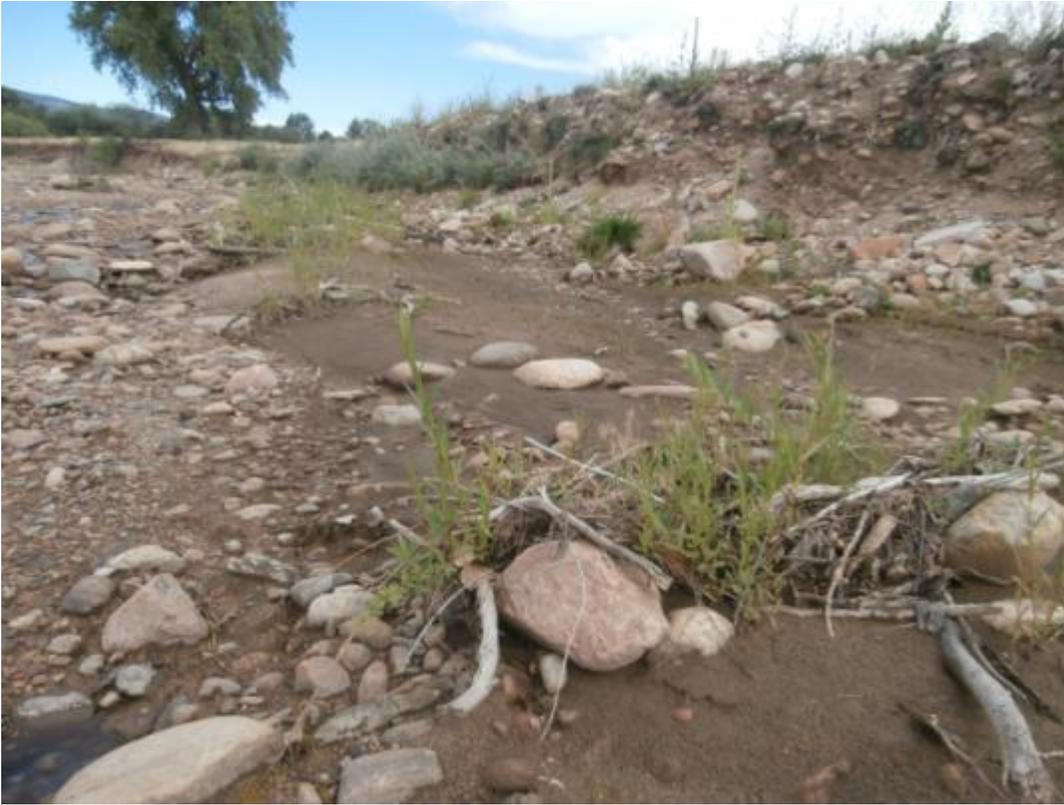
Lower channel, view to west:

August 25, 2014: Note washed-in crack willow rooting in channel downcut by floods, many areas of bare sand deposits, flows visible near upper left side of photograph.

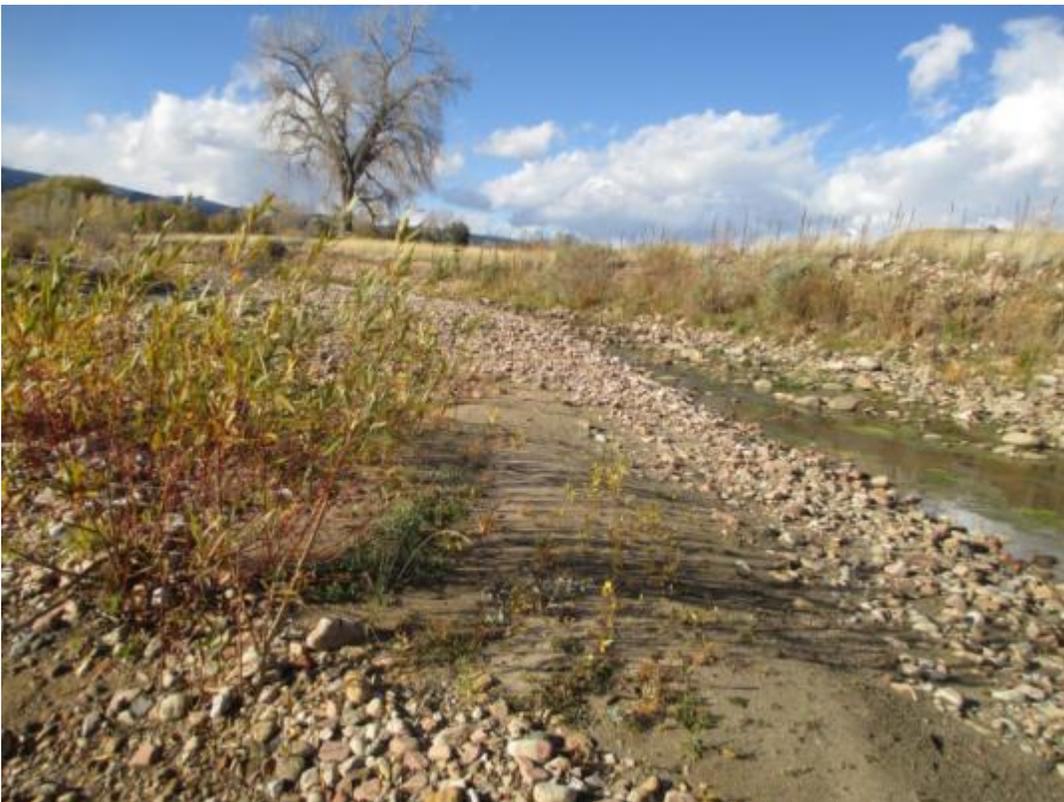
November 5, 2015: Note that flows are now along river left and willows are developing on the sand and cobble deposits.

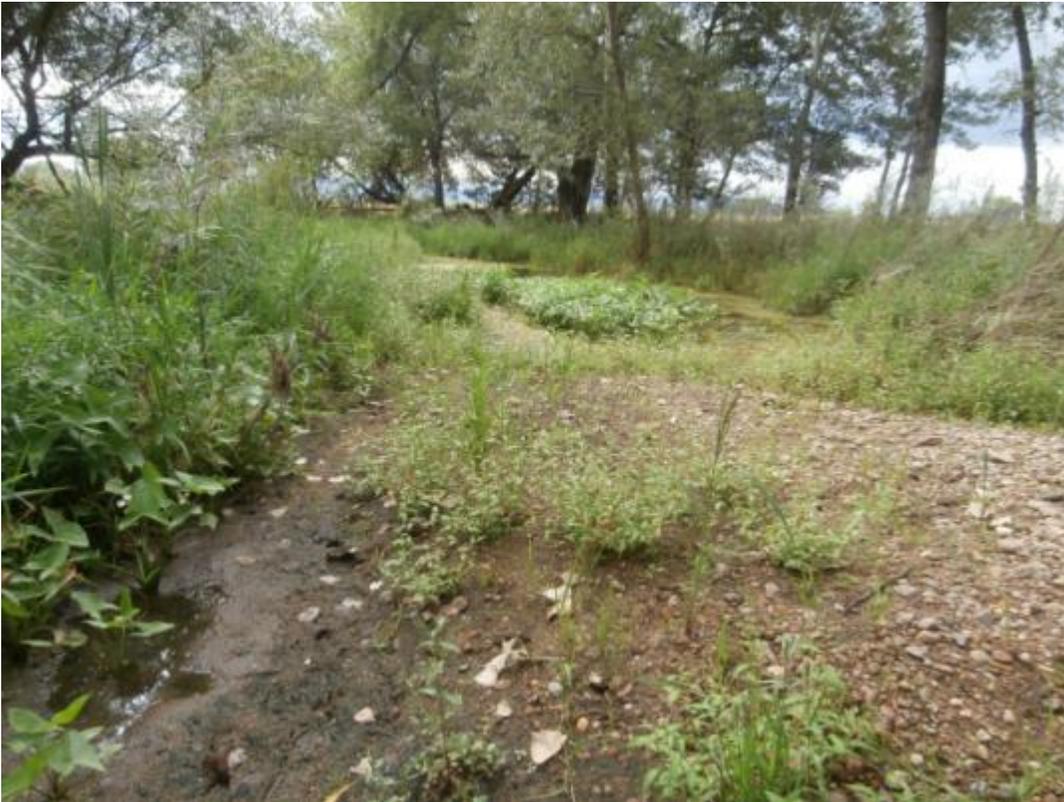
View upstream of minor side channel:

August 26, 2014: Note arrowhead growing at left of photograph.
