Fall 2015 Review of Selected Boulder County Properties Affected by 2013 Floods

Laura Backus
January 29, 2016

The sections that follow are photographic documentation of conditions in the Ramey and Peschel properties along St. Vrain Creek, the Brewbaker-Sorensen property along Left Hand Creek, and the Alexander Dawson Property west of US 287 along Boulder Creek.

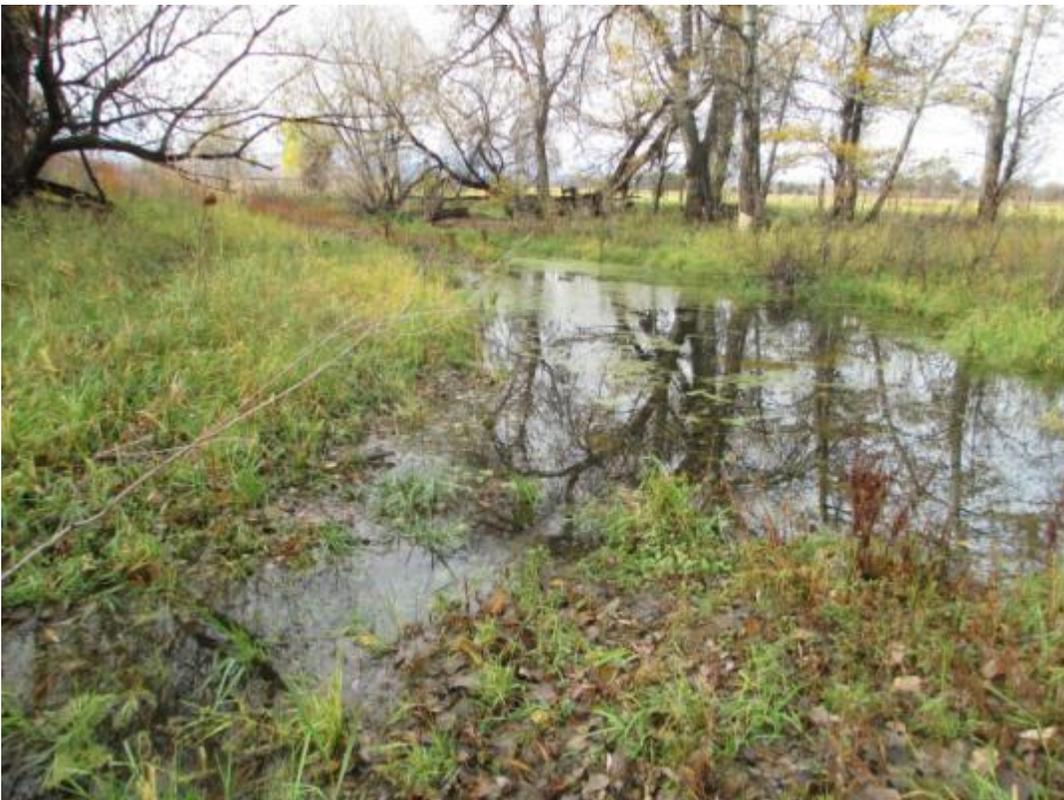
November 5, 2015: Note continued development of wetland vegetation, especially reed canarygrass. Water levels were high, probably due to recent rain.

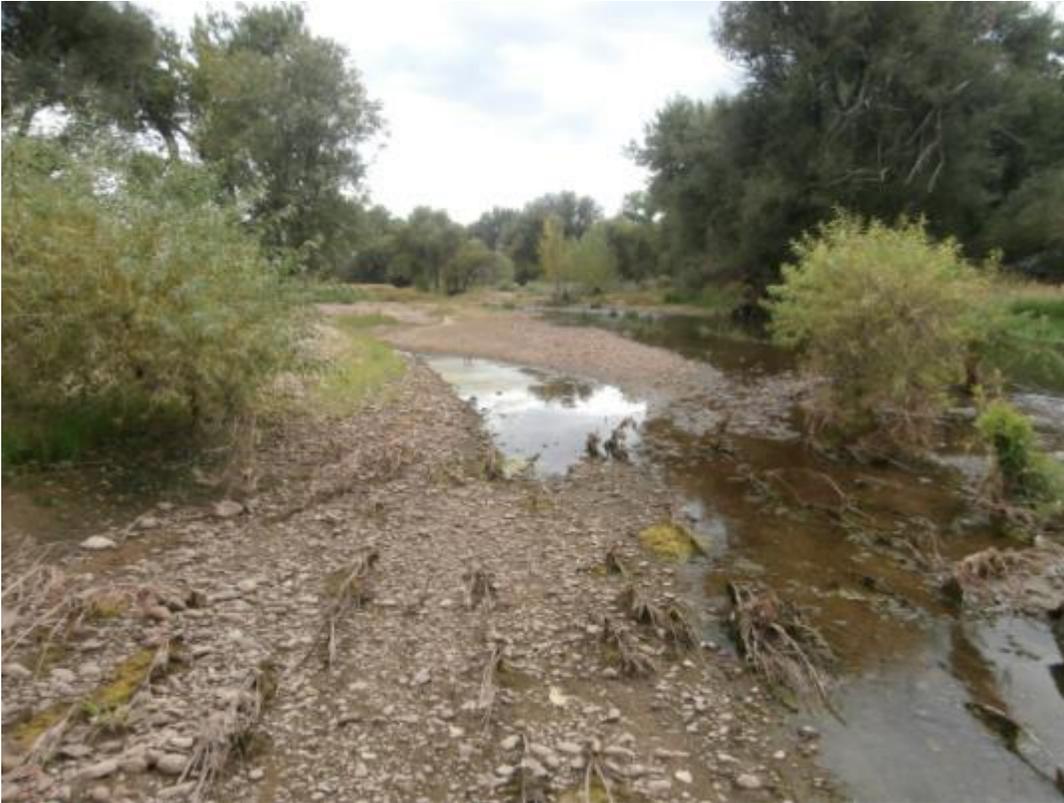
Created meander to north, similar locations:

August 26, 2014, view upstream: Note occasional willow survival, little vegetation on cobble banks.

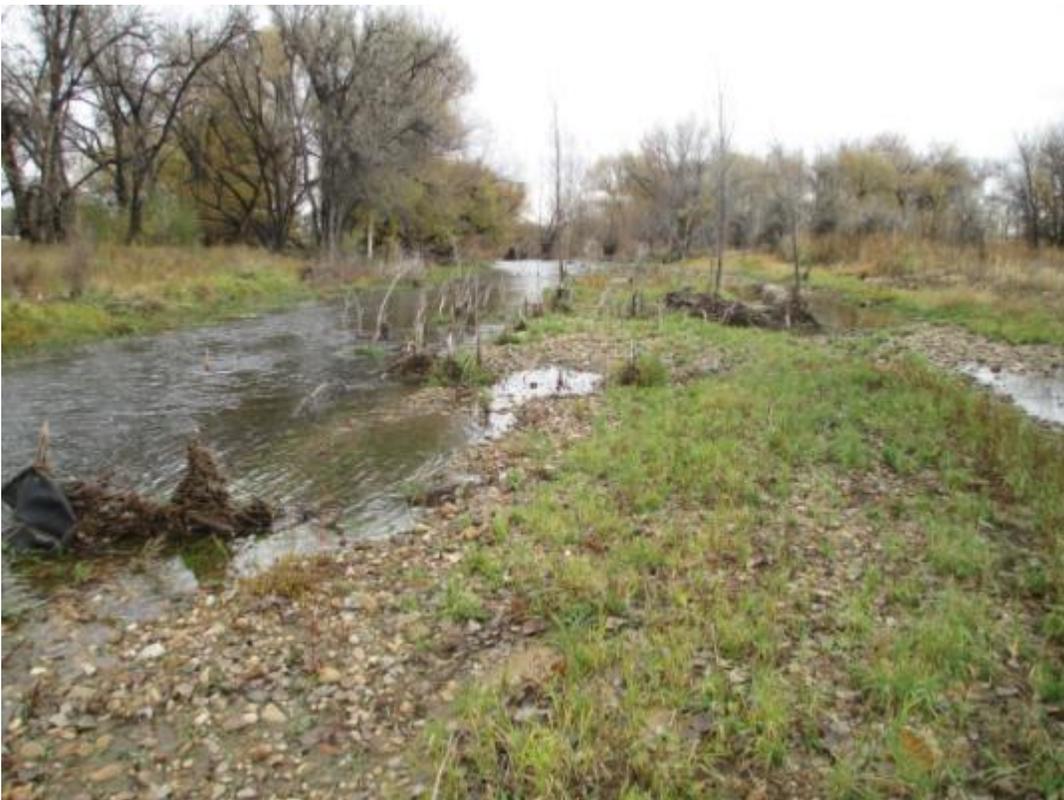
November 5, 2015, view downstream: Note low willow survival, increased vegetation on low bank.

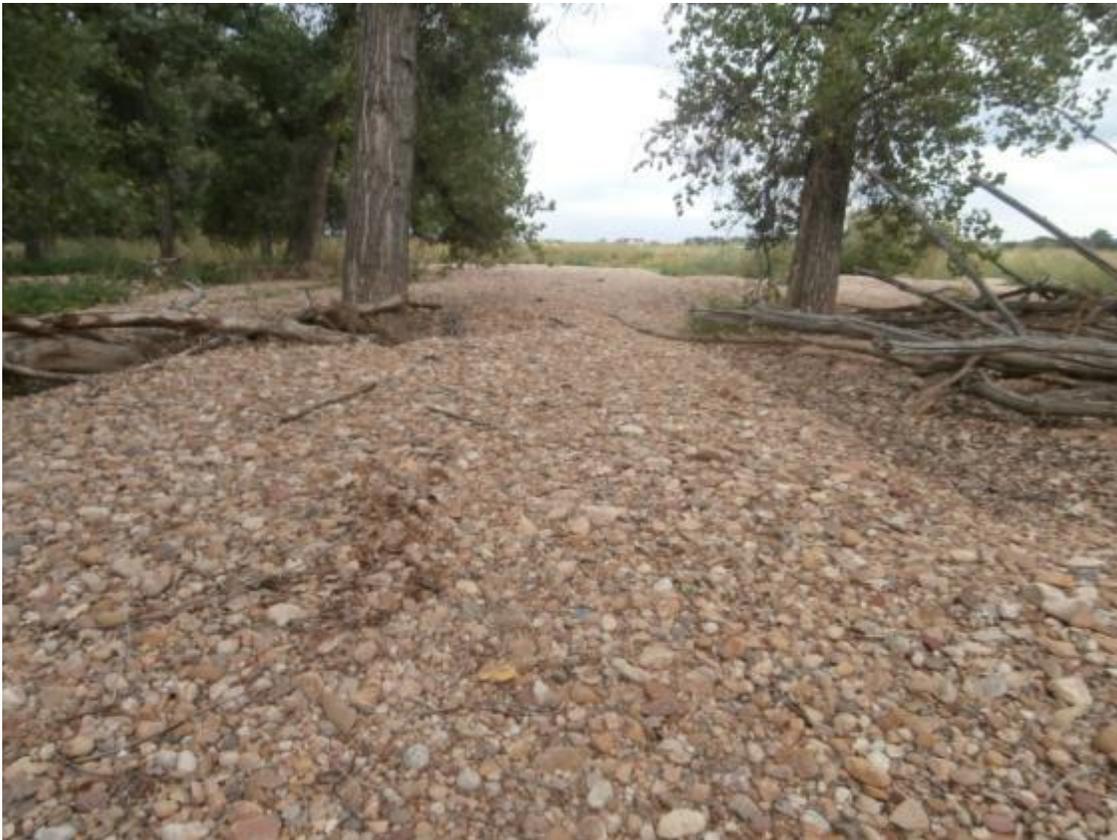
River right cobble deposits, approximately 500 feet west of US 287, view to east southeast:

August 26, 2014: Note large pieces of drifted wood, no vegetation development.

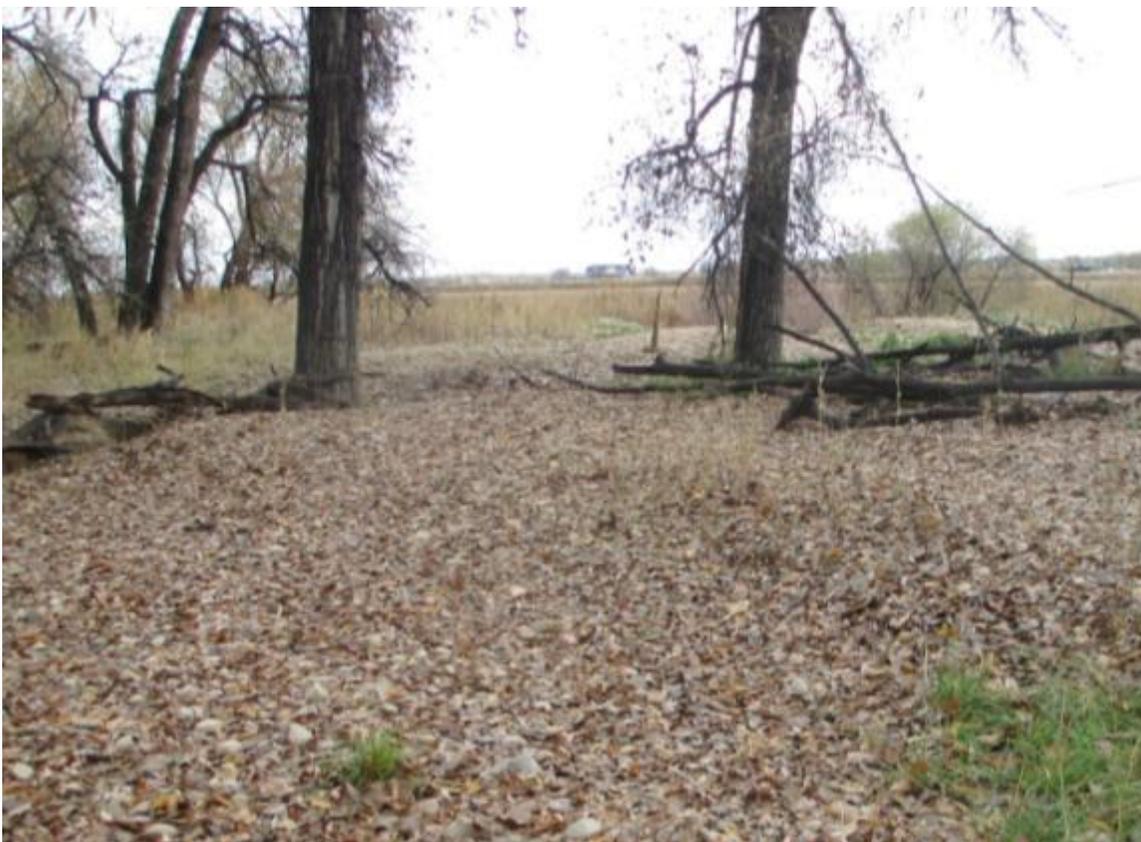
November 5, 2015: Note extensive leaf litter, some vegetation development.

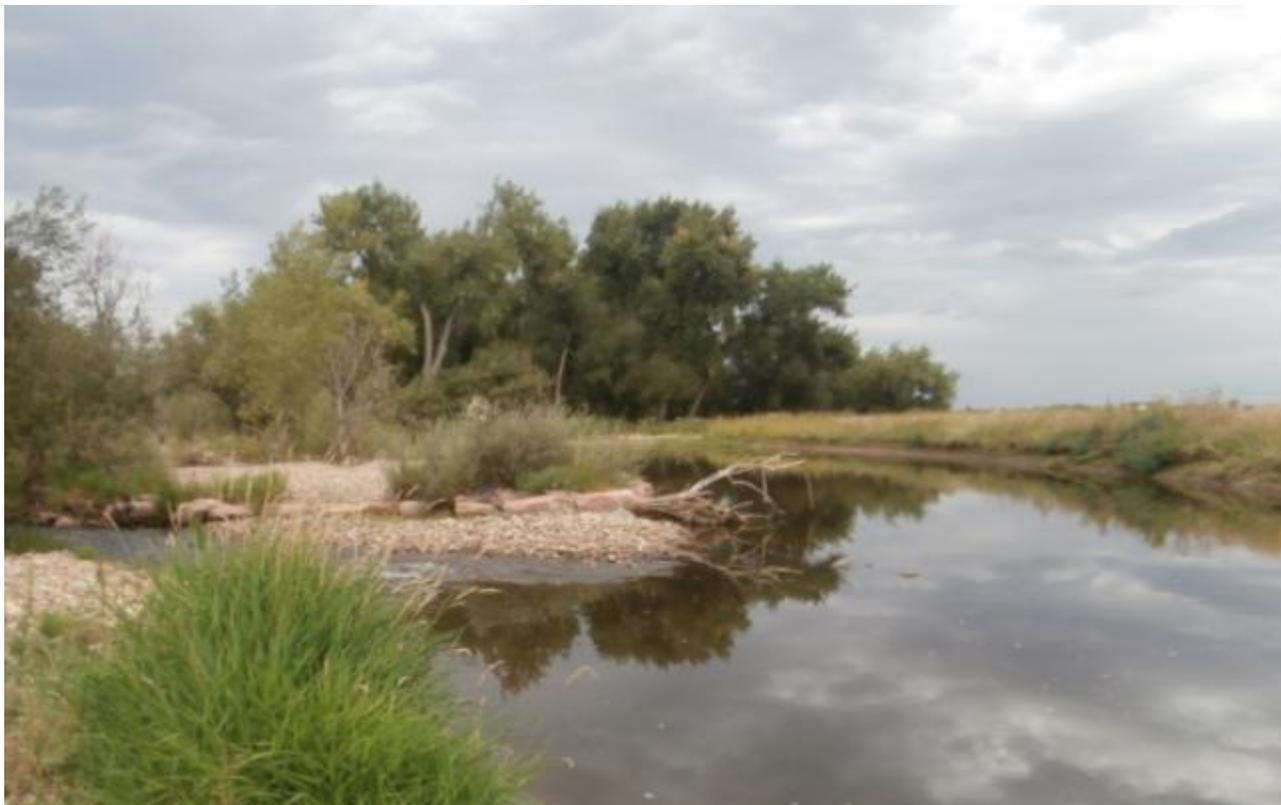
View downstream from breach to river right:

August 26, 2014: Note surviving willows and low vegetation development on cobble area between flow paths, very little vegetation on river right bank in middle ground.

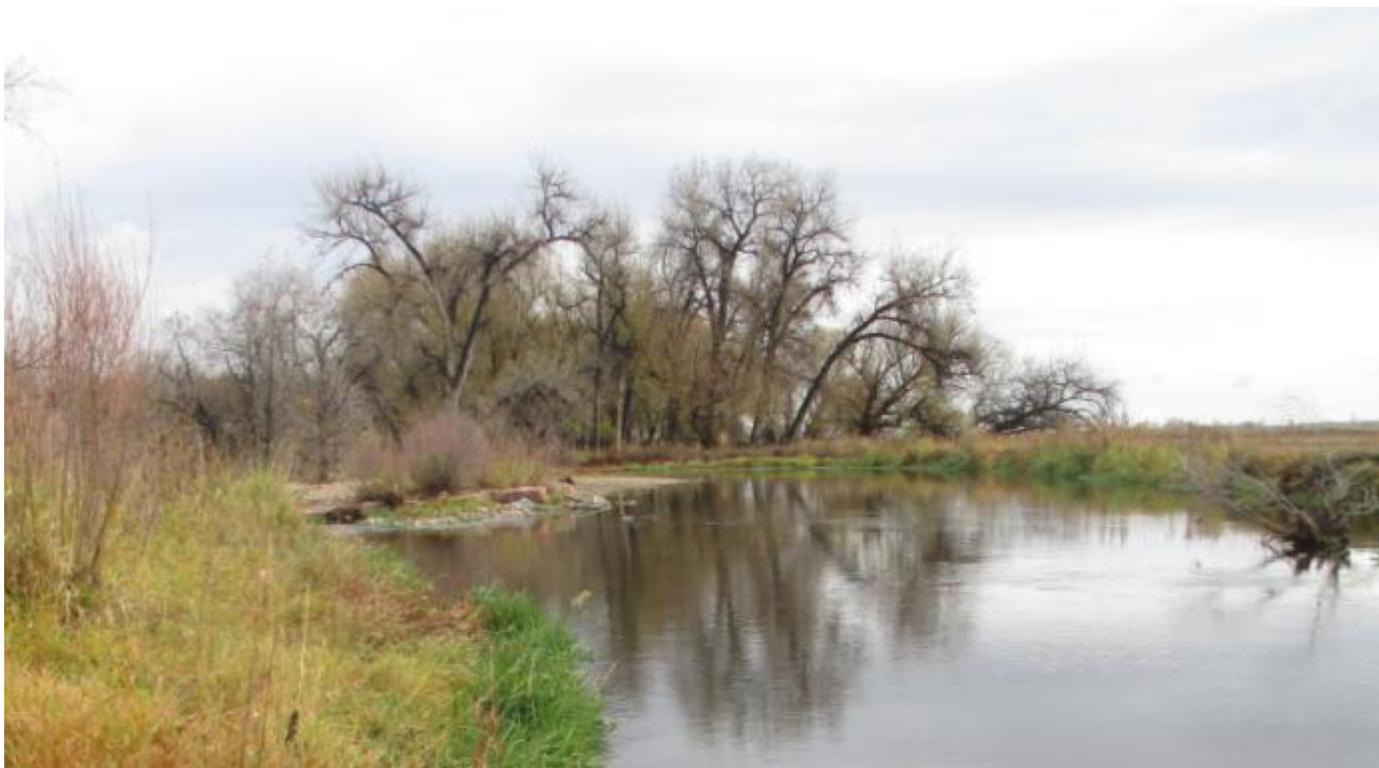
November 5, 2015: Note increased vegetation on cobble area and on river right bank, root clump moved downstream.

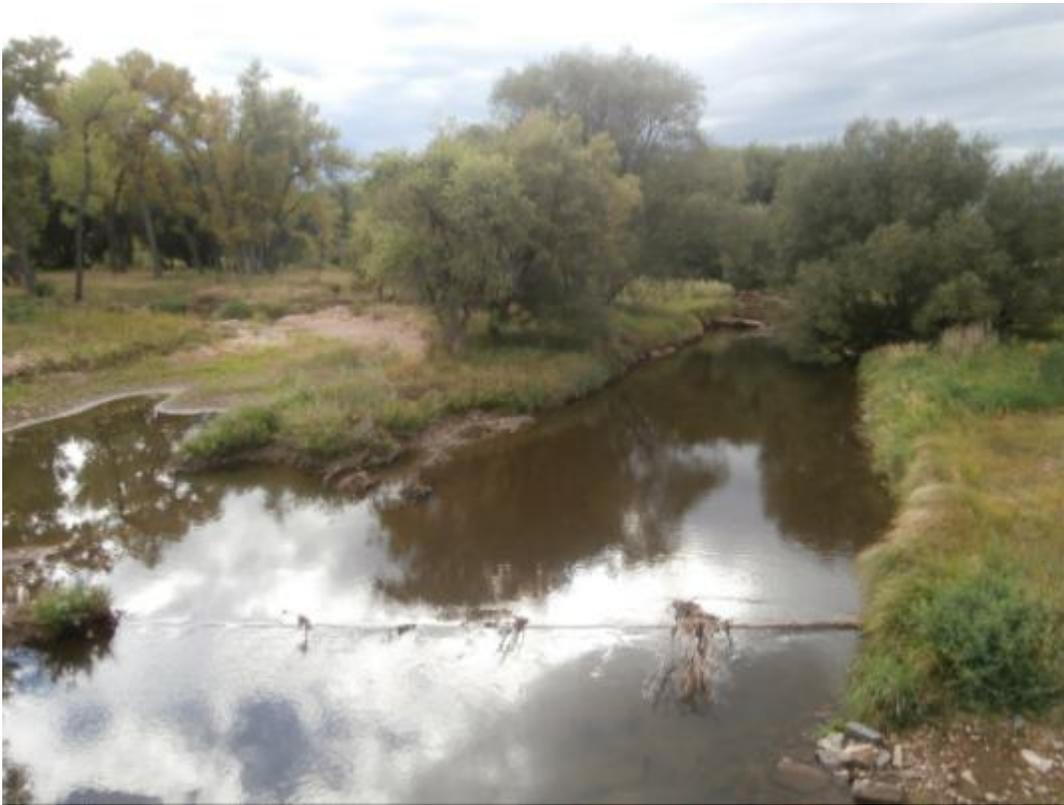
View upstream from US 287 bridge:

August 26, 2014: Note flood flow path at left side of photograph.

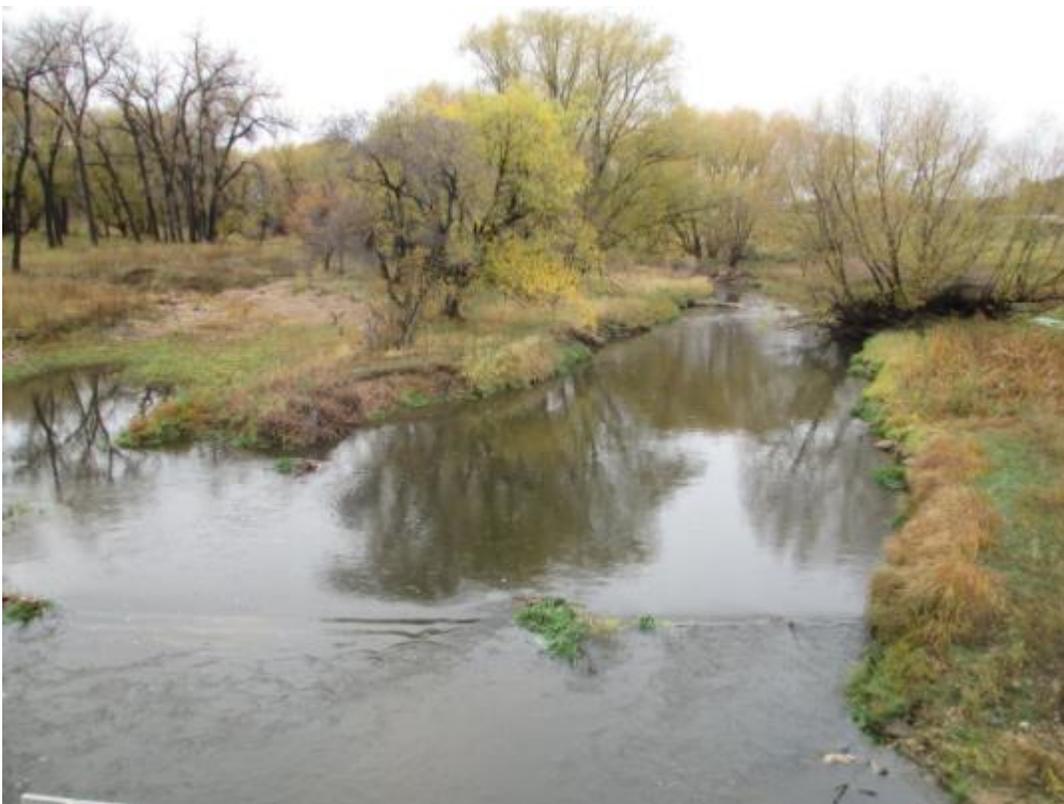
November 5, 2015: Note only minor changes in vegetation, increased cover in river right flood channel and lower right corner.
