2014 Riparian Inventory and Assessment of Post-Flood Conditions
Boulder County Parks and Open Space Properties
Boulder, Left Hand, and St. Vrain Creeks
Boulder County, Colorado

Laura Backus and Susan Sherrod
for
Boulder County Parks and Open Space
2014 Small Grants Program

December 11, 2014

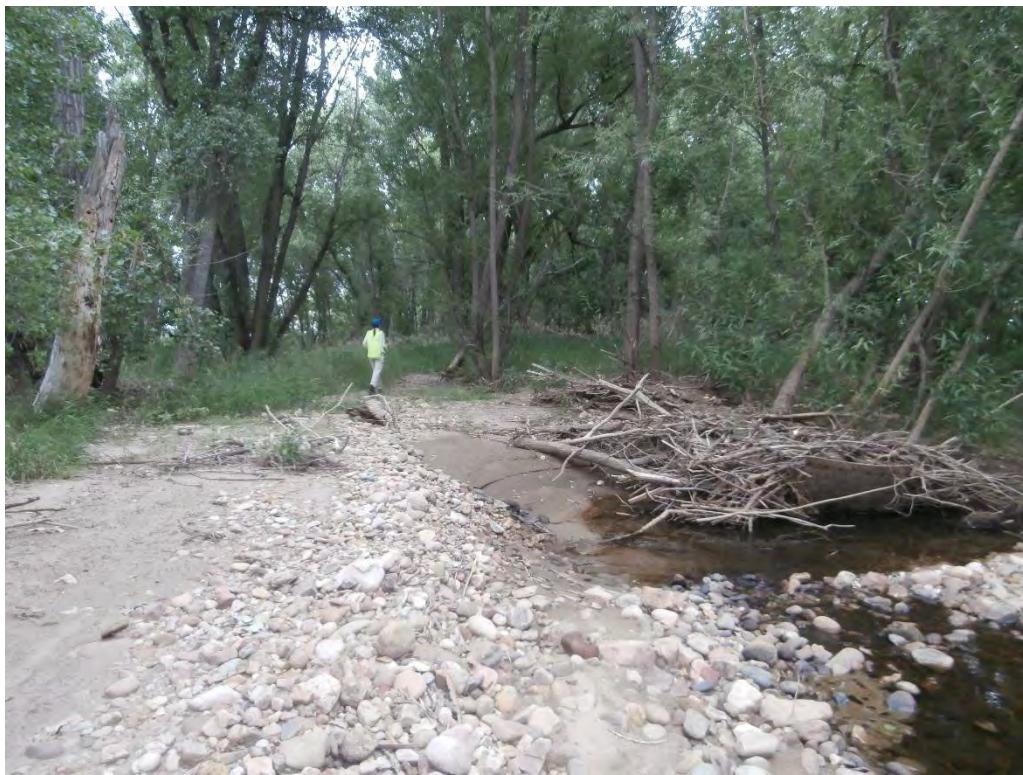
View downstream to beginning of secondary flood channel through river left forest. Note cobble deposition and woody flood debris.

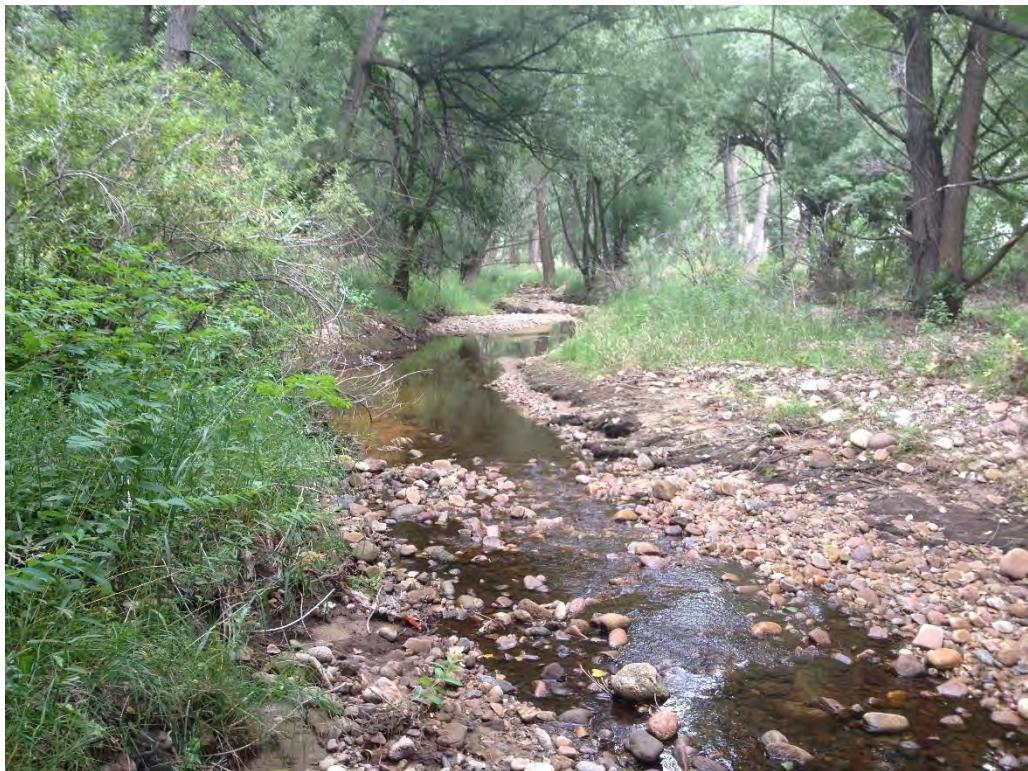
View downstream from approximately ¼ way downstream from Nimbus Road.

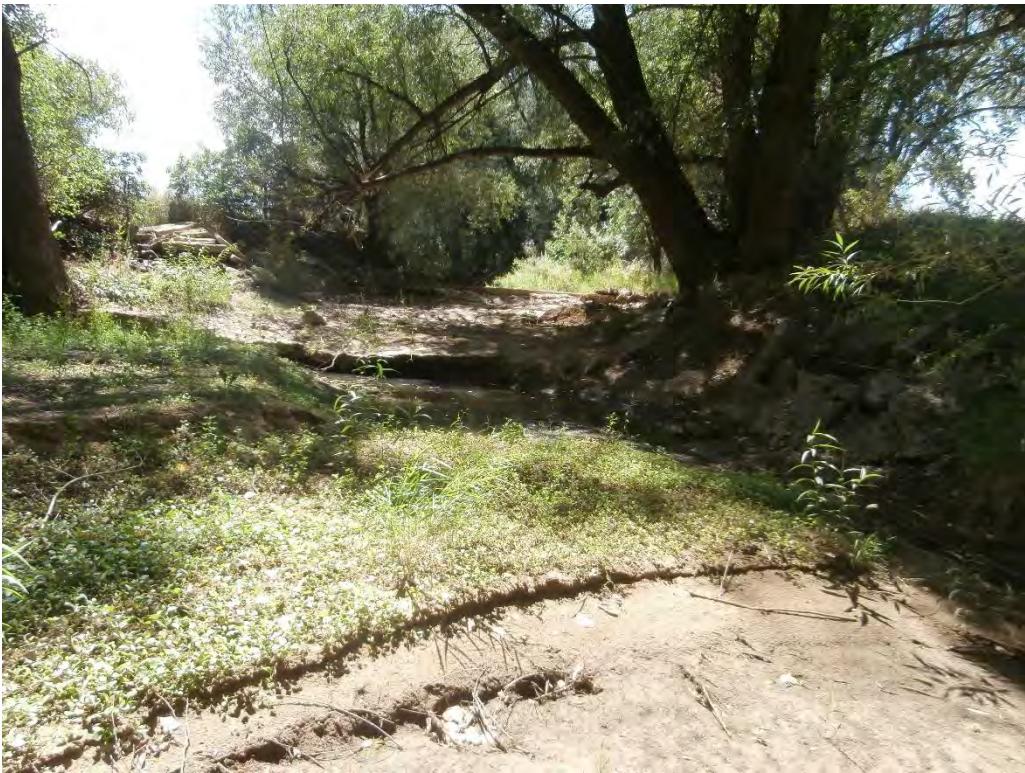
View upstream of cottonwood seedlings in channel sand deposit, foreground.

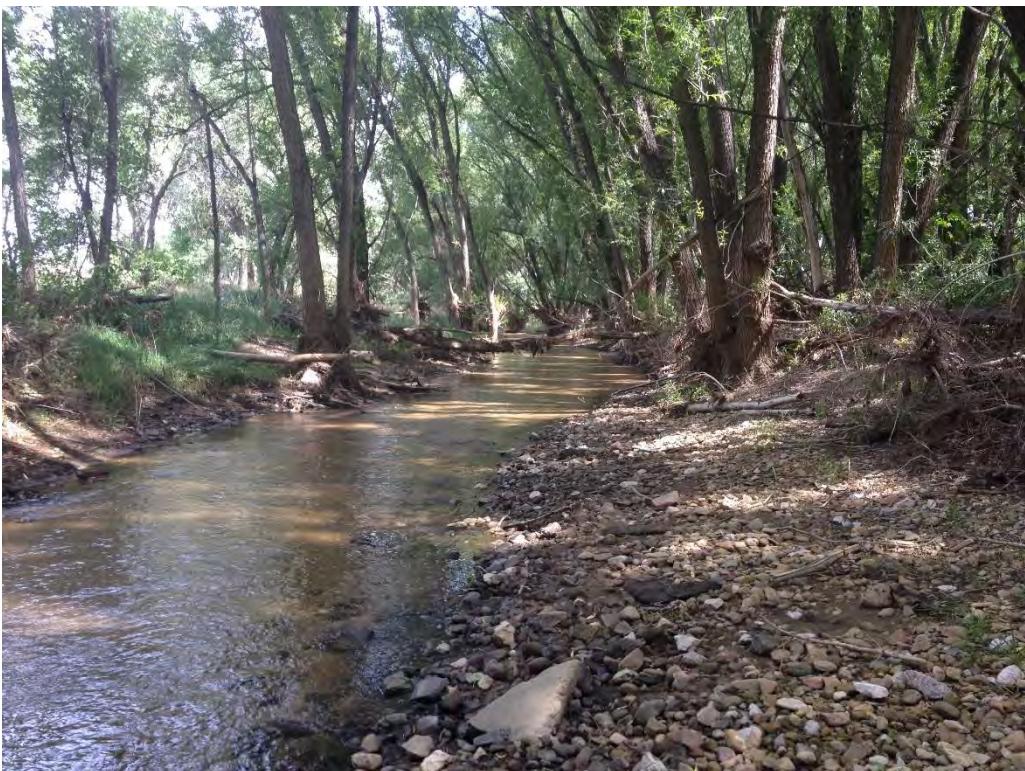
View downstream of riparian forest. Note crack willow in middle ground and eroded bank on river right.

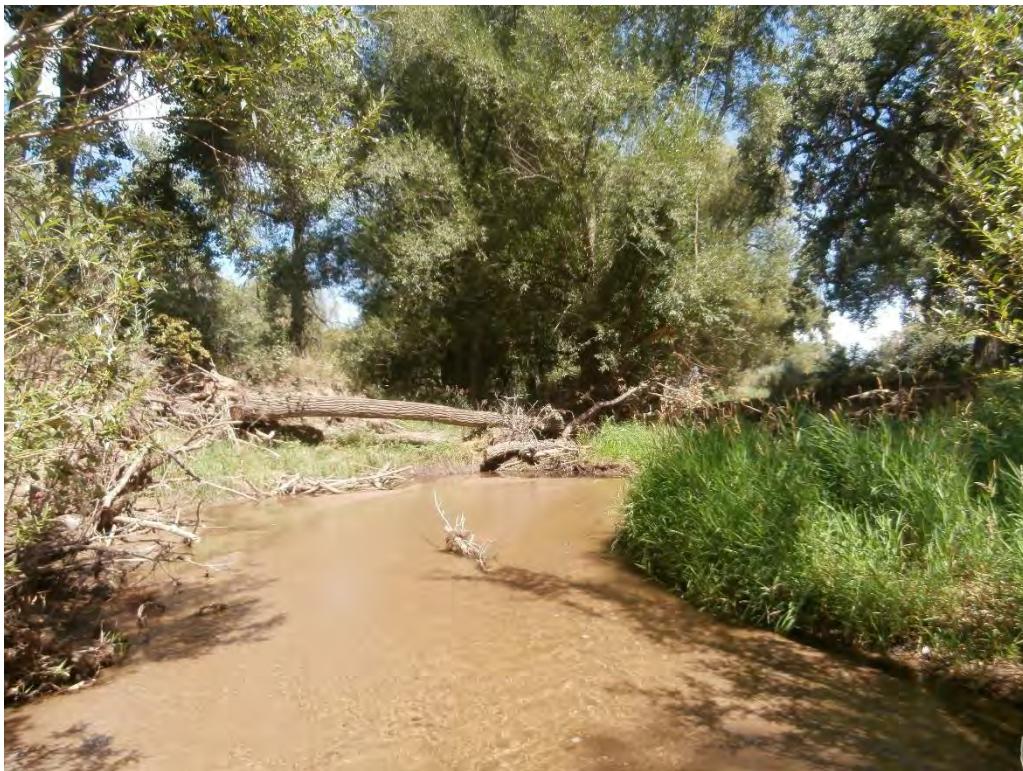
View downstream from upper end. Note large flood debris on river left and sandy channel bottom in foreground.

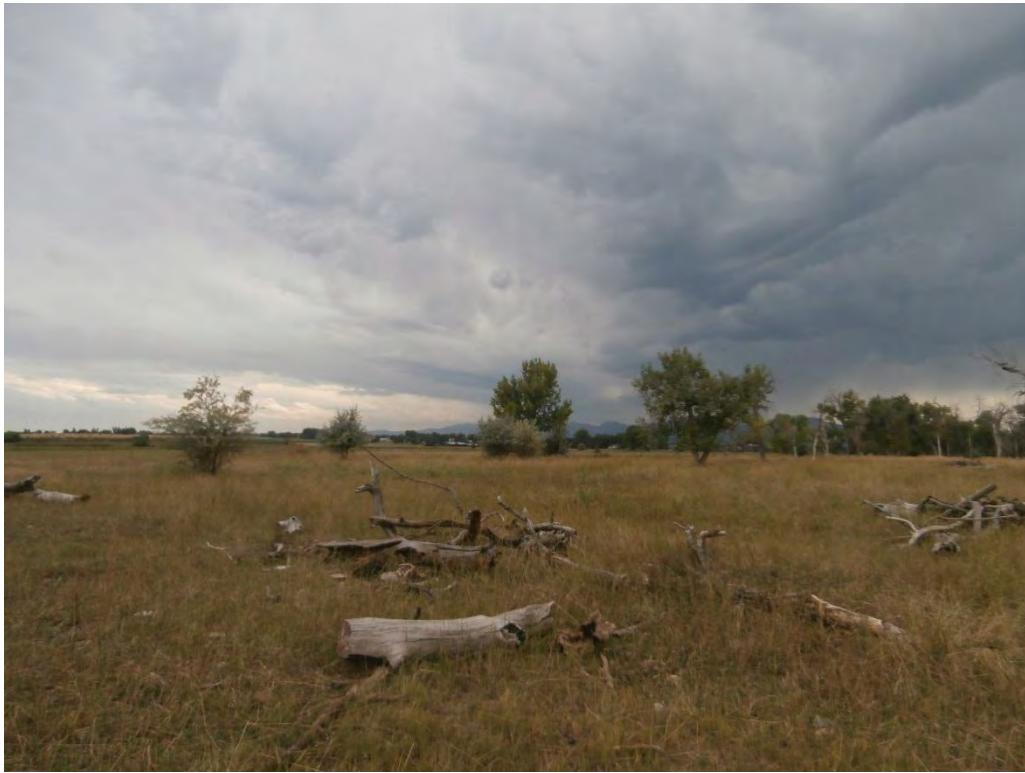
View to west from near northeast corner of property. Note that much of property is meadow.

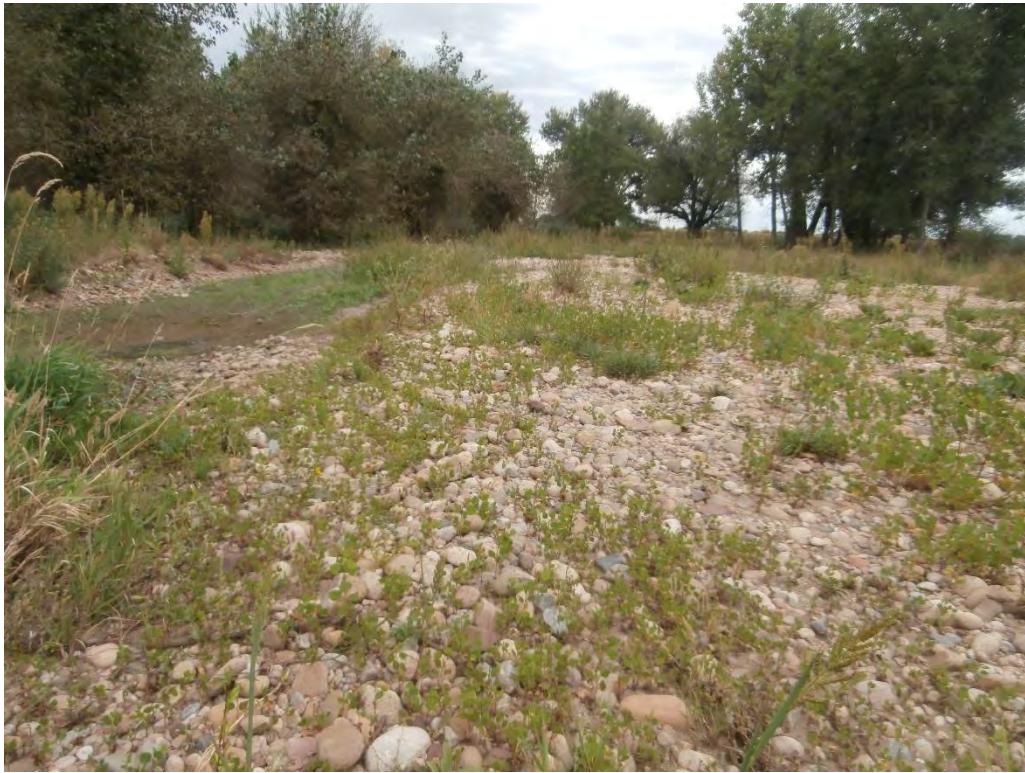
View to upstream of river left cobble bar with many cottonwood seedlings. Note side channel on left appears to be a developing wetland.

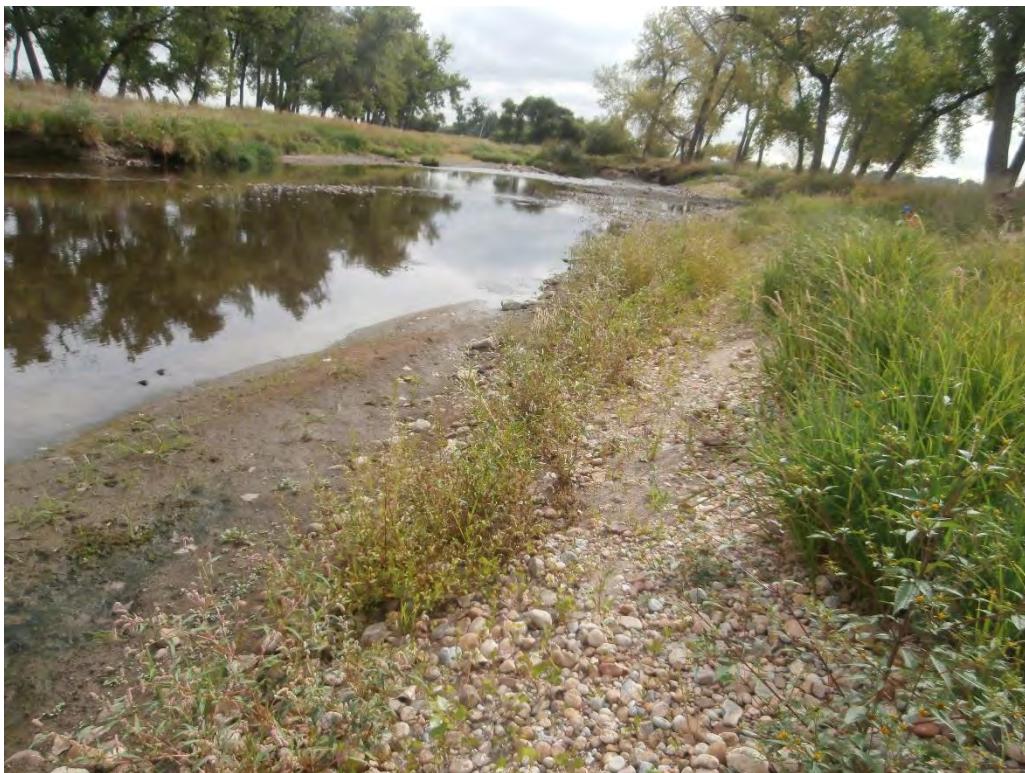
View to downstream of cottonwoods sprouting in strip at toe of river right bank and established reedcanary grass above, probably at former edge of channel.

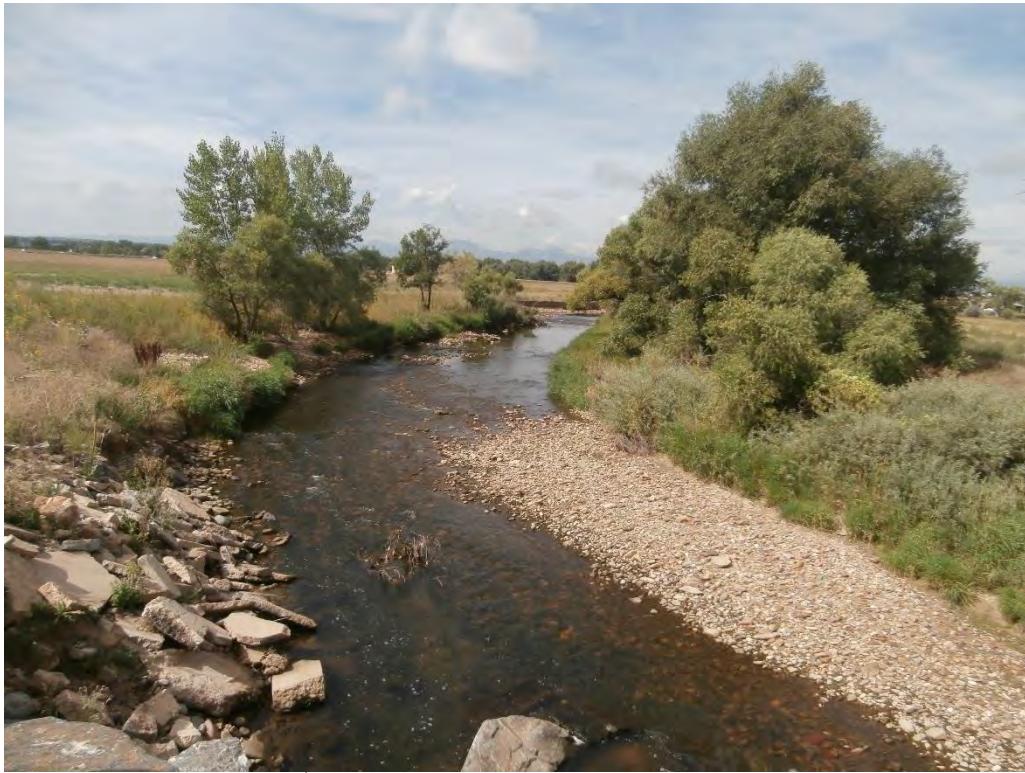
View to upstream at 109th Street. Note intermittent and very narrow riparian area at left side of photograph.

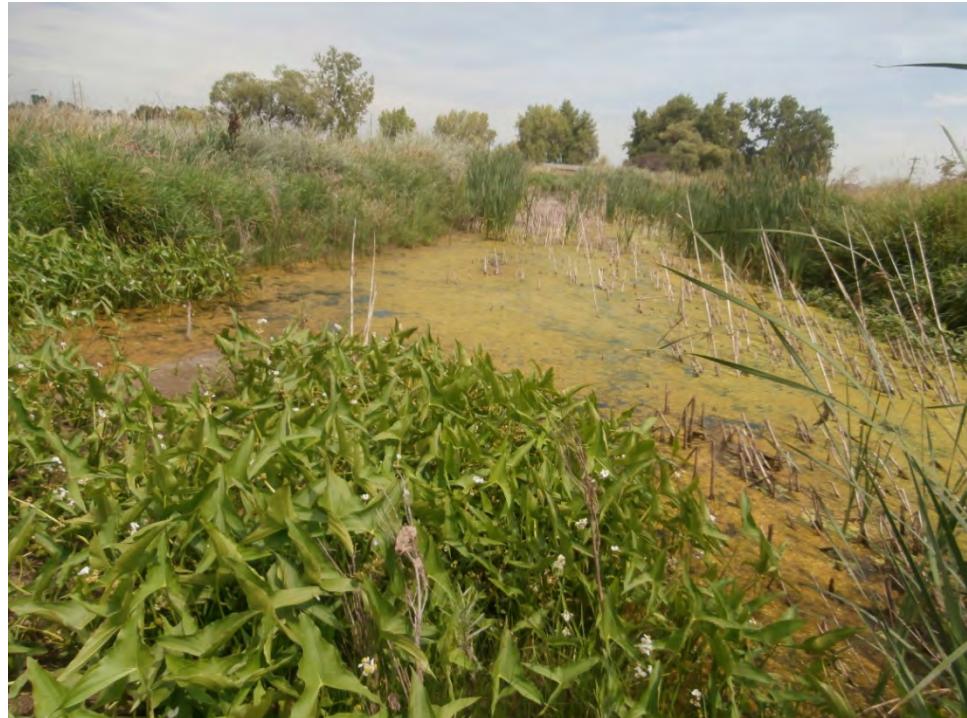
View to east northeast of wetland adjacent to a ditch on river right near downstream end of property with Kenosha Road bridge in center background. Note good condition of wetland vegetation.

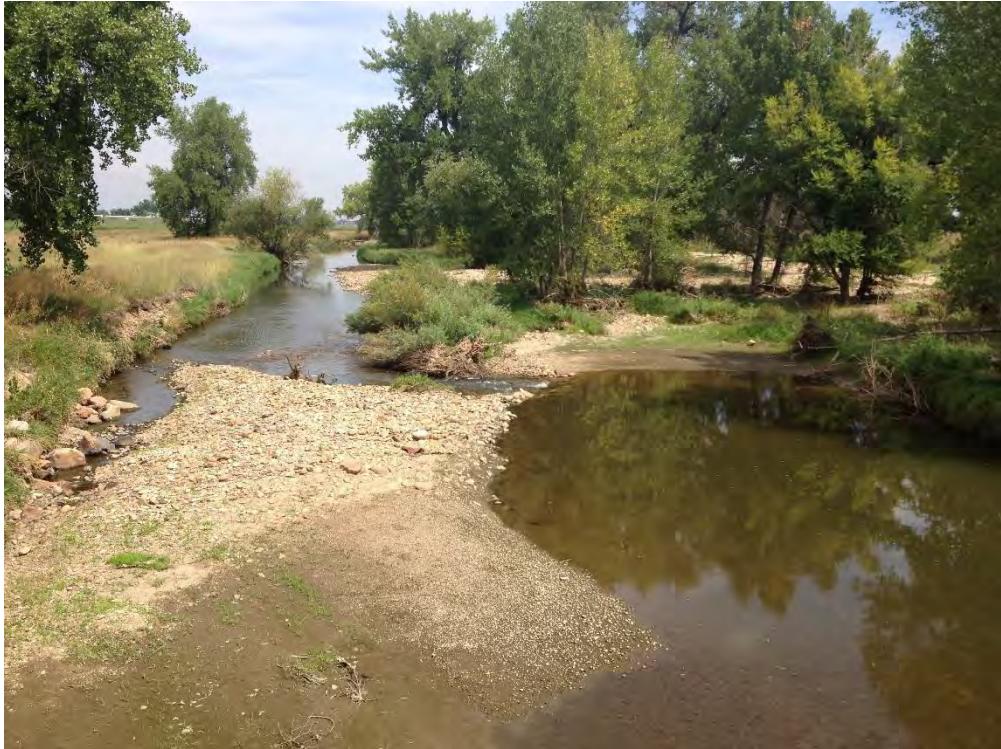
View to downstream from Kenosha Road. Note gravel/cobble deposit developing vegetation in left foreground, and secondary flood channel with cobbles through the riparian forest in right background.

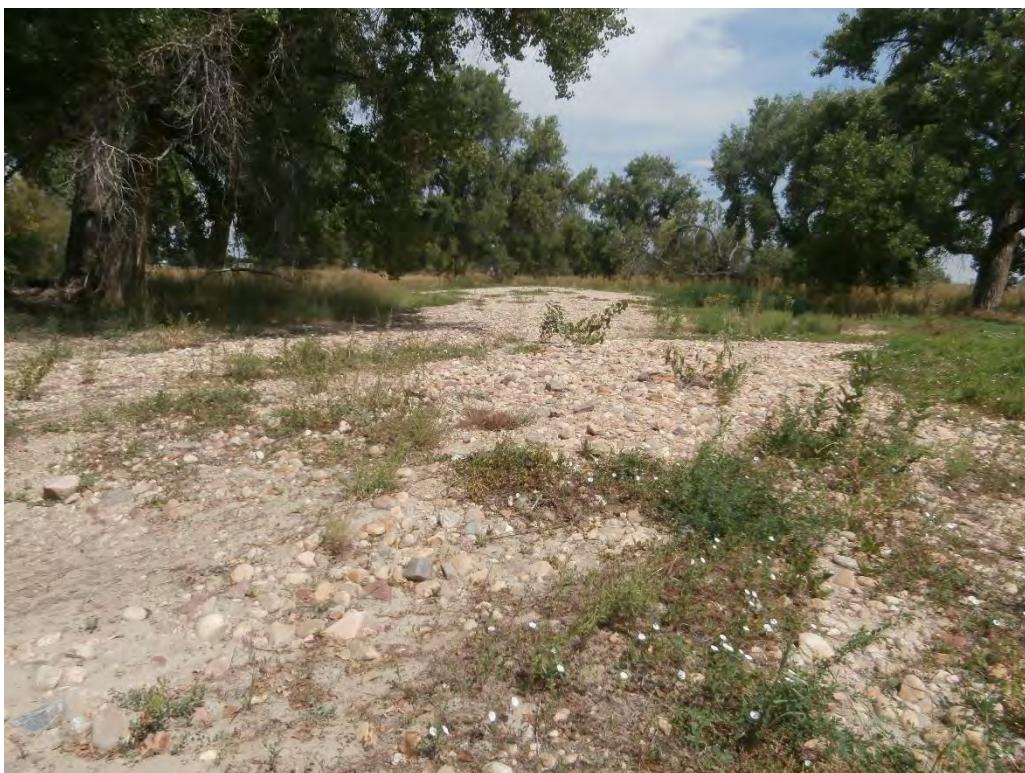
View down channel of river right flood flow channel, now cobble deposits on river right. Note bindweed colonizing cobble deposits.

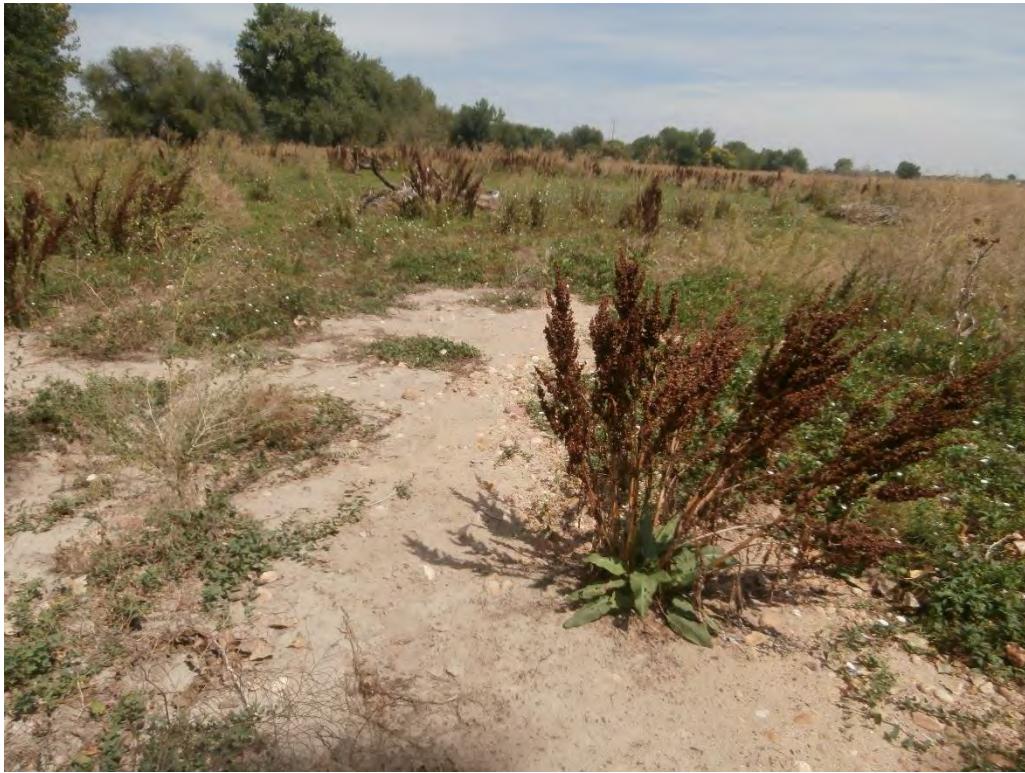
View to southeast of weedy meadow on river right. Note curly dock, Scotch thistle, and bindweed.

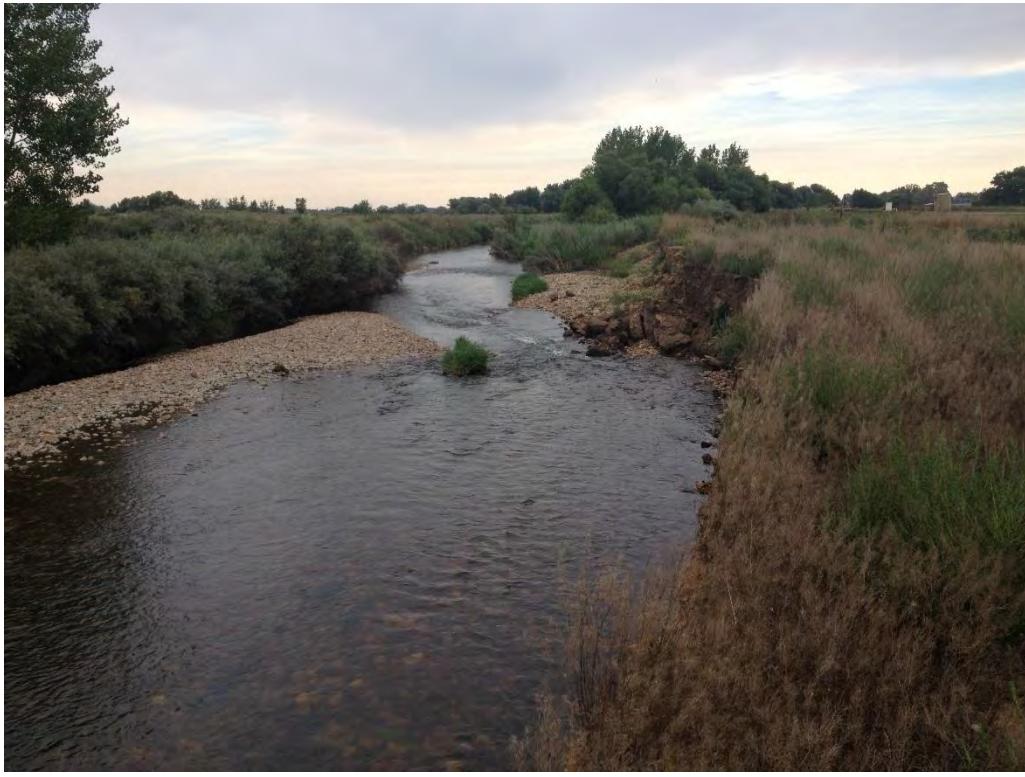
View to downstream of river right bank incision, river right. Note absence of riparian trees on river right, bank willow present on river left, and development of cobble point bars.

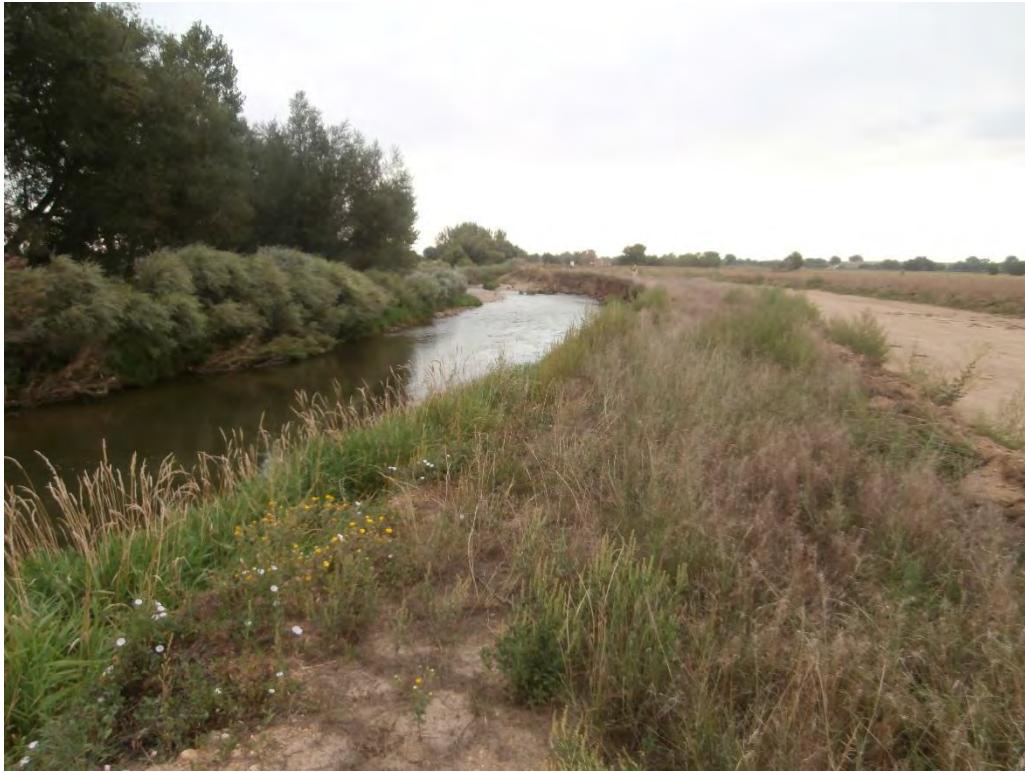
View to downstream of weedy bank above long reach with river right bank erosion.

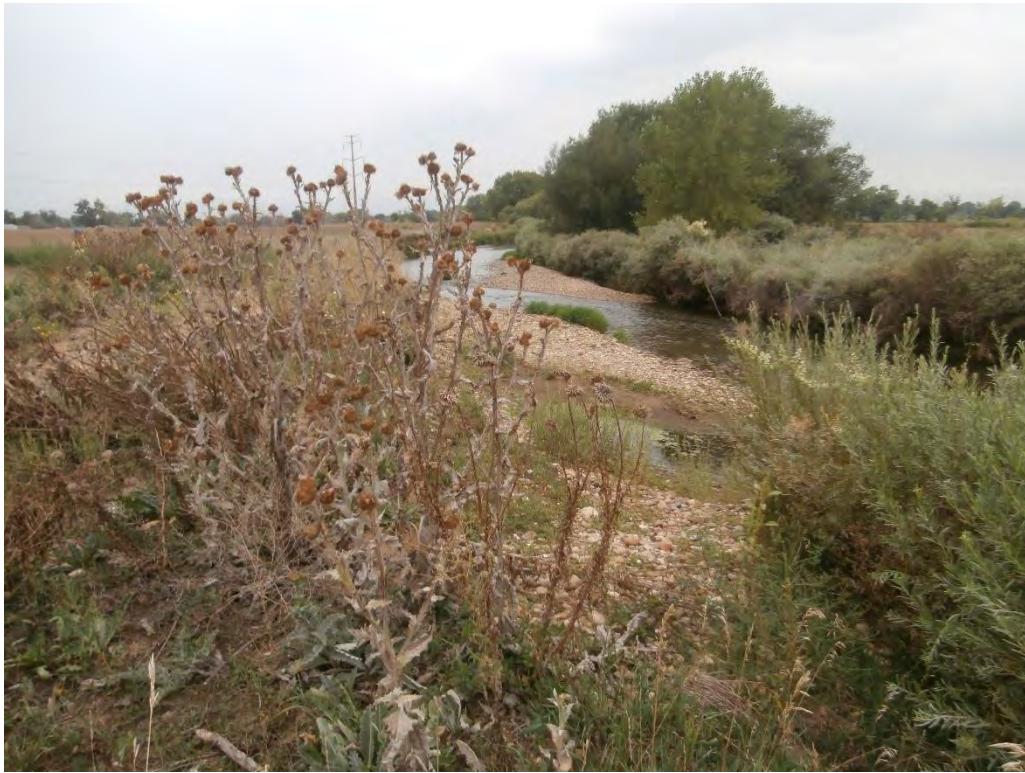
View to upstream of Scotch thistle on river right (left side of photograph). Note areas of intact willows in foreground and bank of river left.

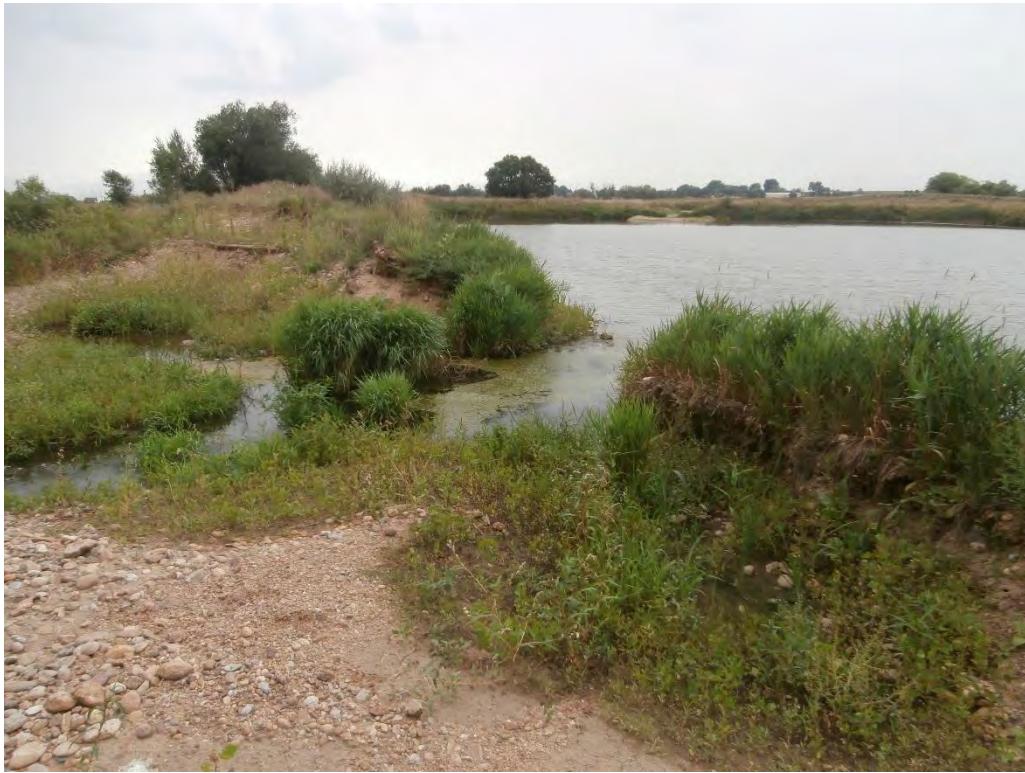
View to northwest of breach from lowest pond. Note that minor out flows continue and cottonwoods plus wetland vegetation are developing on river left upper bank.

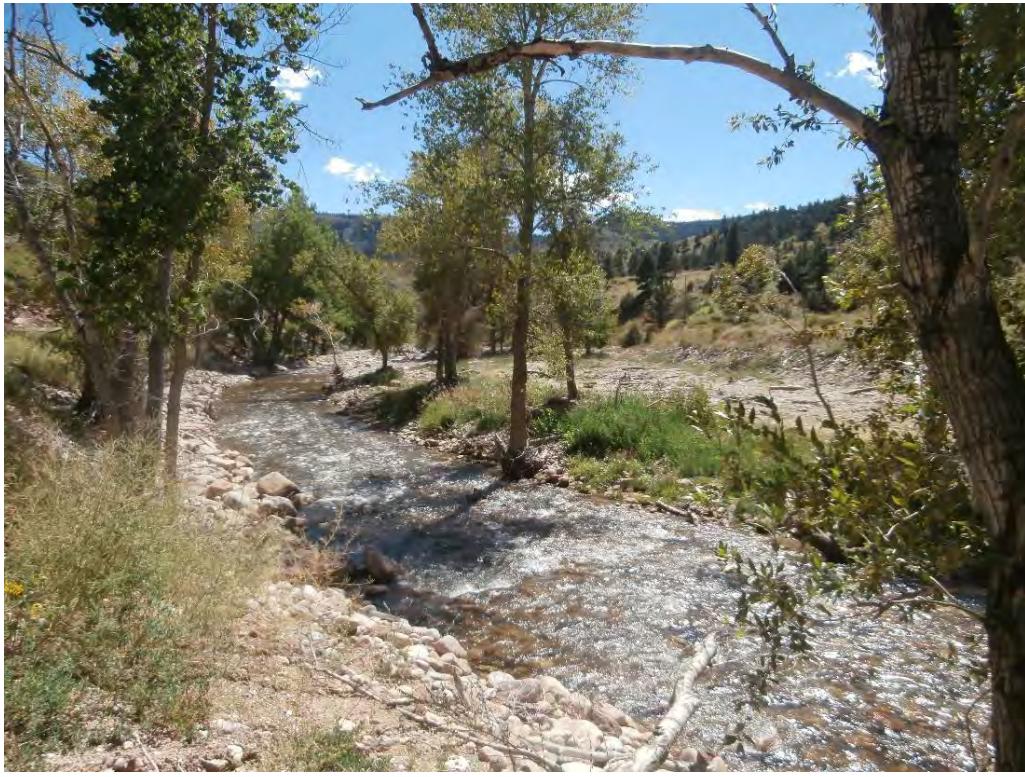
View downstream of remnant riparian area on river right bank. Note flood flow area to right of remnant riparian area.

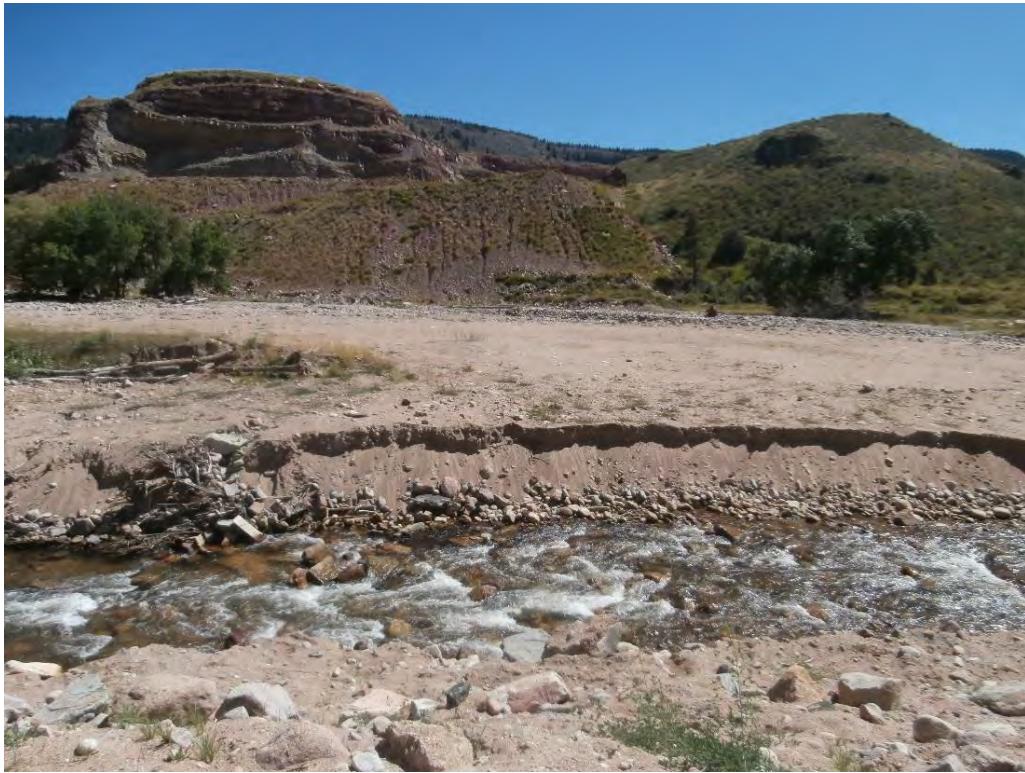
View to south of flood flow channel in middle ground. Note former quarry in background.

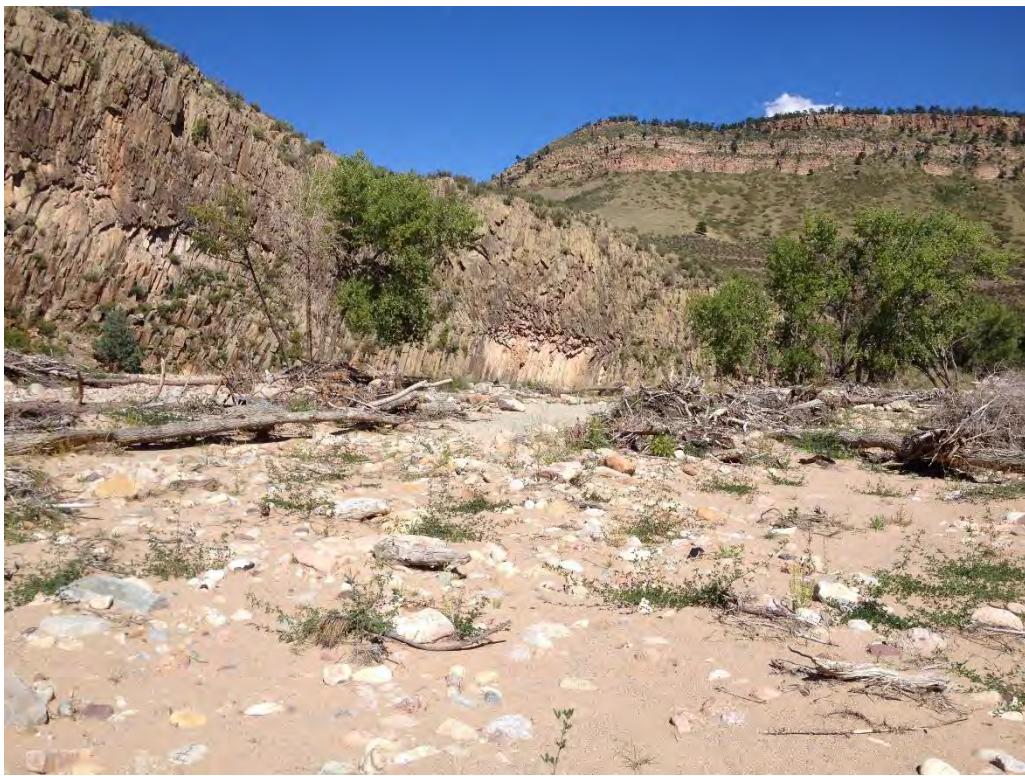
View downstream of woody flood deposition north of the quarry. Note abundance of alfalfa.

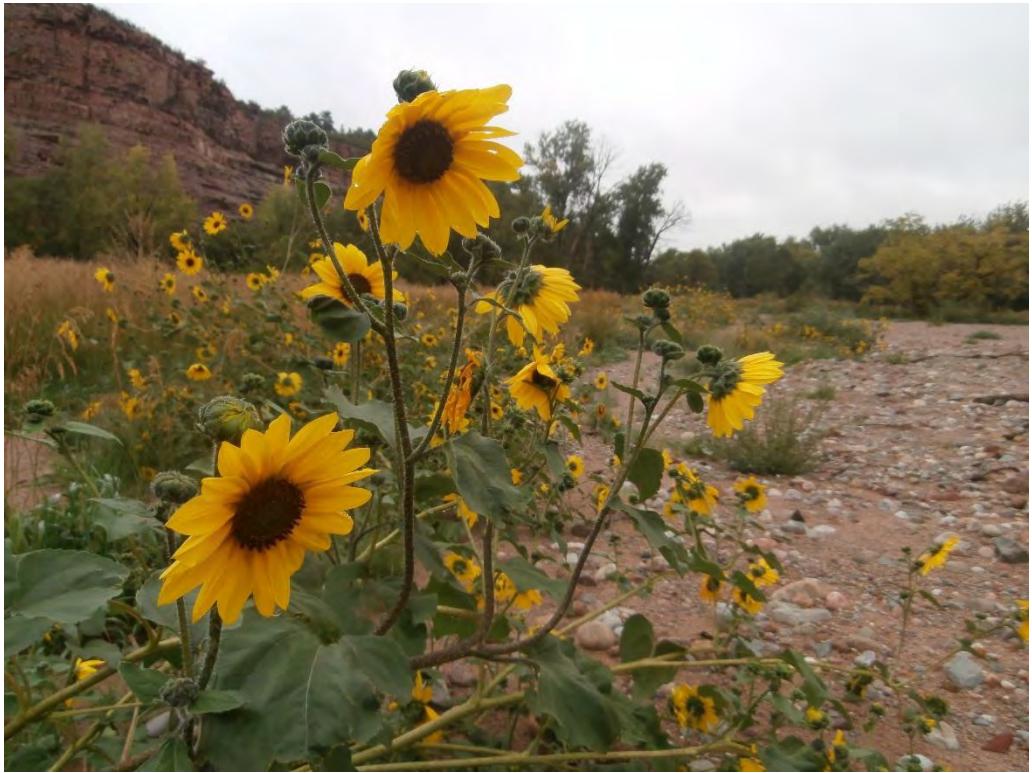
View downstream of native sunflower at edge of flood channel.

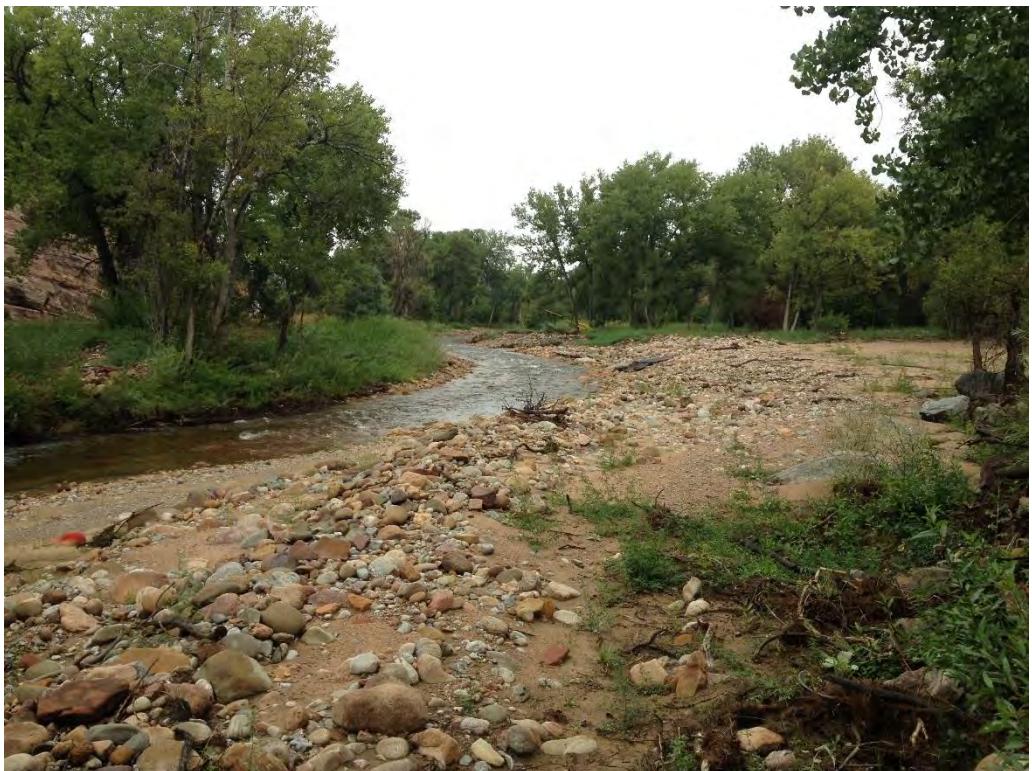
View downstream of reach where the channel has been moved back to the pre-flood location. SH 7 is between the cliff and the trees on river left.

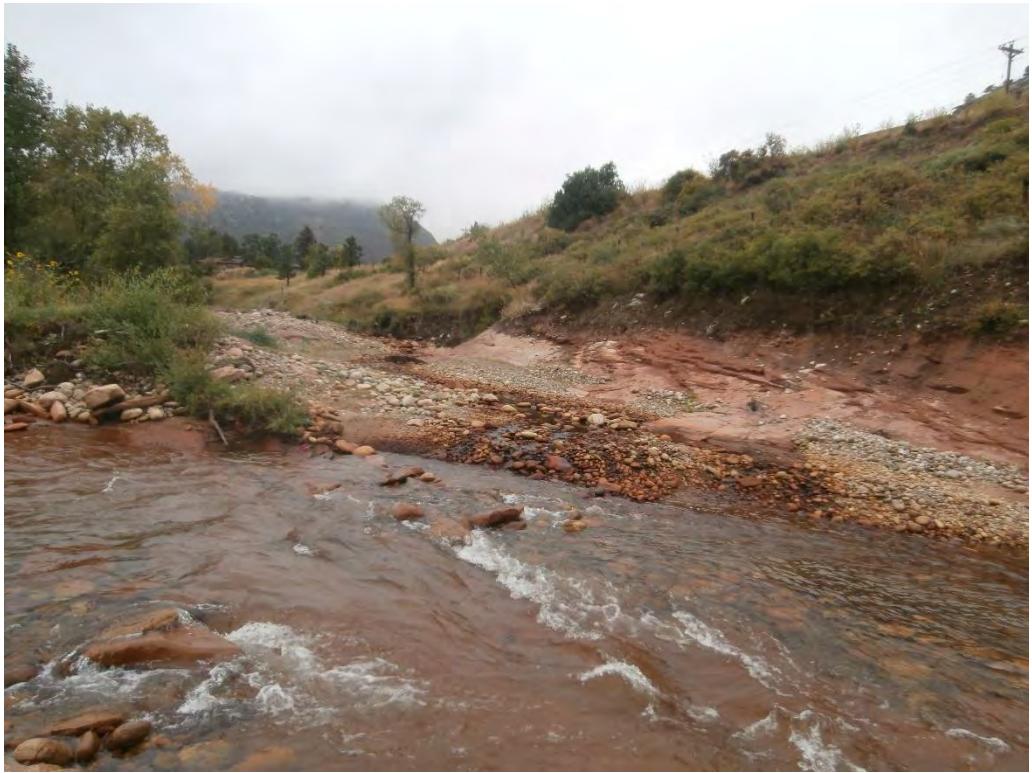
View upstream of pre-flood channel at right of photograph. Note bank is scoured to bedrock.

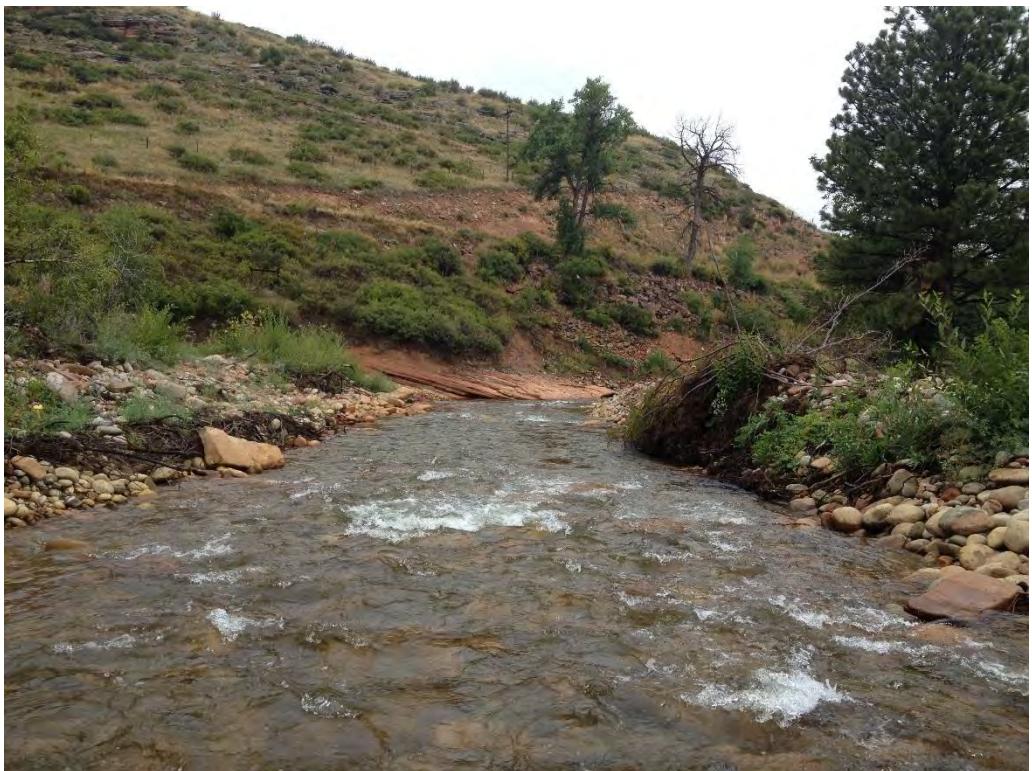
View downstream from upper boundary. Note river left bank scour and SH 7 above.

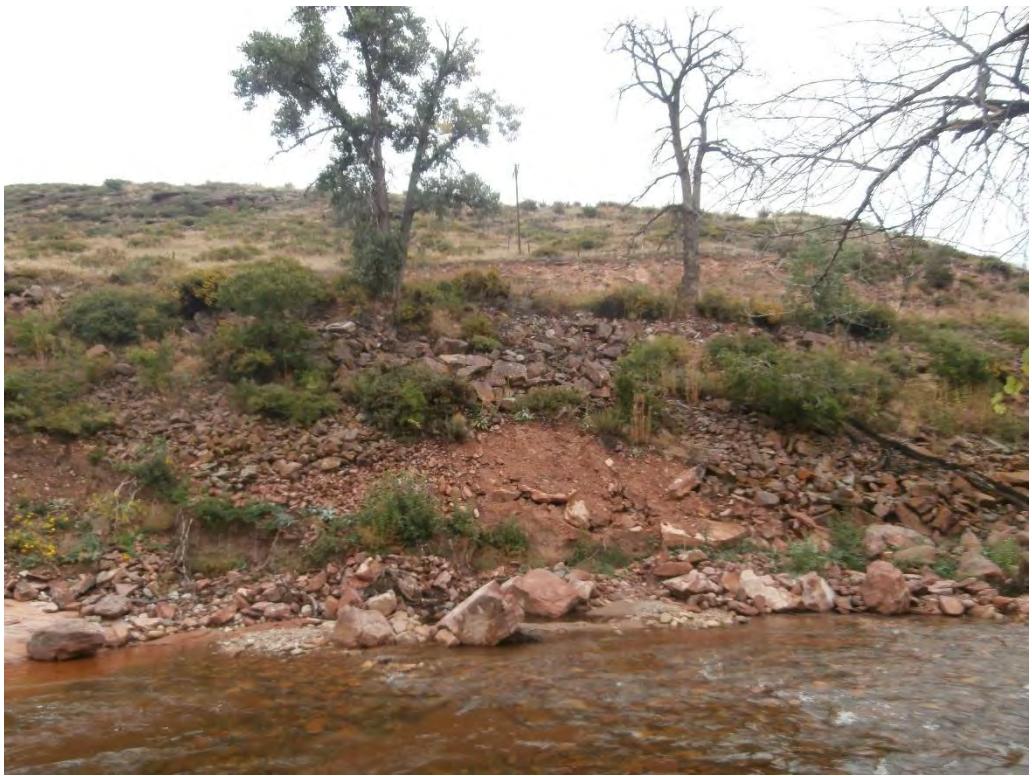
View toward SH 7 from river right (detail of previous photograph). Note potentially hazardous eroded area below highway.

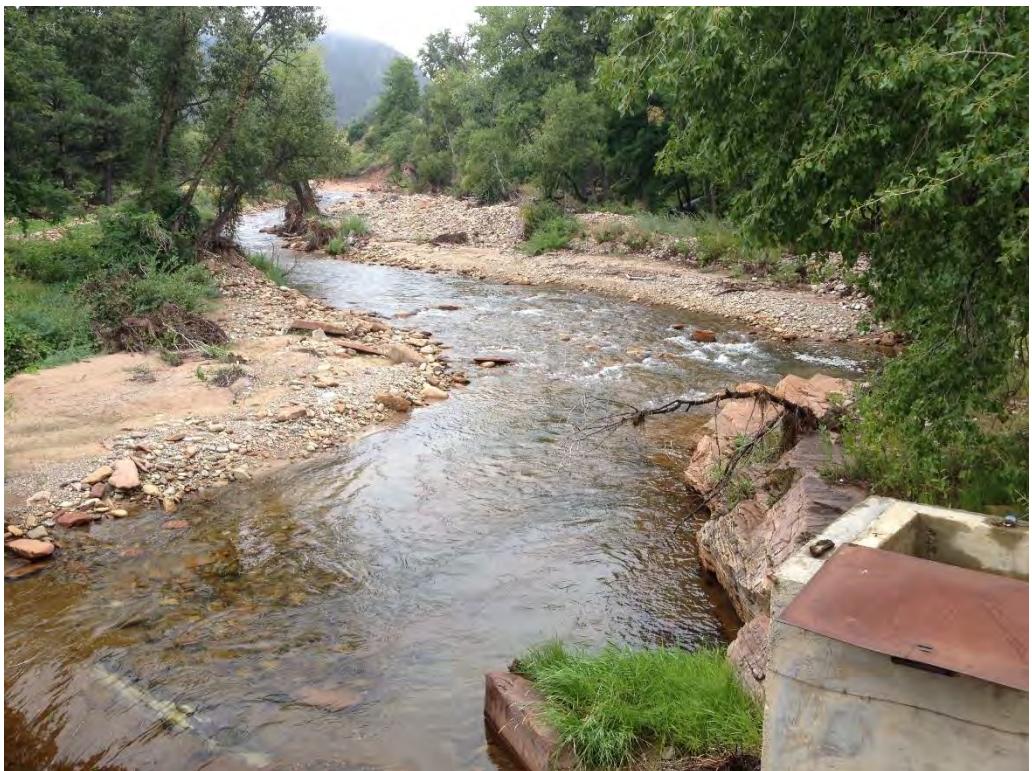
View upstream from Old St. Vrain Road. Note unvegetated cobble banks.

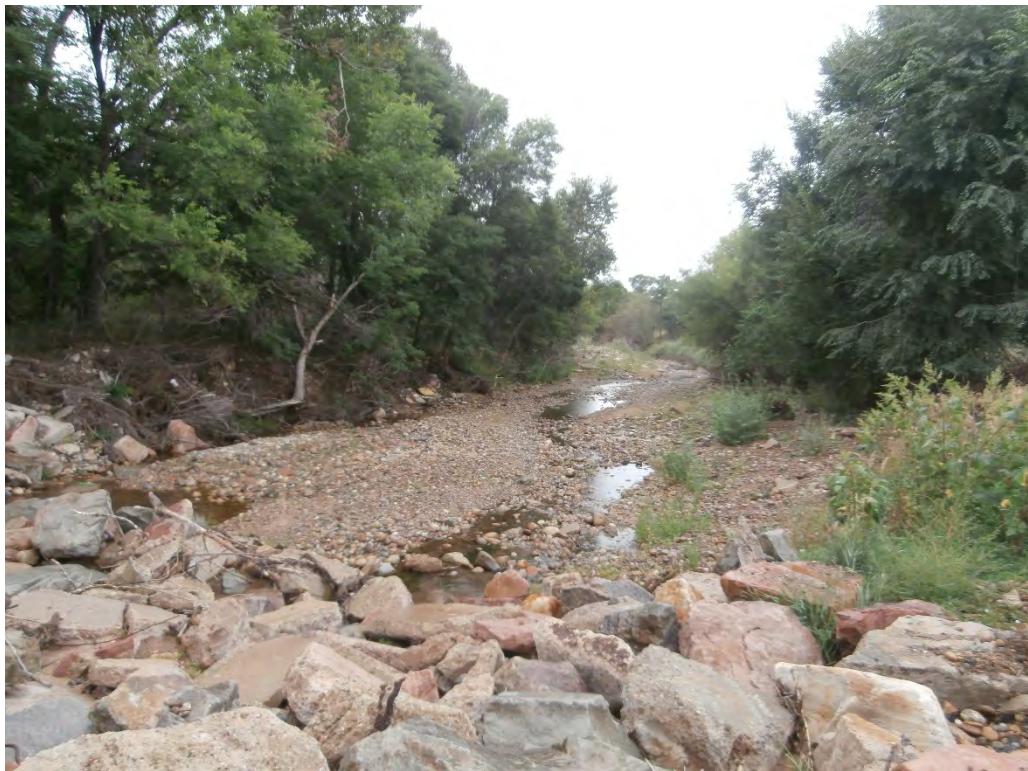
View downstream of an old channel on river right blocked off by boulders in foreground.

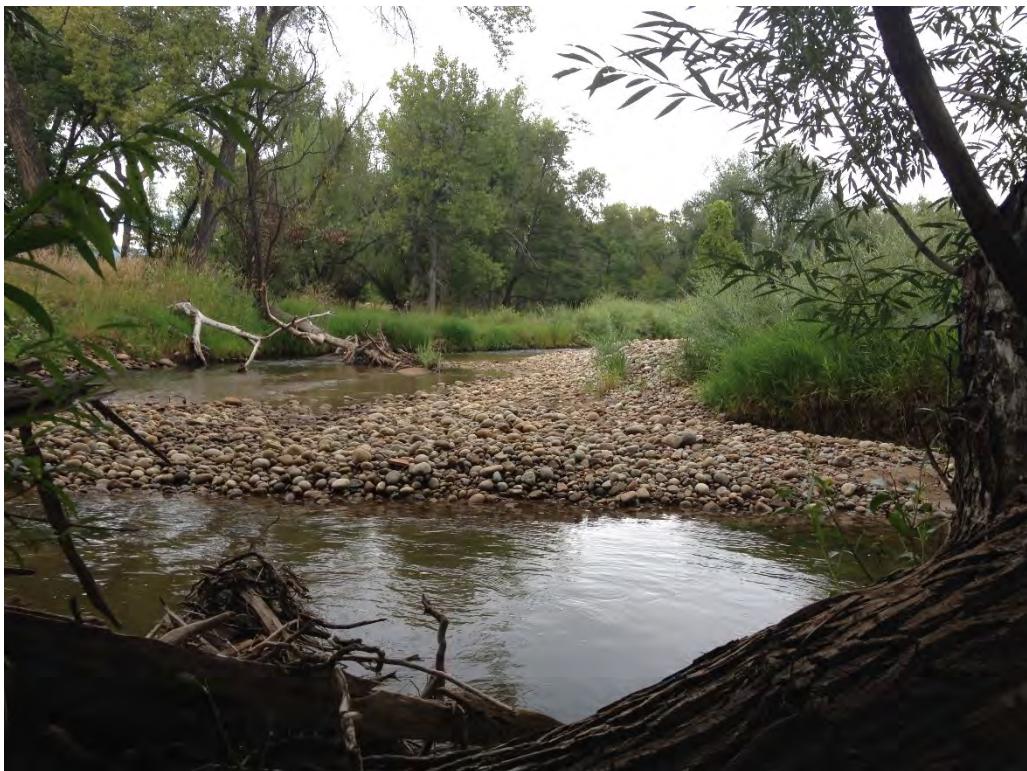
View upstream through trunks of crack willow at downstream end of reach. Note well-vegetated banks at the left side of the photograph.
