2014 Riparian Inventory and Assessment of Post-Flood Conditions
Boulder County Parks and Open Space Properties
Boulder, Left Hand, and St. Vrain Creeks
Boulder County, Colorado

Laura Backus and Susan Sherrod
for
Boulder County Parks and Open Space
2014 Small Grants Program

December 11, 2014

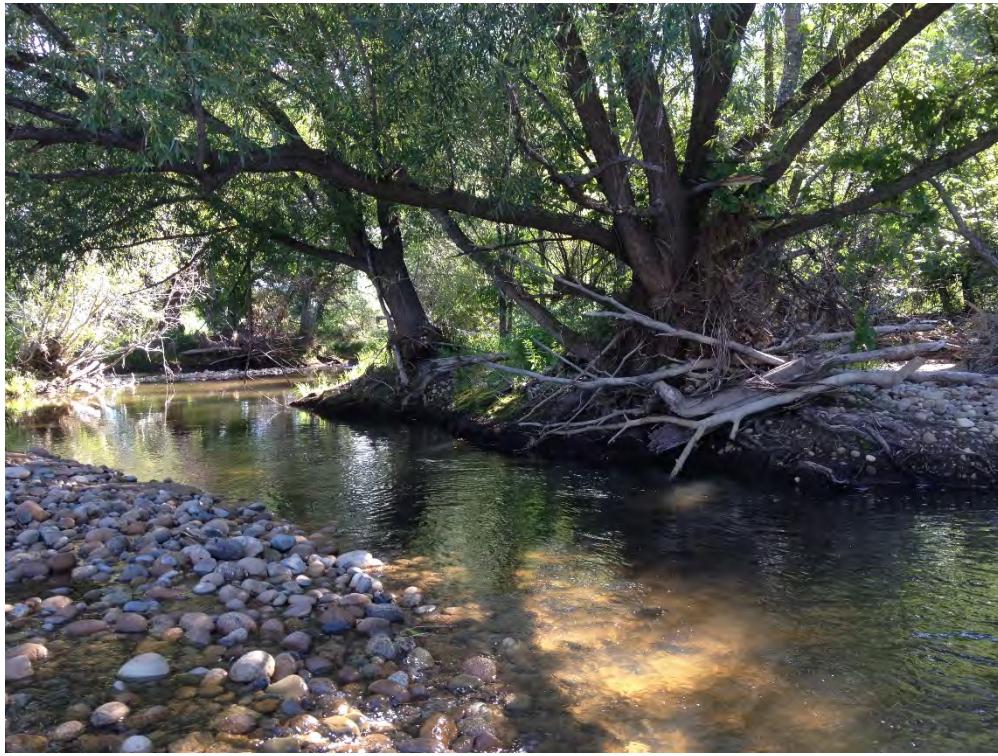
View downstream at the lower boundary. Note flood debris piled against river right crack willow.

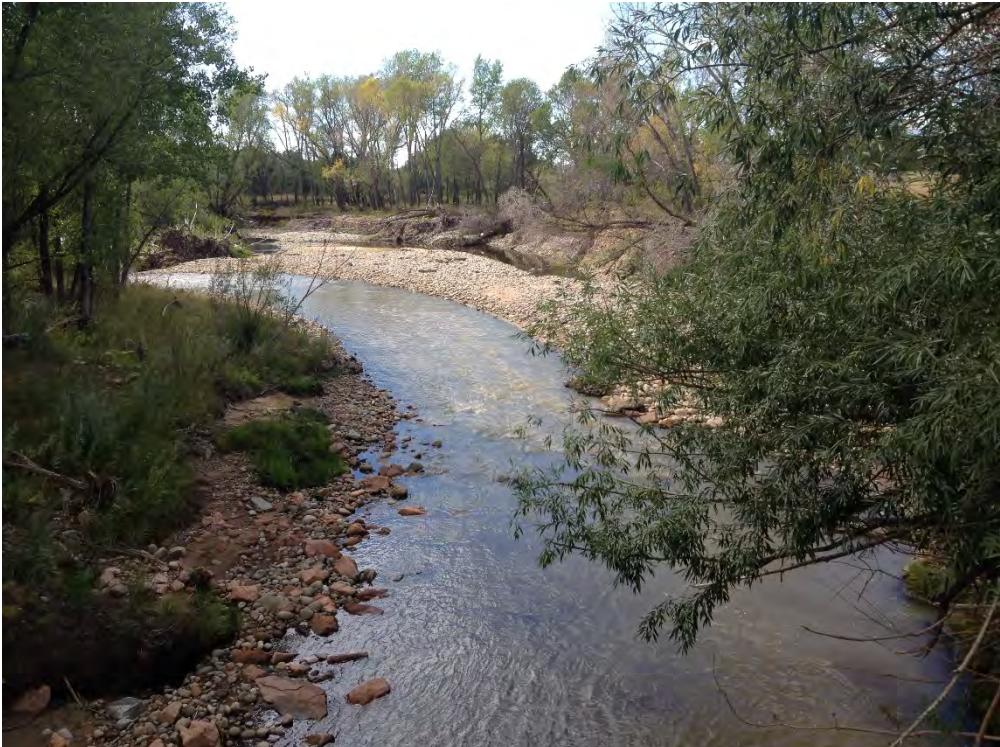
View downstream from 63rd St. bridge. Floodwaters re-entered the main channel at the long area of cobble deposition on river right in the center background of the photograph. Note short stretch of relatively intact bank vegetation on river left just upstream of the confluence.

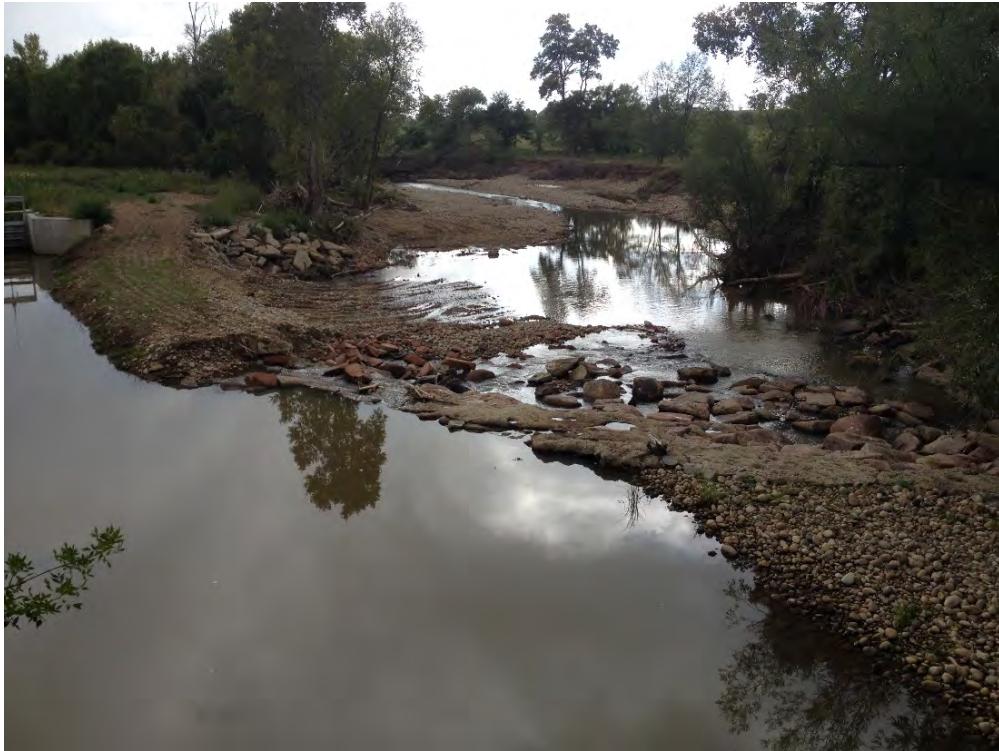
View downstream from Hygiene Road of repaired irrigation diversion structure.
Note eroded banks, loss of riparian forest on river right.

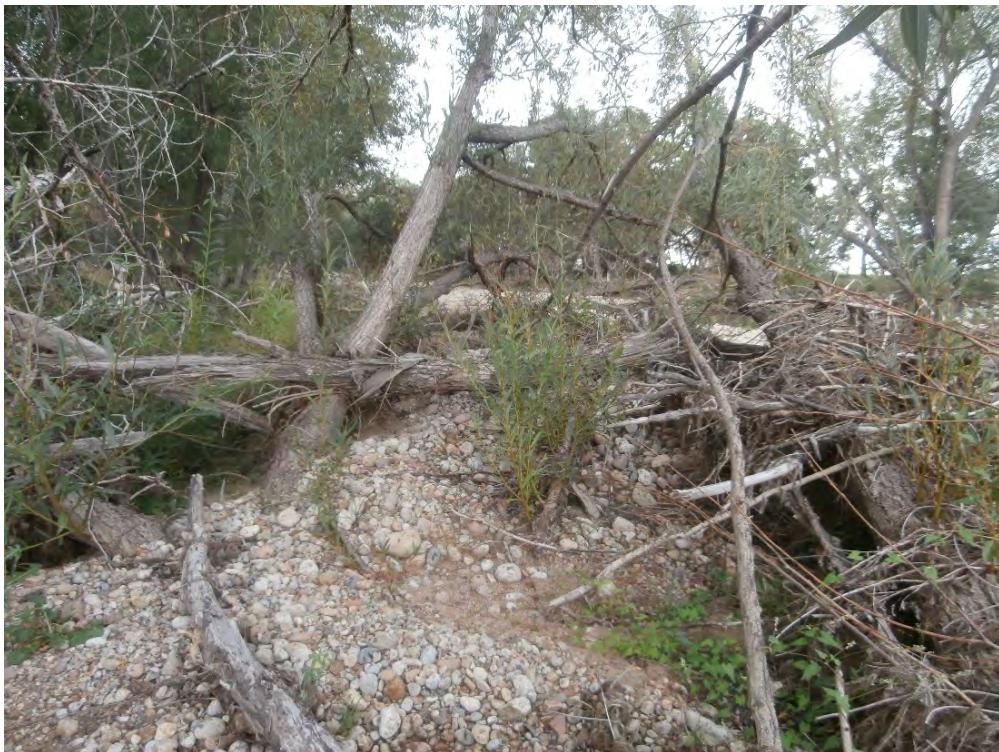
View to southeast of resprouting narrowleaf cottonwood on river left. Note cobbles and piled up debris.

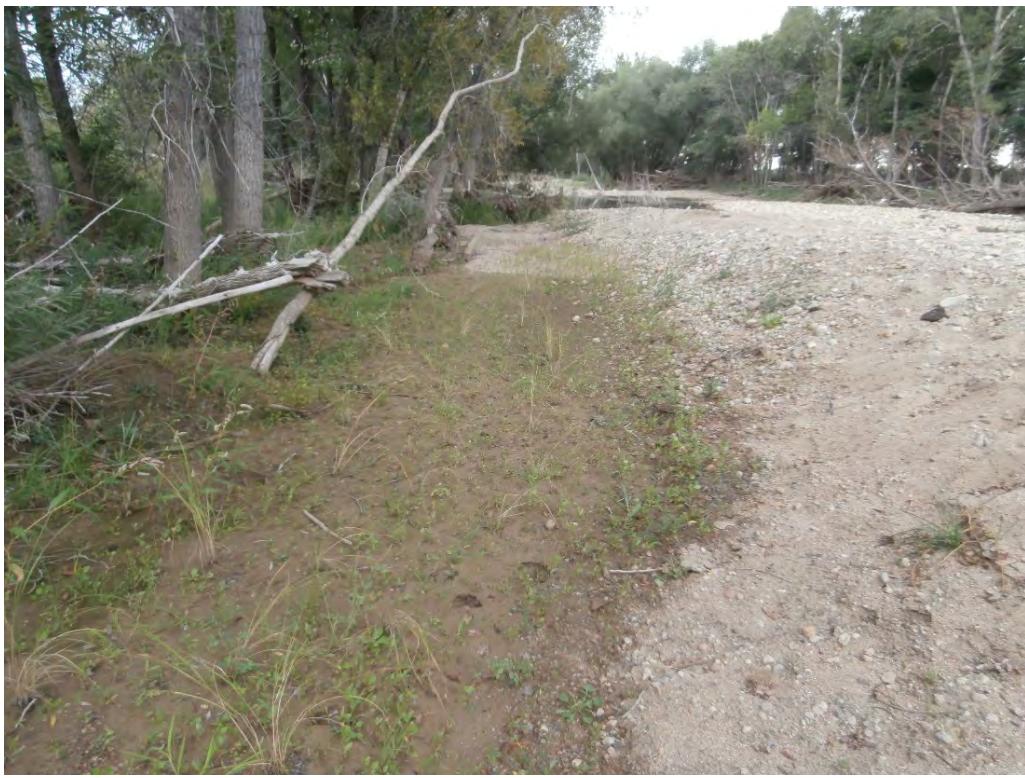
View downstream of river left sandy deposits overflow channel with woody seedlings and wetland plants.

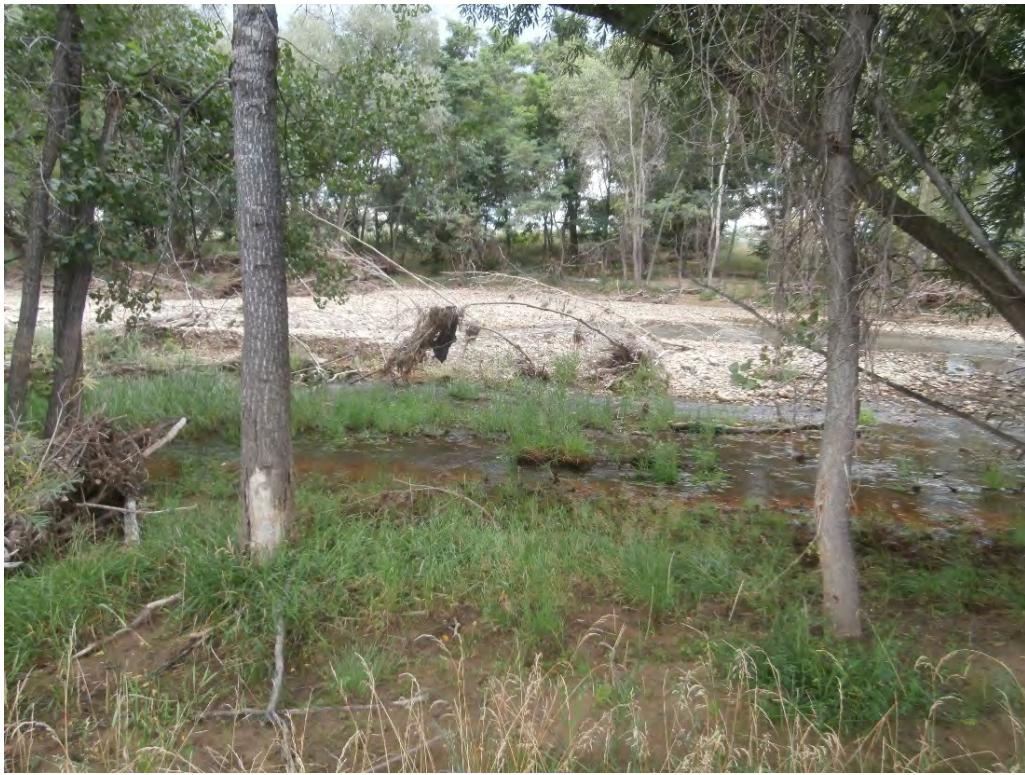
View across the creek of channel side channel, still with flows. Note debris caught up in dead stems in center of photograph.

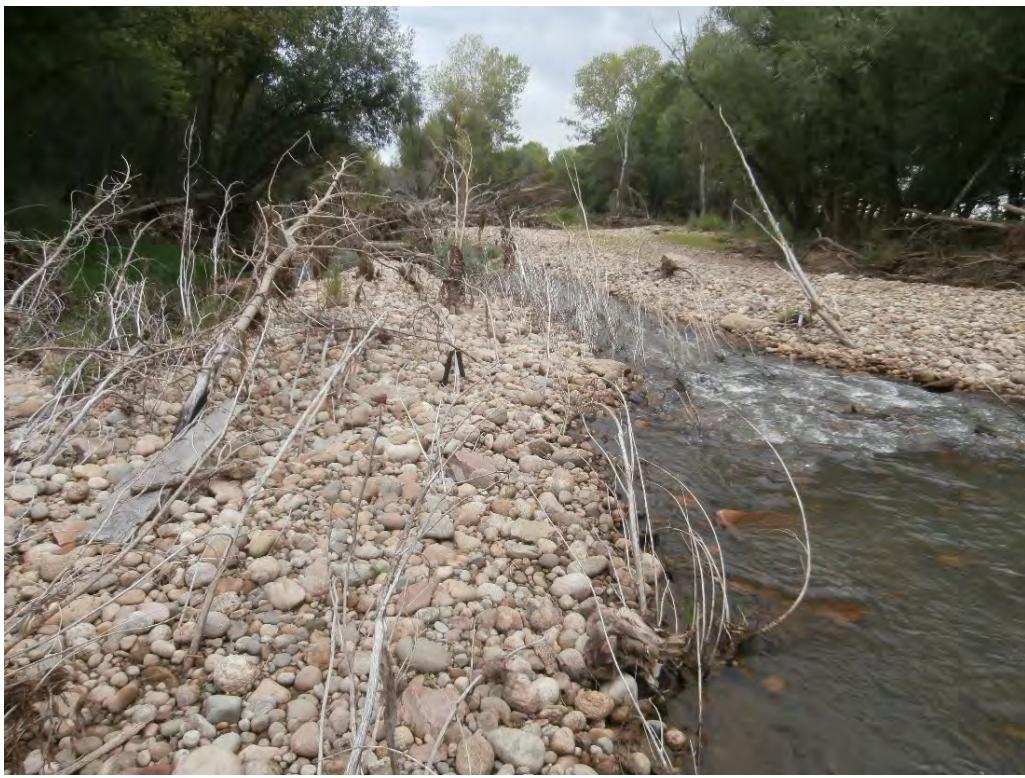
View downstream of dead sandbar willow and small trees in area of cobble deposition.

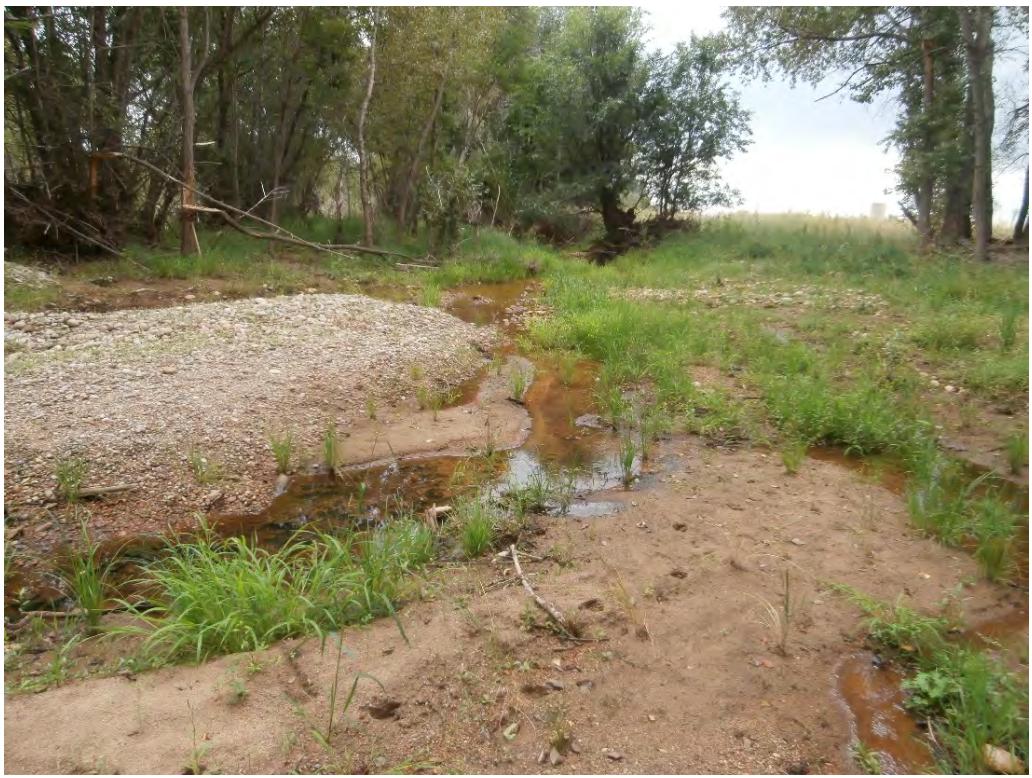
View downstream of river-left overflow channel. Note wetland plantings.

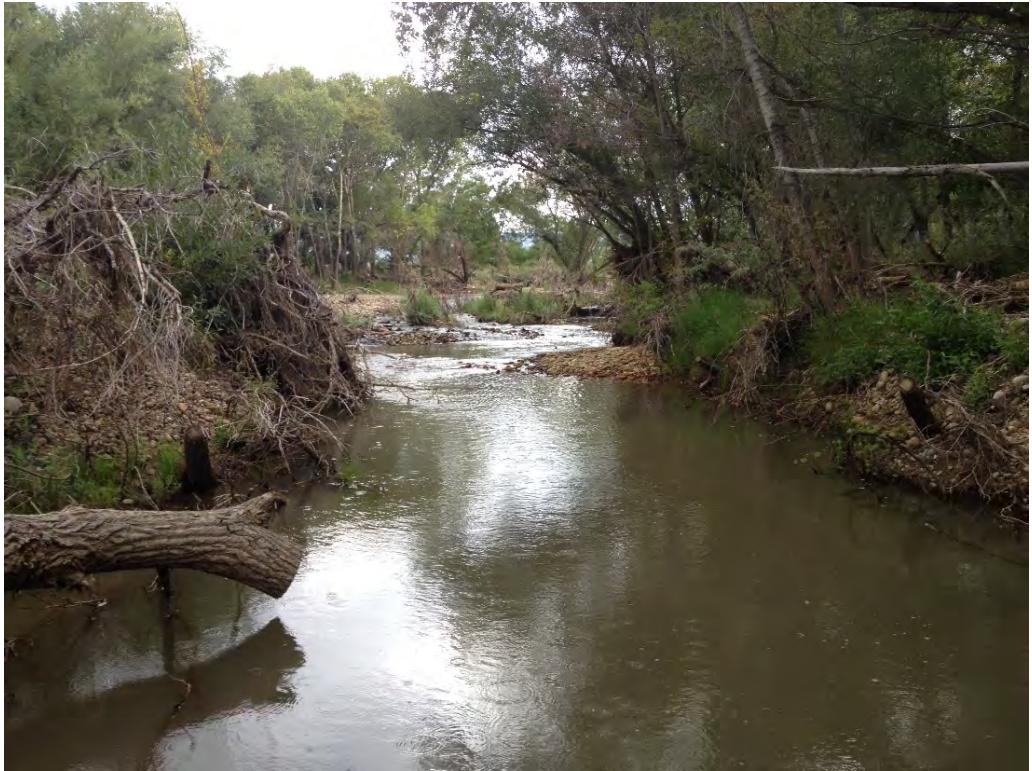
View downstream of woody debris on both sides of channel. Note that tree trunk on left has been sawed off.

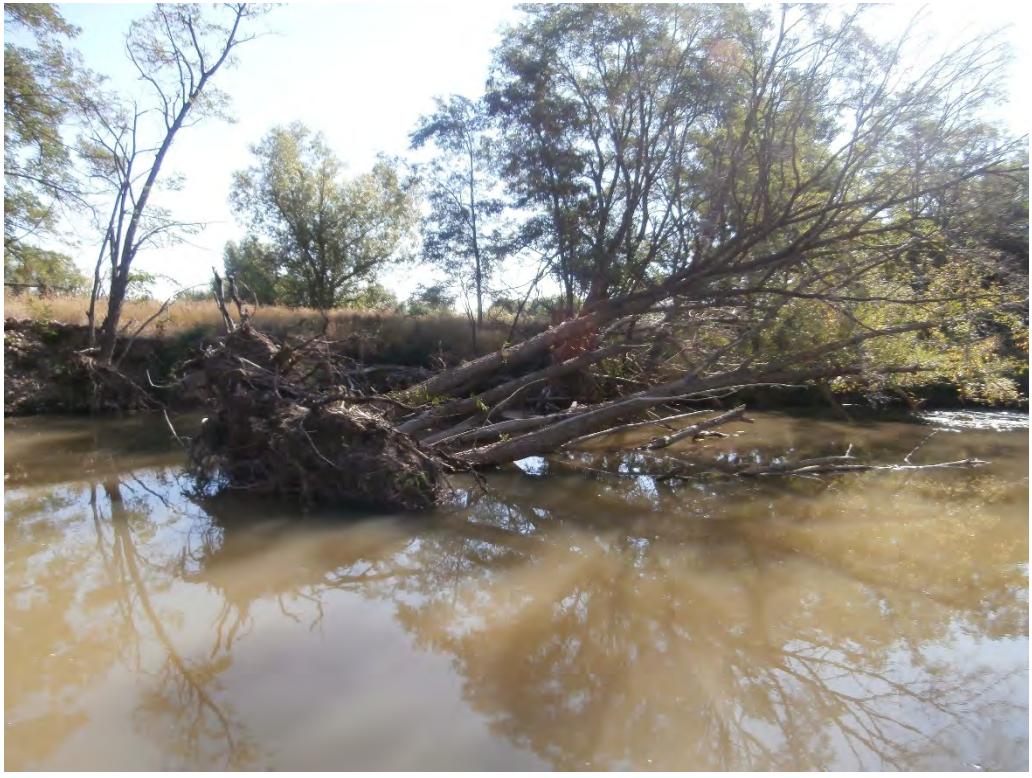
View across the channel to the north of downed tree in channel.

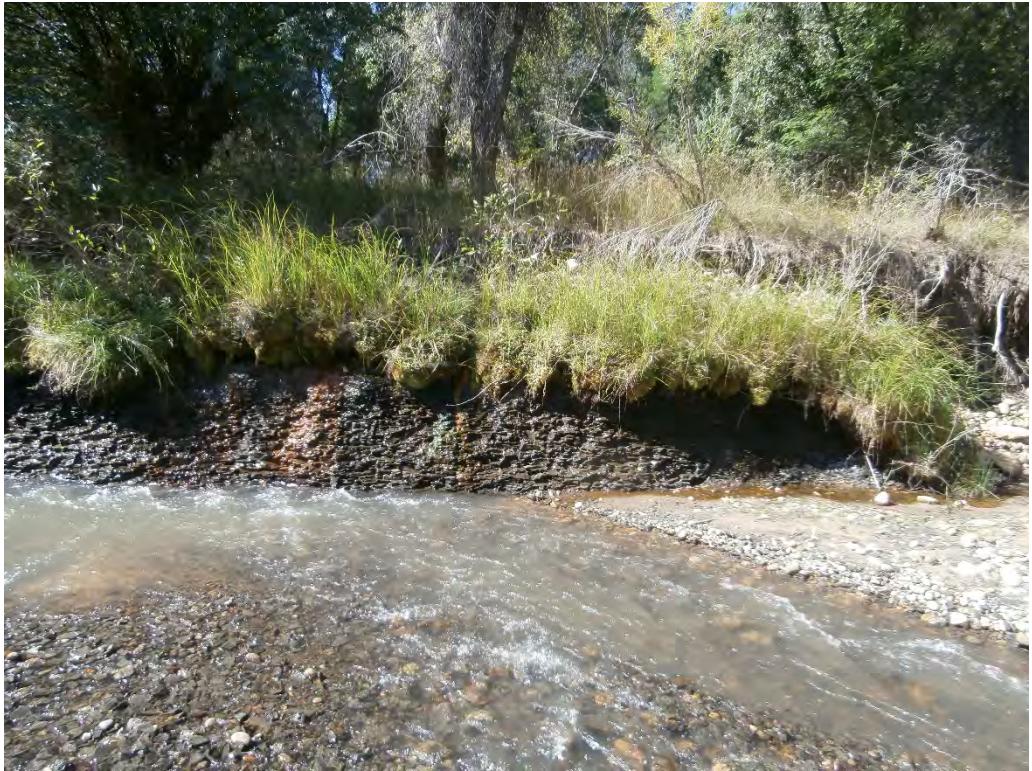
View across the channel of river left bank eroded to shale bedrock. Note wetland plants growing above the shale exposed by downcutting.

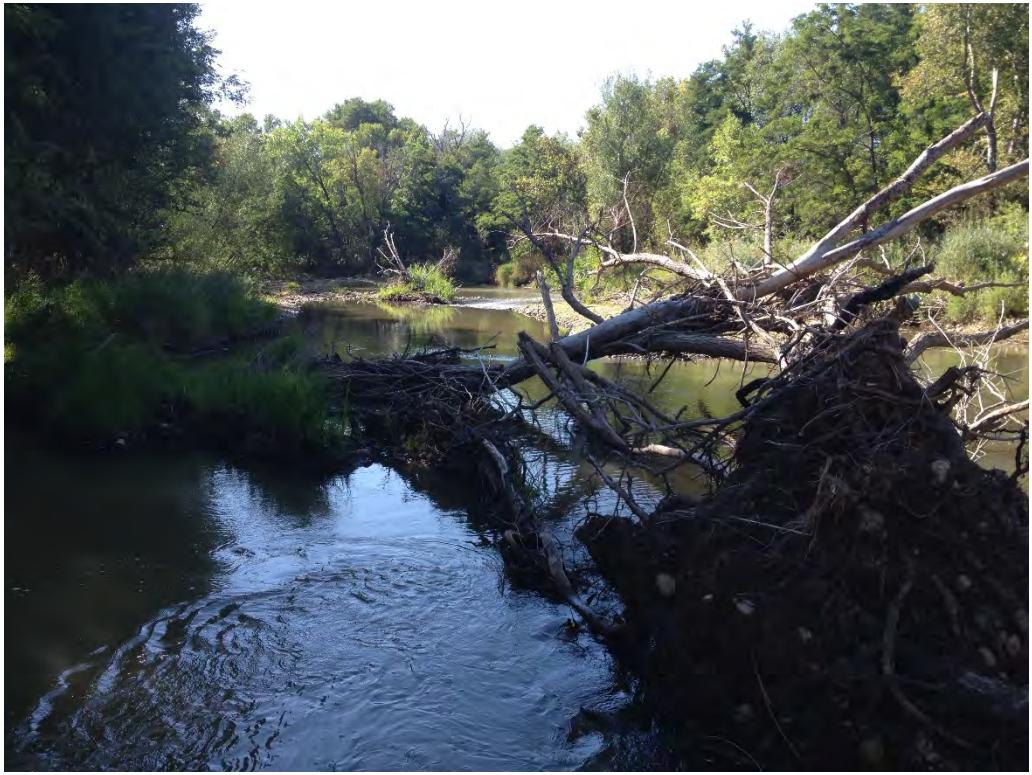
View downstream of resprouting flood debris at the left of the photograph.
Note that the snag in foreground creates a sharp meander.

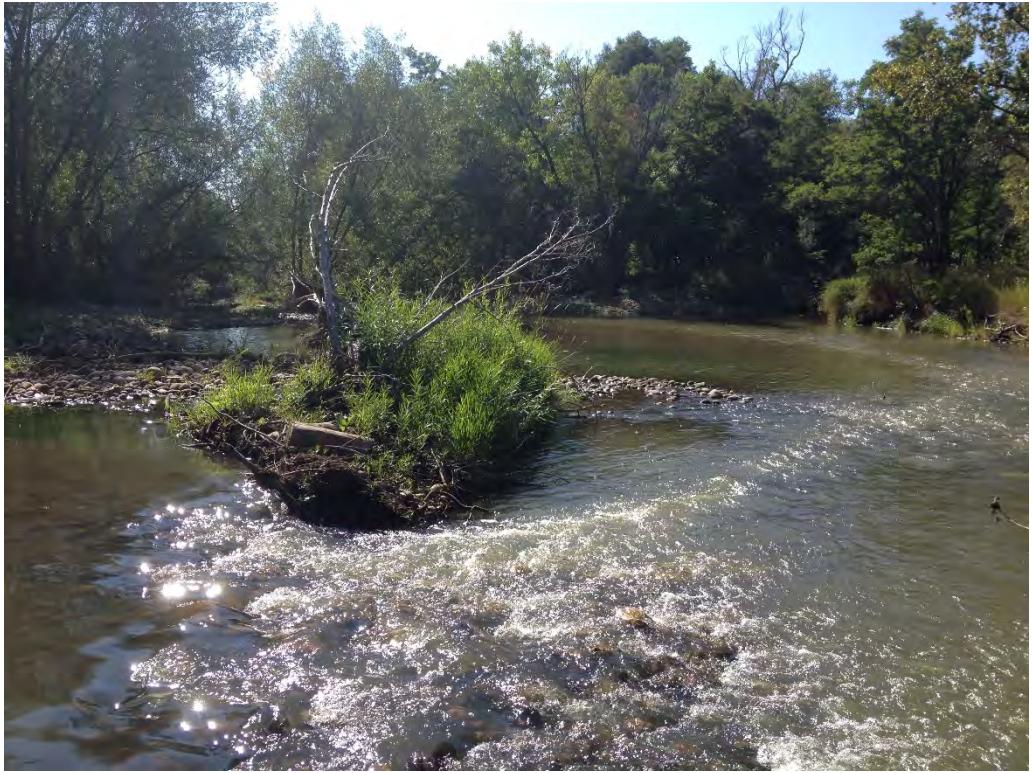
View of same meander from just downstream of previous photo. Note that this is a very sinuous stretch.

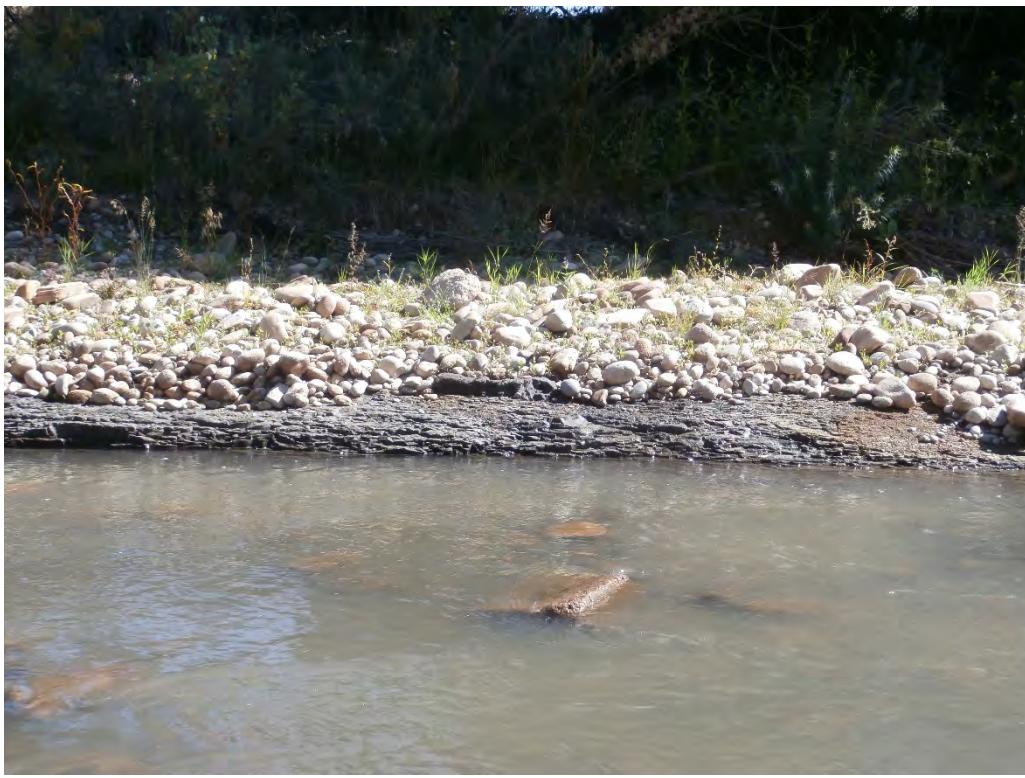
View across the channel of river left exposed shale bedrock overlain with cobble deposits. Note colonizing plants in the cobble.

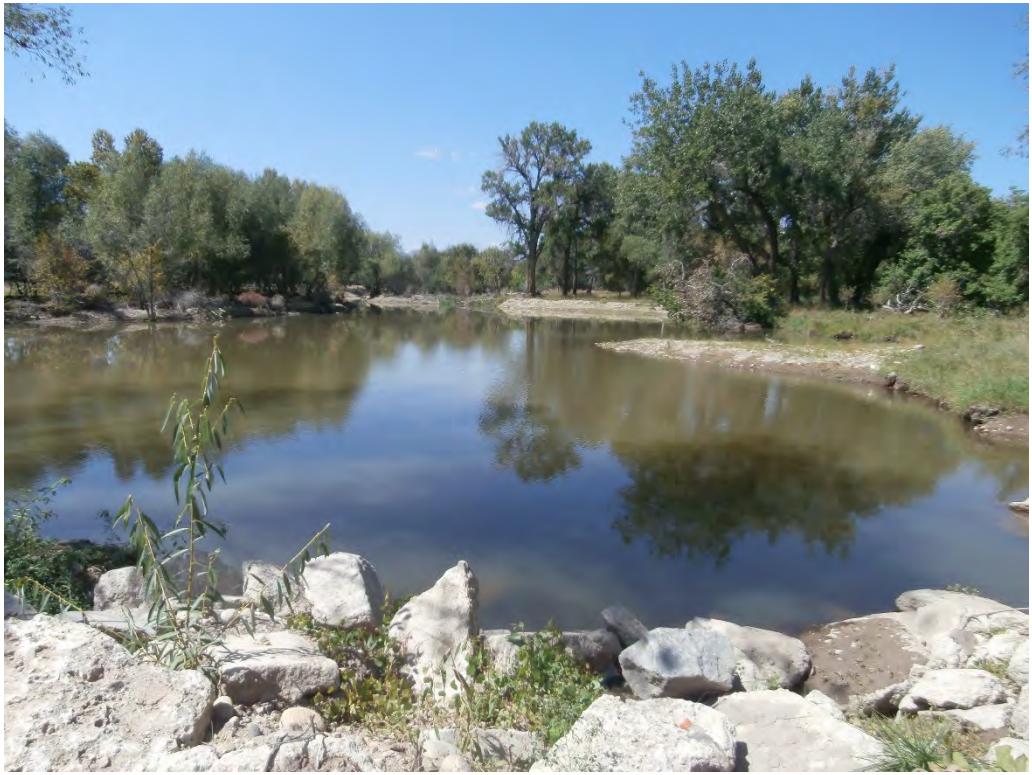
View upstream of impoundment behind irrigation structure. Note cottonwoods developing in riprap, possible crack willow at left.

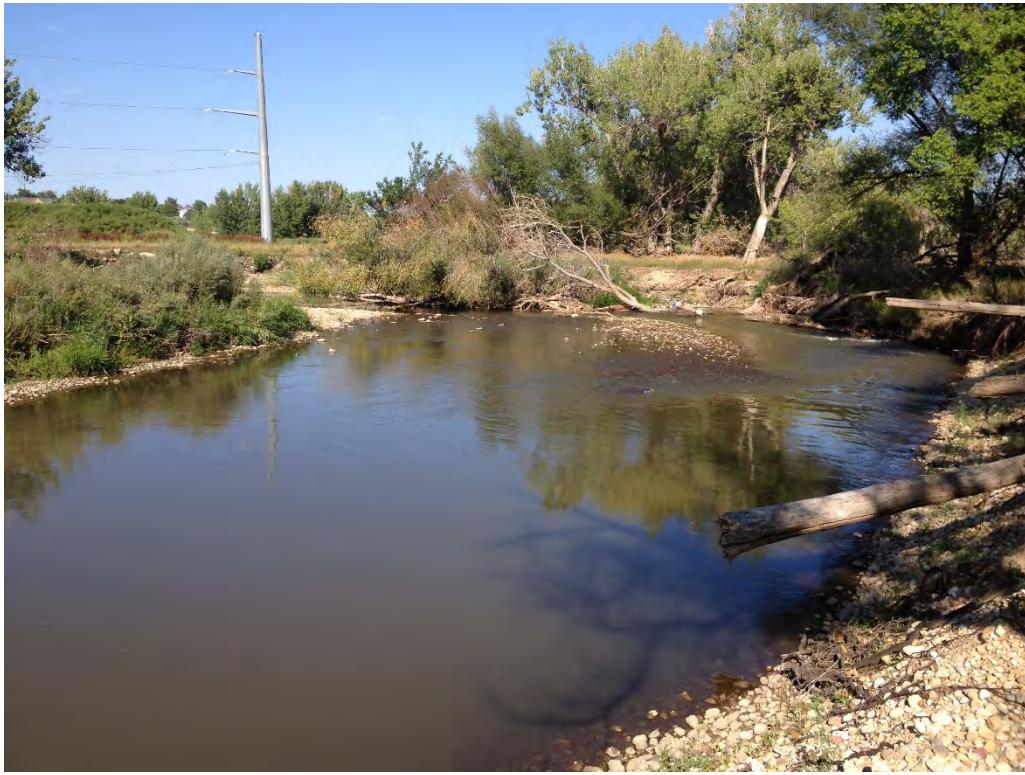
View to downstream of cobbles wave pattern in river right flood channel.

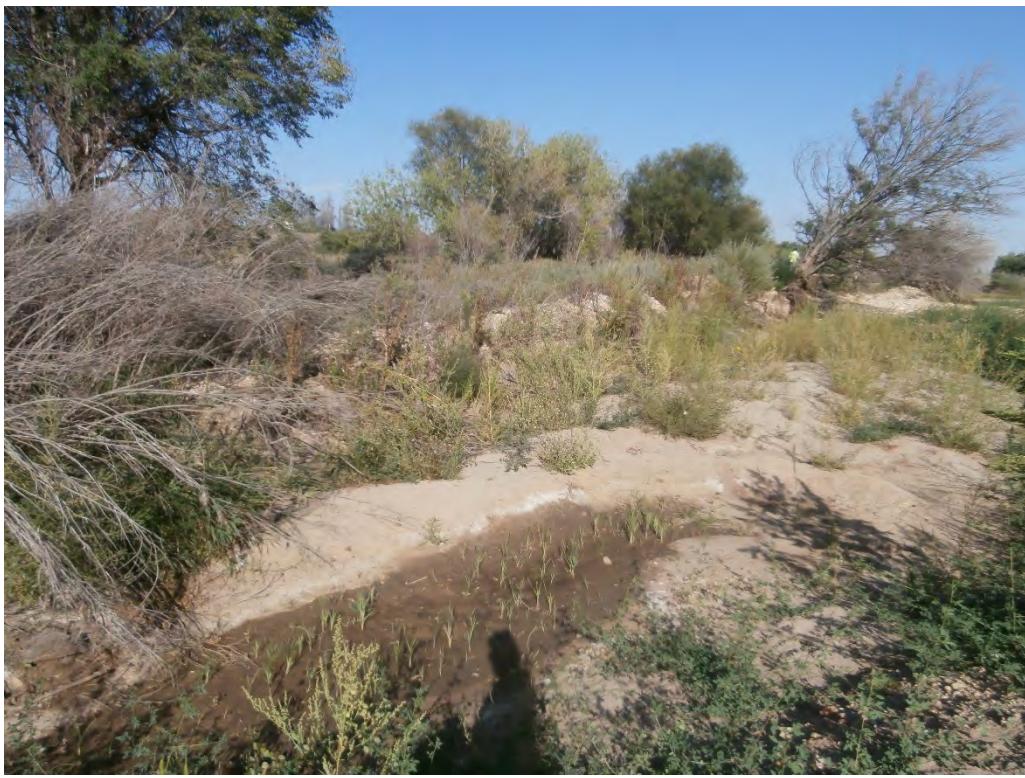
View to downstream the river right flood channel just to the south of the main channel. Note wetland developing in damp area, weeds in drier areas.

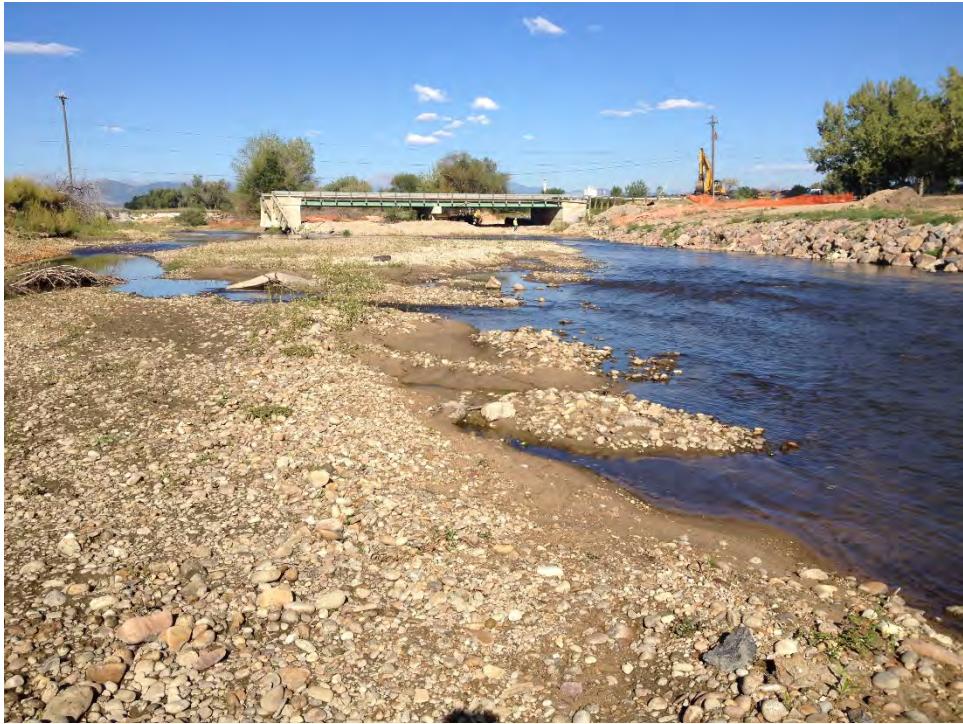
View upstream toward the damaged County Line Road bridge. Note vegetation development in foreground cobbles, new riprap bank downstream of the bridge at the right of the photograph.

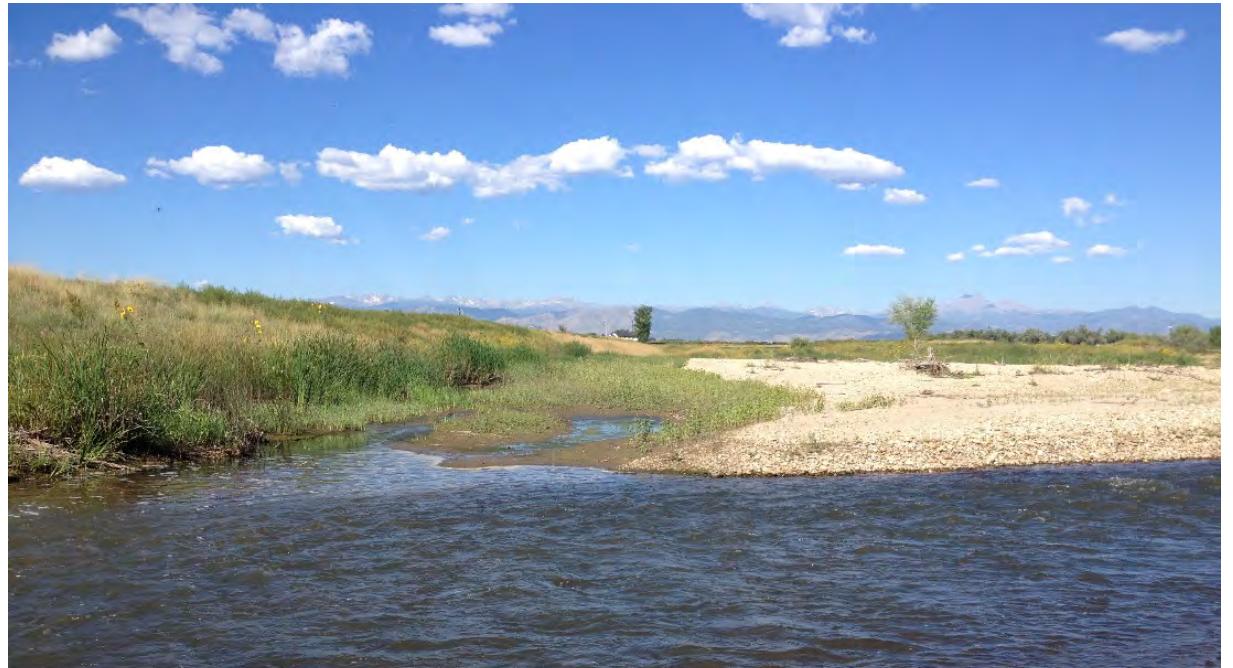
View to west of developing wetland back channel along river right of the post-flood main channel.

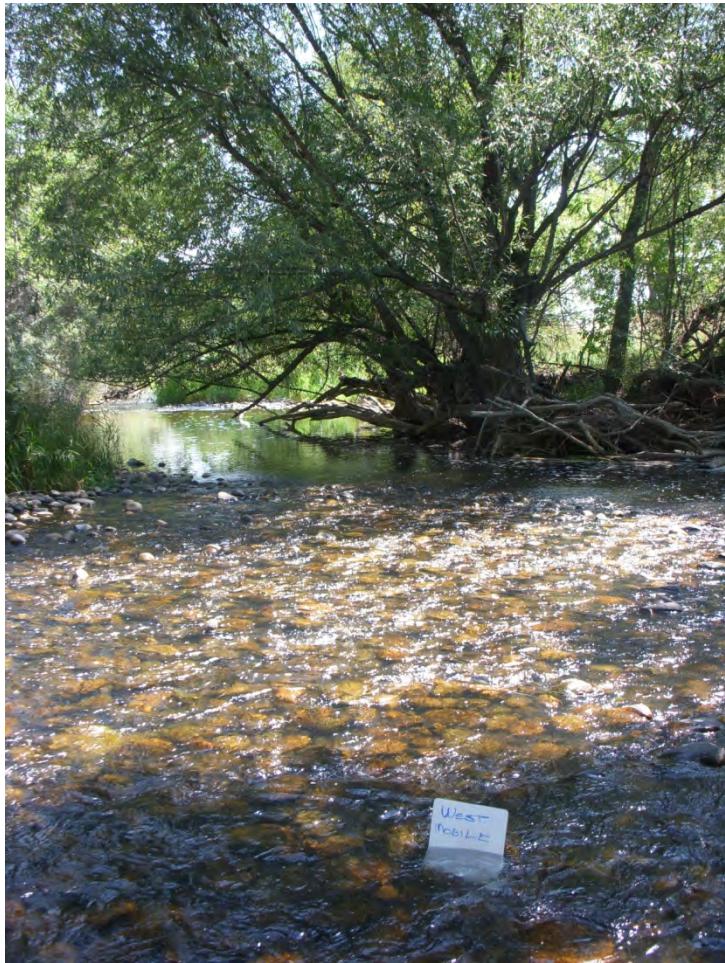
2008: View downstream from upper boundary. Note presence of low bank vegetation, woody debris pile on river right below crack willow.

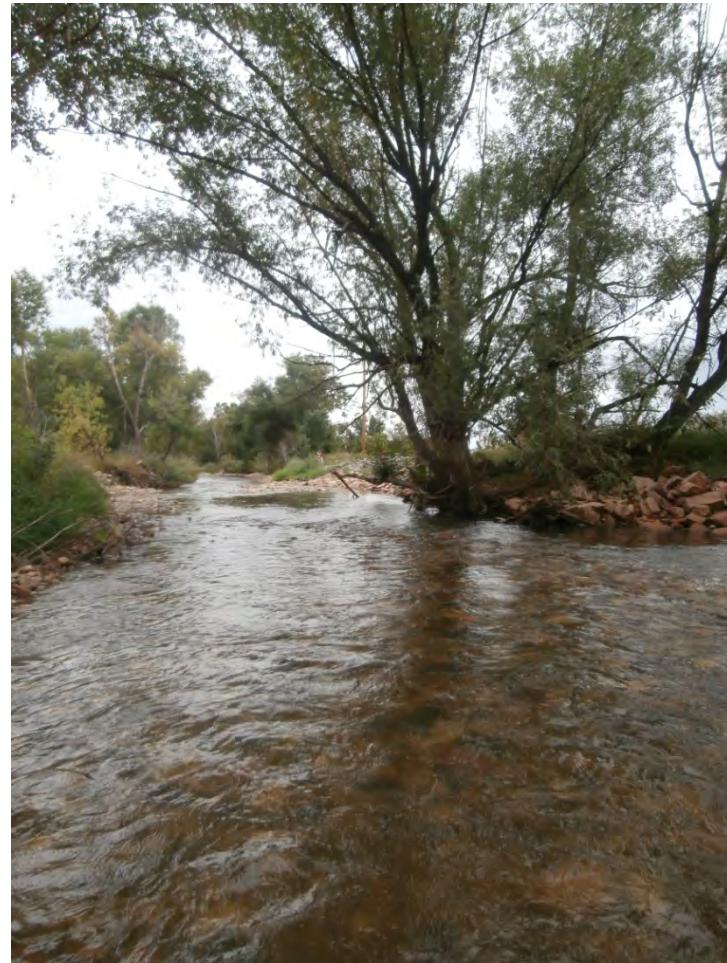
2014: View downstream from upper boundary. Note loss of branches on river right crack willow, rip rap on river right below crack willow at repair of major breach to south.

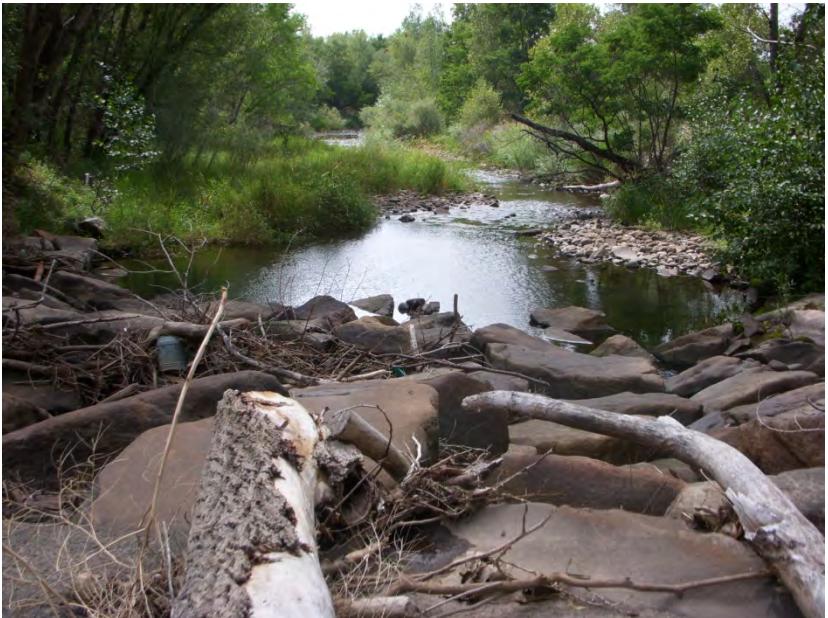
2008: View to southeast from boulder dam blocking off a portion of an old channel. Note woody debris on dam boulders, well-developed low bank vegetation, minor cobble bank deposits.

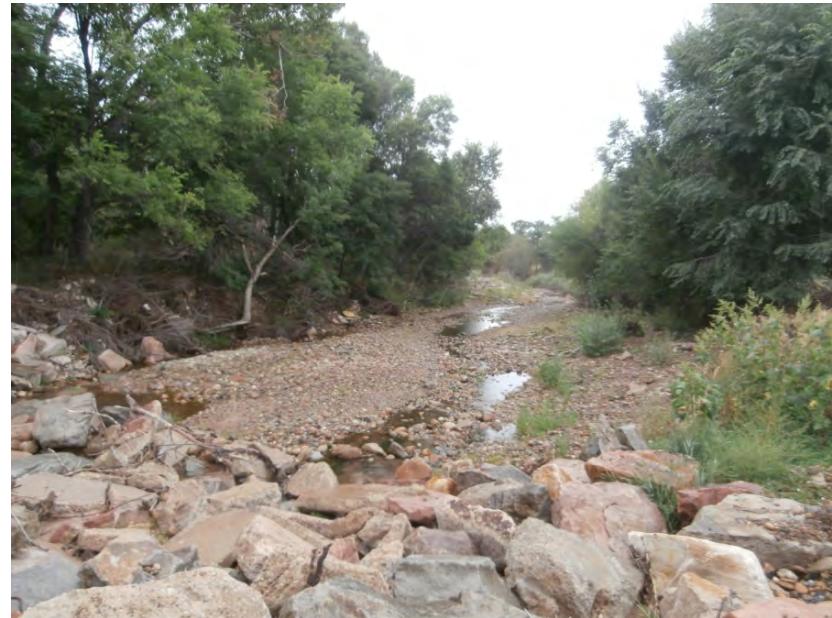
2014: View to southeast from repaired boulder dam blocking off a portion of an old channel. Note cobbly and sparsely vegetated low banks, very narrow flows.

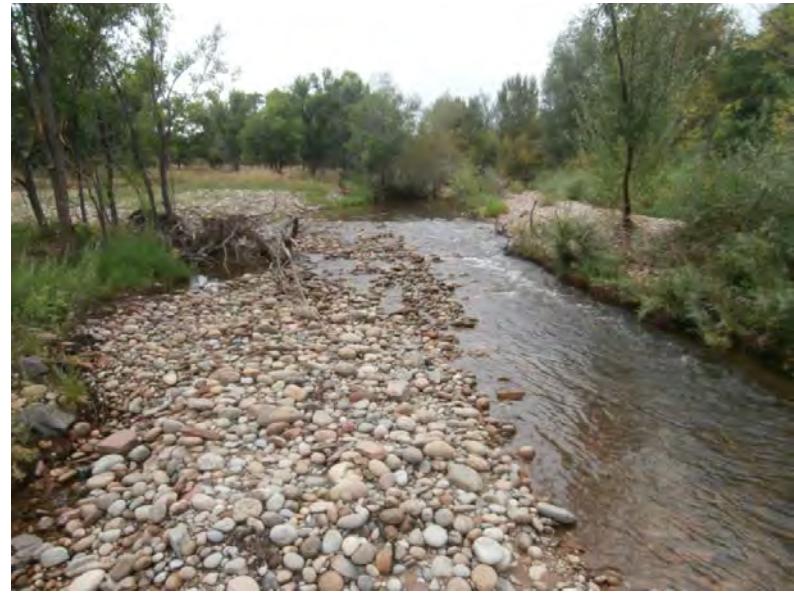
2014: View upstream from bridge east of former processing structures. Note unvegetated cobble deposits, loss of riparian trees, narrower flows.
