**Boulder County Parks and Open Space Hall Ranch 2
Road Repair and Stream Hazard Mitigation**

South Saint Vrain Creek
Boulder County, Colorado

Prepared on October 21, 2016
By Amec Foster Wheeler

FINAL DESIGN REPORT

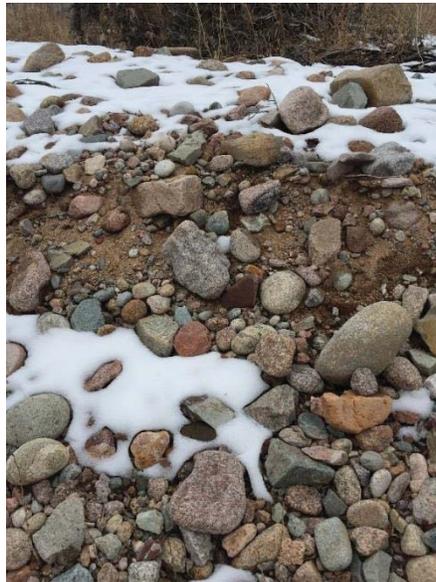
The streambed and bank materials are composed of unconsolidated material deposited from the 2013 flooding event and modified by subsequent runoff events (Figure 2). The stream bed is armored with large cobble underlain by smaller gravels and sands.

Figure 2 Unconsolidated material with limited vegetation on banks

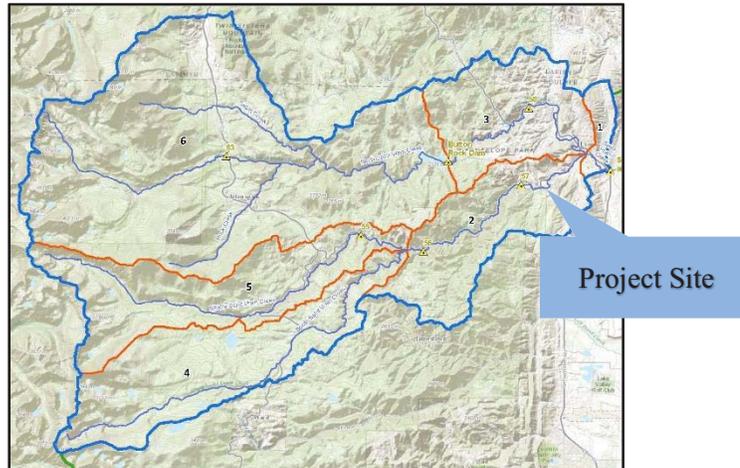
Figure 6 Saint Vrain Watershed Map (Blue) from CDOT 2014

The CDOT report published values for peak flow discharges for the 10, 25, 50, 100 and 500 year events at various locations along South Saint Vrain Creek. The project is located about midway between design points upstream of the confluence with Saint Vrain Creek and South Saint Vrain Creek and “The Narrows”, upstream of the site. Peak flows were compared to these in relation to the watershed map provided in the report contained in the Appendix, and median values of peak flows between the two points were used to assess impacts for regulatory purposes:

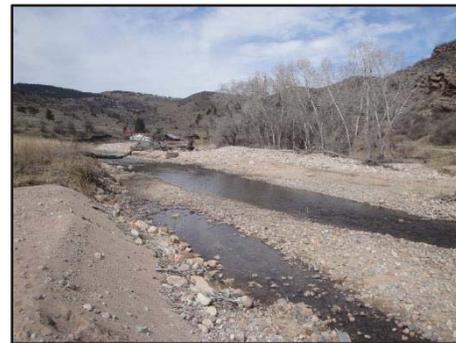
A stable stream has the capacity to move sediment load without aggrading or degrading. The area below the site experience significant avulsions (shift in channel location) abandoning the previous channel during the 2013 flooding, resulting in an unstable channel geometry. Evidence of resultant material deposition (mid channel bar formation) just downstream of the site is also indicative of an adverse channel bed slope change. In realigning the stream centerline, our goal was to provide a stable slope at which channel material can move through the stream system without causing undue aggradation or degradation of stream bed material. In order to analyze the stream's ability to move sediment through the design section it was necessary to calculate the critical dimensionless shear-stress. Utilizing this value, bank full geometry and mean depth could then be determined.

Figure 7 Mid-channel bar looking downstream from road cut
