Reach 4b SSV1 and SSV2

Weekly Construction updates

Date: 8/23/2017

Location: South St. Vrain, West of Lyons, CO

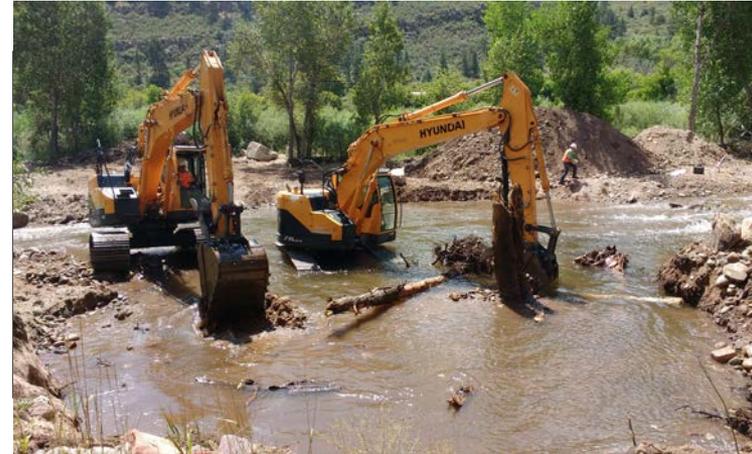
Completed the installation of Type 3 Large woody structure at 61+20

4. Completed the installation of Type 3 Large woody structure at 61+20.
5. Completed the installation of Type 1 Large woody structure at 63+95.
6. Imported 29 Large woody material from Parrish Ranch to be incorporated in final design modification.

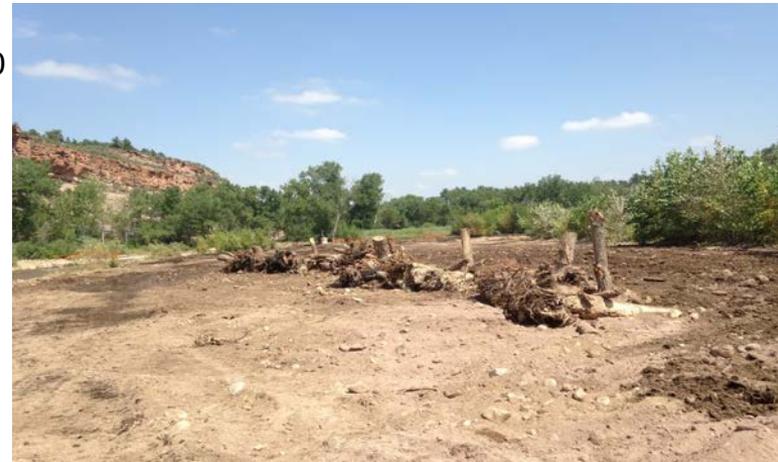
Type 5 large woody structure at main channel St. 66+90.

1. Relocation of existing power pole at main channel St. 87+50 and 71+60 completed.
2. ACOE NWP permit for non-EWP areas obtained and work commenced.
3. Completed two floodplain Type 5 large woody structure adjacent to main channel St. 66+90.

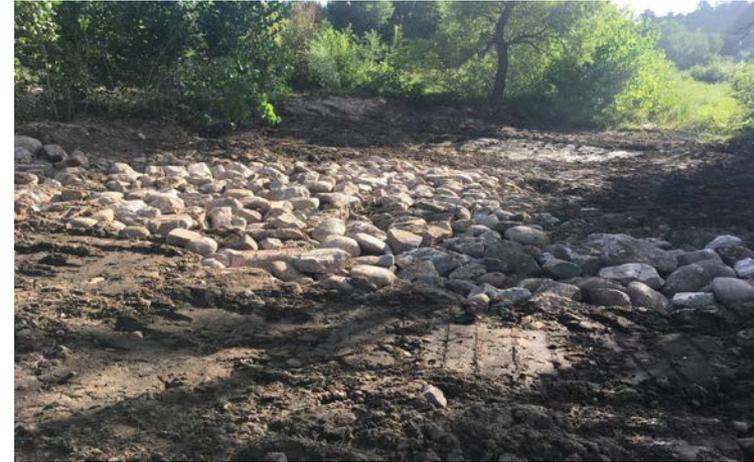
Downstream view: Knick point stabilization rock structures in overflow channel C.

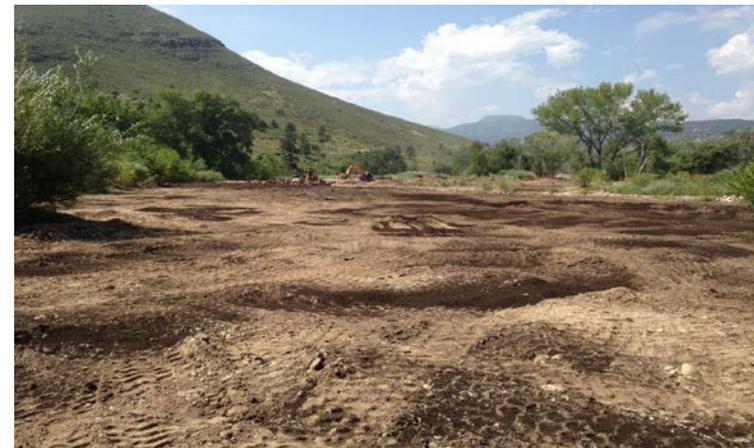
Flood plain benching adjacent to main channel St. 63+00 and 67+00, right bank

12. Completed construction of two Knick point stabilization rock structures in overflow channel D.
13. Flood plain benching adjacent to main channel St. 63+00 and 67+00. right bank.

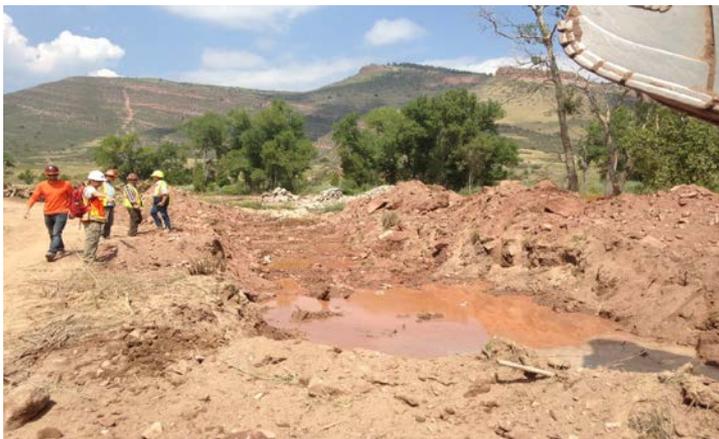
Upstream view: Mass grading of proposed main channel alignment between St. 66+50 to 77+00

15. Mass grading of proposed main channel alignment between St. 66+50 to 77+00.
16. Floodplain benching, mass grading and salvaging onsite embedded rocks for several design structures between main channel St. 66+50 to 81+50.
17. Rock screening operation in progress to generate rock mix of specified classes from overflow channel B.

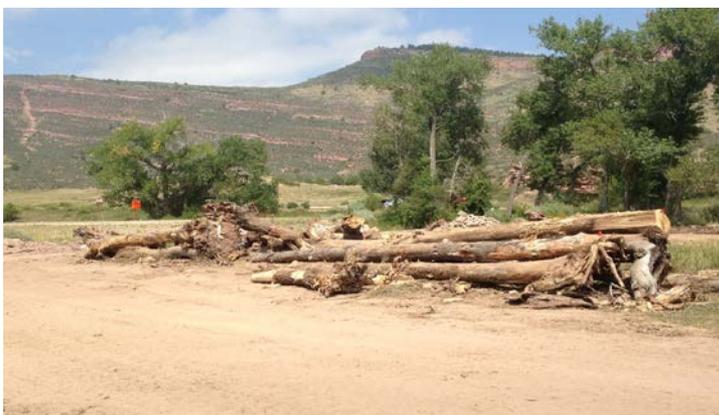
Imported LWM from Parrish ranch.

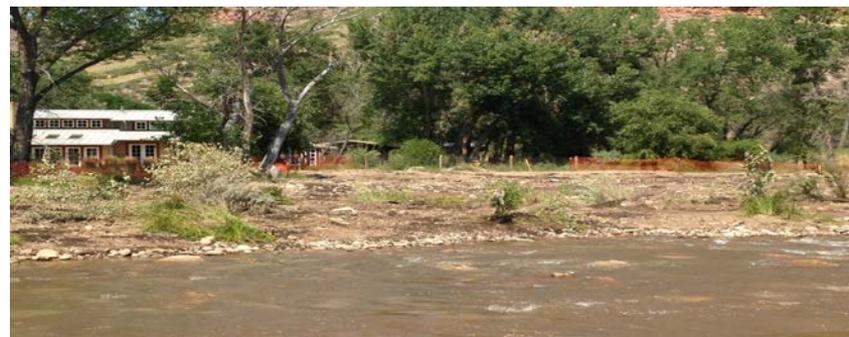
Willow transplant at the confluence of OFC C and main channel St 67+00

10. Mature Willow transplant in floodplain bench adjacent to main channel St. 63+00 in progress.
11. Construction of riffle structure at main channel St. 65+09 and 67+50 in progress.
