Reach 4b SSV1 and SSV2

Weekly Construction updates

Date: 9/20/2017

Location: South St. Vrain, West of Lyons, CO

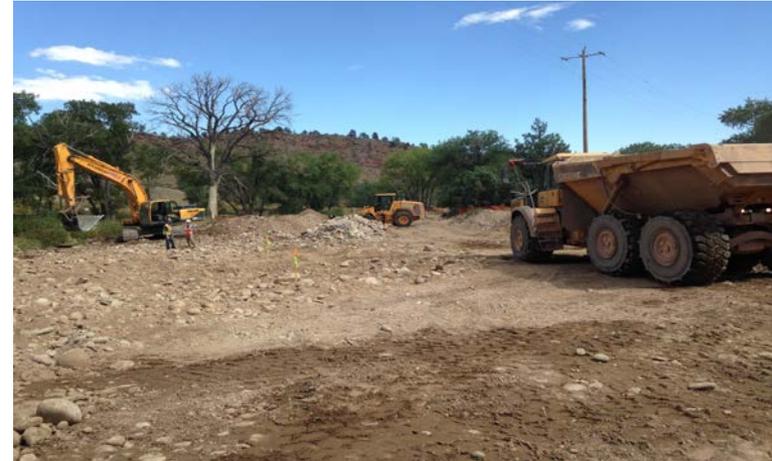
Downstream View: floodplain grading between main channel St. 86+00 to 89+50

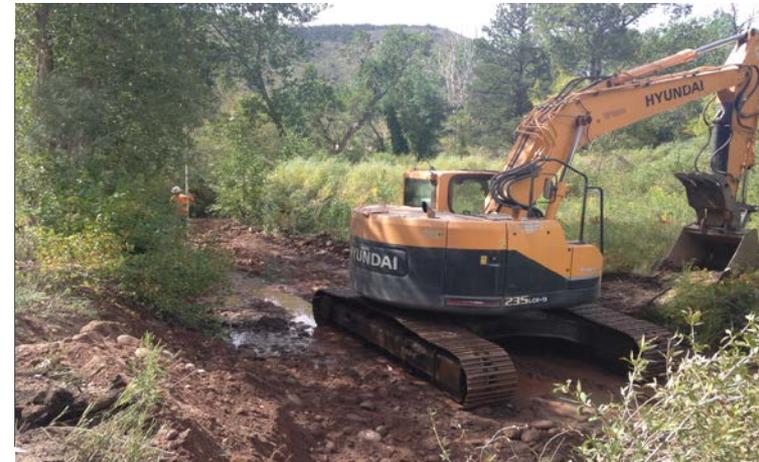
Upstream View: overflow channel E grading for installation of Knick point stabilization rock structures at St. 5+95.

9. Completed overflow channel E grading and installation of Knick point stabilization rock structures at St. 5+95.
10. Overflow channel A grading and substrate harvest in progress.

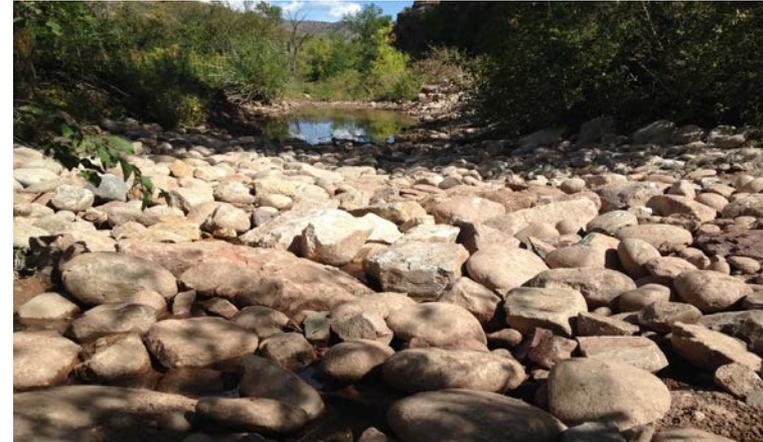
Downstream view: Installation of Knick point stabilization rock structures in overflow channel E at St. 5+95

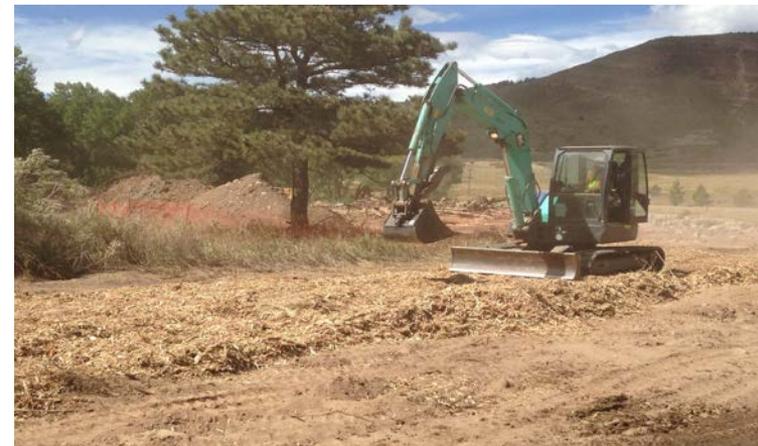
Spreading and mixing chipped woody material in left floodplain between main channel St. 73+50 to 83+00

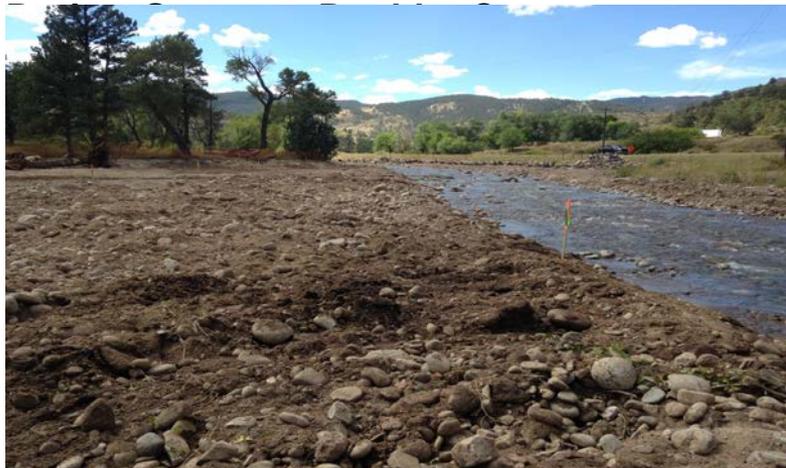
Upstream View: Overflow channel A grading in progress.

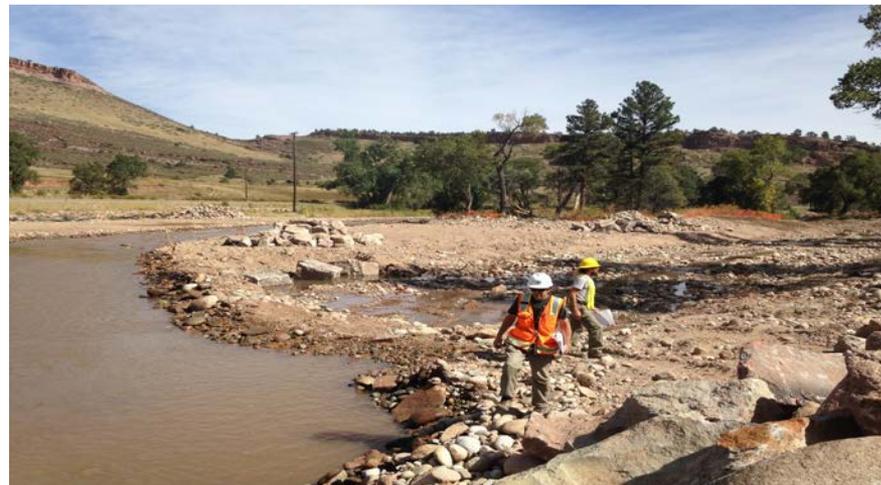
Downstream View: Boulder Toe construction in progress at upstream confluence of OFC A and main channel.

1. Staging large woody materials and specified rock mix at different allocated areas for ease of construction .
2. Installation of boulder toe bank stabilization feature between main channel St. 92+94 to 94+30 in progress.

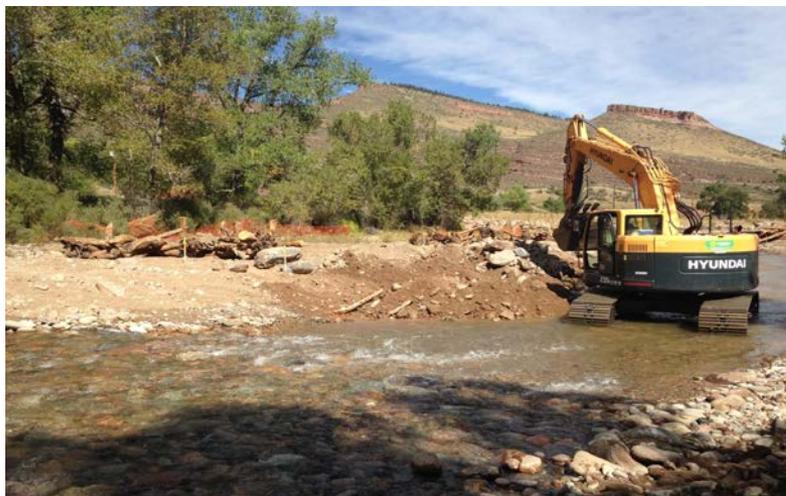
Downstream View: Type 5 large woody structure left floodplain adjacent to main channel St. 97+55 and 98+50 respectively.

3. Completed installation of two Type 5 large woody structure (priority 1) left floodplain adjacent to main channel St. 97+55 and 98+50 respectively.
4. Fine Grading i.e. low flow , pool and bankline between main channel St. 73+00 to 78+00 in progress.

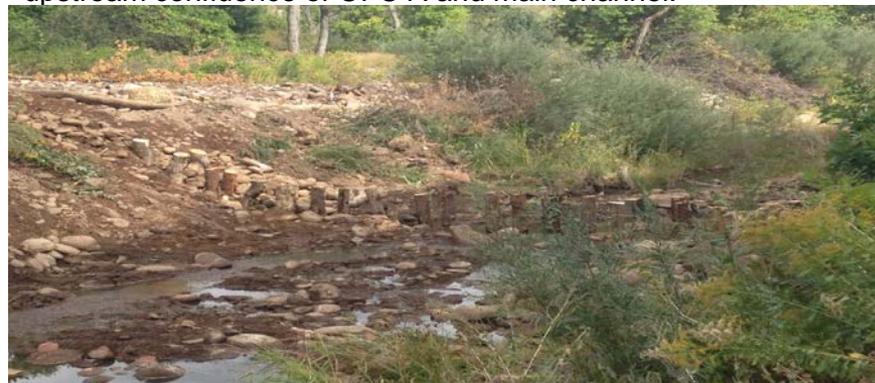
Downstream View: installation of Beaver Dam analogue posts in overflow channel E St. 3+30

11. Cobble toe bank stabilization feature between main channel St. 66+50 to 76+50 in progress.
12. Completed installation of Beaver Dam analogue posts in overflow channel E St. 3+30
