SVR3 EWP Stream Restoration

Project Weekly Construction Notes: 11/27 to 12/1/2017

Date: 12/5/2017

Location: St. Vrain Reach 3 – Hygiene Road Work Site

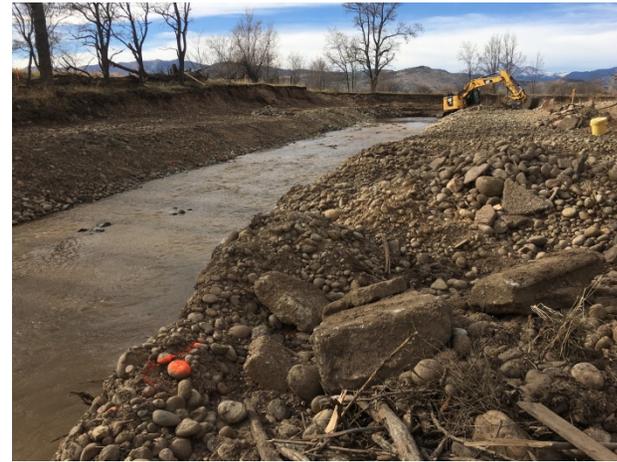
11-27-17: Rough grading for bankfull elevation bench on the outer meander bend at the Gage stream restoration work site.

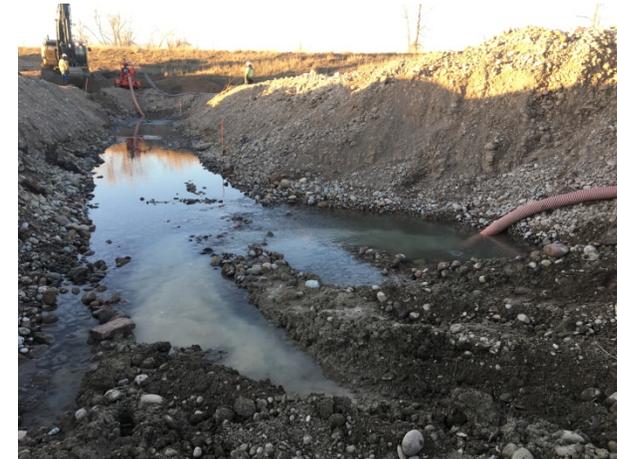
11-28-17: Dewatering showing progress in the North ½ of the 7a berm clay core trench excavation.

6. Monday started pumping from the stream using negotiated water rights purchase;
7. Conditioning of clay for 7a berm;
8. Tuesday 11-28-17 late afternoon dewatering of 7a berm trench location was accomplished in the North ½ of the trench;

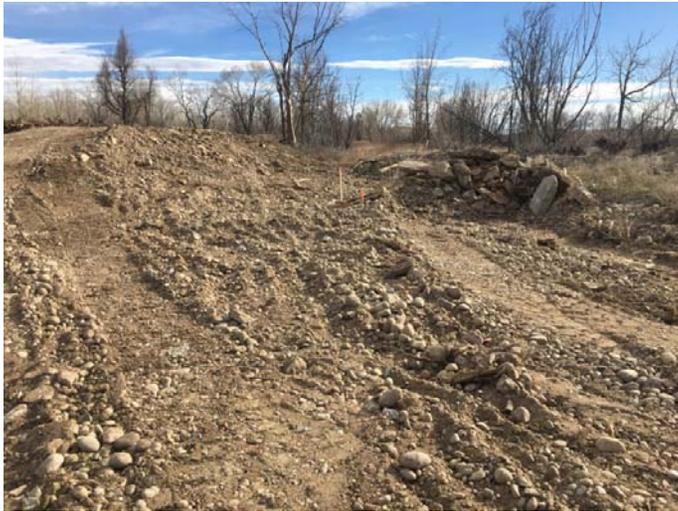
11-29-17: Construction impact to the work sites continues to be monitored and concerns brought to the attention of the Contractor to limit overall impact and restoration costs upon demobilization.

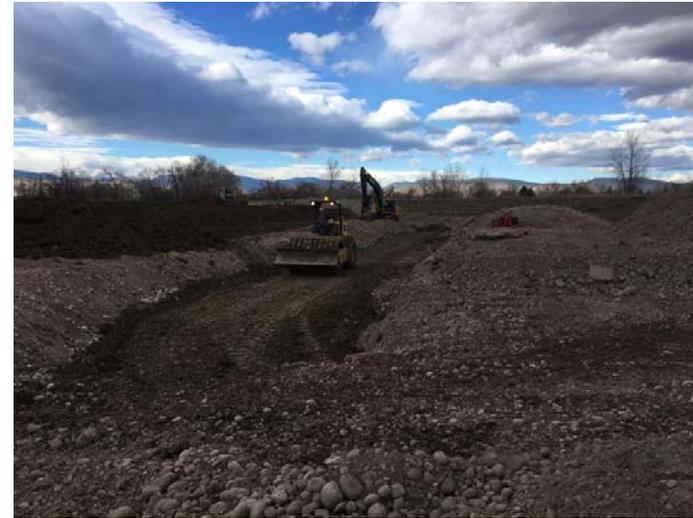
12-1-17: Clay core lifts on the North side of the 7a berm with sheepsfoot roller compaction and material testing for proper moisture and compaction.

9. Wednesday 11-29-17 sand and clay placement began in North ½ berm 7a after clean-up and survey;
10. Friday meeting with landowner Mr. Hepp to review changed berm 7a design (work change directive #1) on the property and the decreased fill volumes as a result;

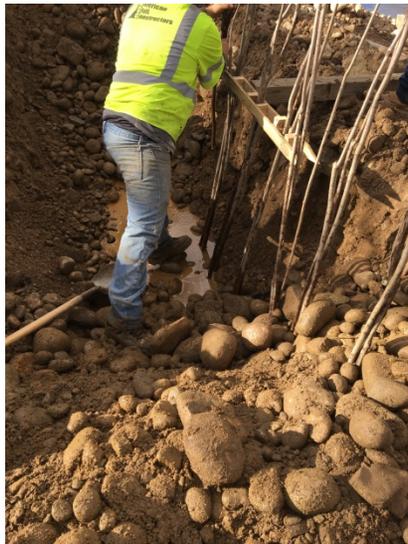
12-1-17: Willow installation on the downstream end of the Gage stream restoration work area.

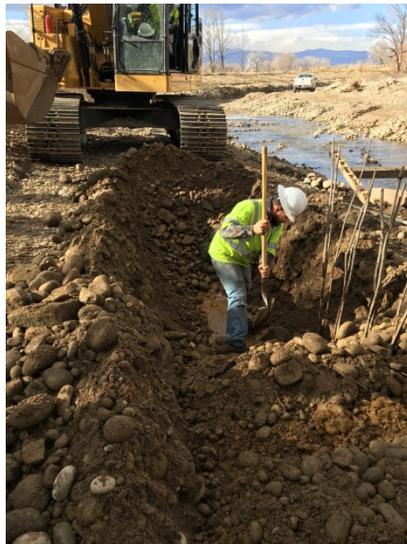
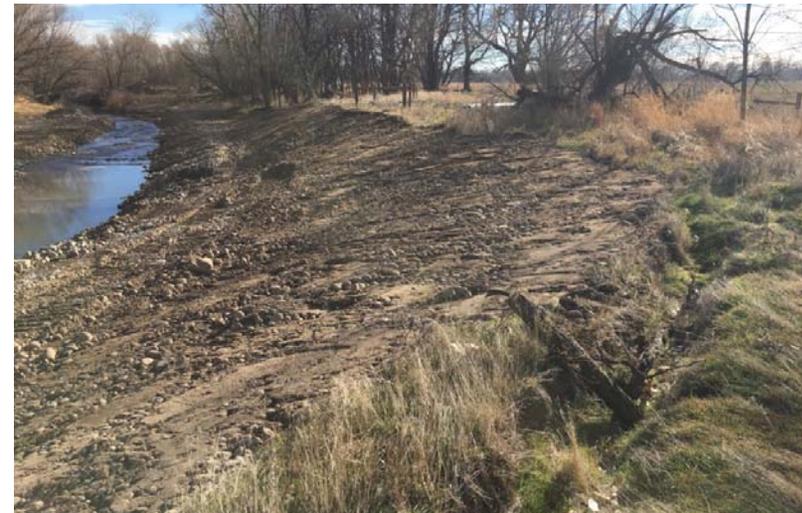
12-1-17: Technical discussion of engineering hydraulics and re-vegetation potential of outer meander bend configuration began Friday with design team – addressed as Work Change Directive 2.
