SVR3 EWP Stream Restoration

Project Weekly Construction Notes: 2/12 to 2/16/2018

Date: 2/19/2018

Location: St. Vrain Reach 3 – multiple work sites

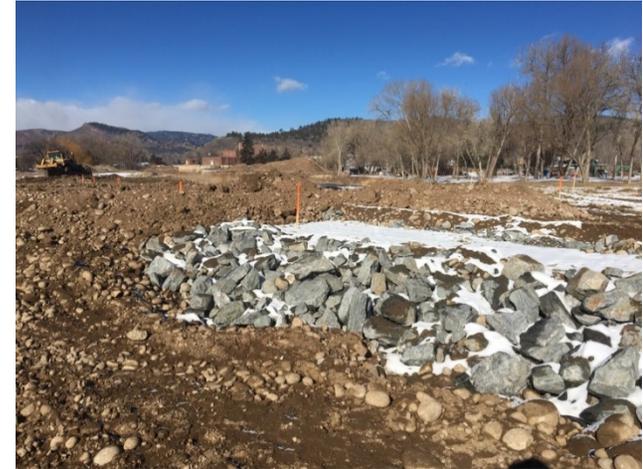
2-12-18 Breach 1: Type M riprap placement on both sides of clay core of breach repair embankment.

2. Breach 1 embankment replacement/repair: finished riprap placement and embankment placement;
3. Breach 1 clearing and grubbing and mass grading for in-stream work and bank stabilization.

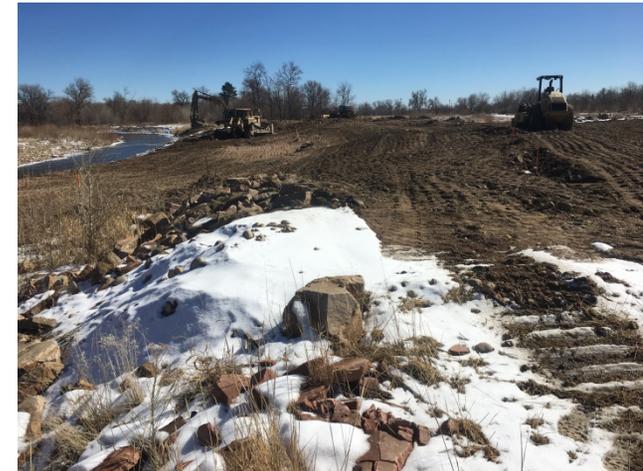
2-13-18 Breach 1: Embankment material compacted over riprap and clay core.

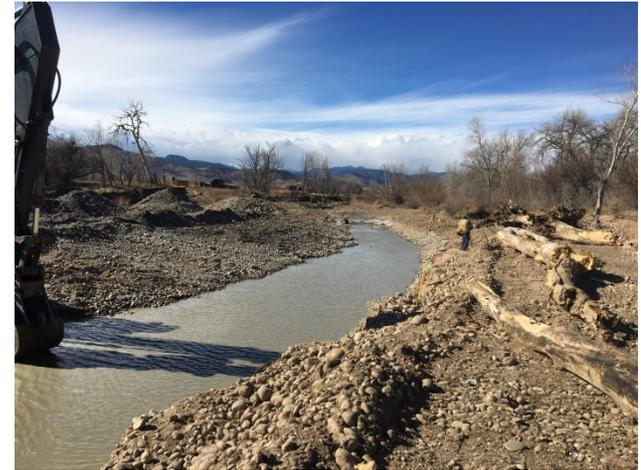
2-14-18: Bank stabilization preparation at Sta. 51+20 to Sta. 54+20; what appears to be a shale layer caused a water quality concern/investigation and ACC moved equipment over to work at Sta. 59+00.

8. Bank stabilization work started at Sta. 51+20 to Sta. 54+20; what appears to be a shale layer caused a water quality concern/investigation and ACC moved upstream to work the next bank stabilization location at Sta. 59+00.

2. The 2-14-18 water quality concern/investigation was primarily resolved the morning of 2-15-18 when the pH sample was found to be 7.4, close to neutral and not a concern for fish impairment. The contractor took measures prior to work activity to prevent release of turbidity downstream, and then further measures to minimize release when the groundwater flow through the ponded work area could not be stopped. The turbid water in the off-line ponded area seems to have been caused by breaking through a shale layer to obtain the necessary elevations. A sample of the gray layer was taken for further testing, final results are expected on 2/20/18.

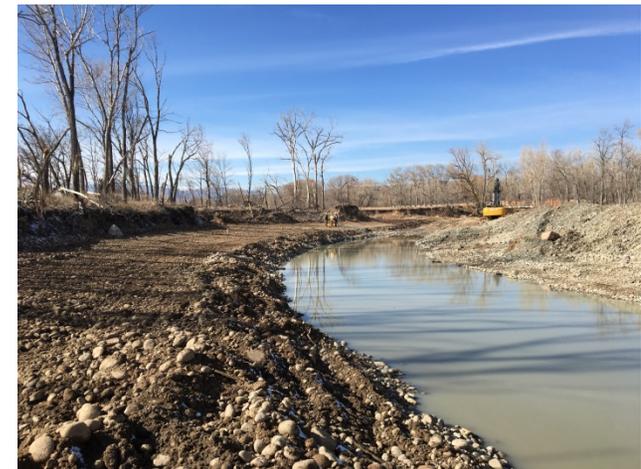
2-16-18 Bank stabilization preparation at Sta. 59+00, south of the 63rd Street bridge.

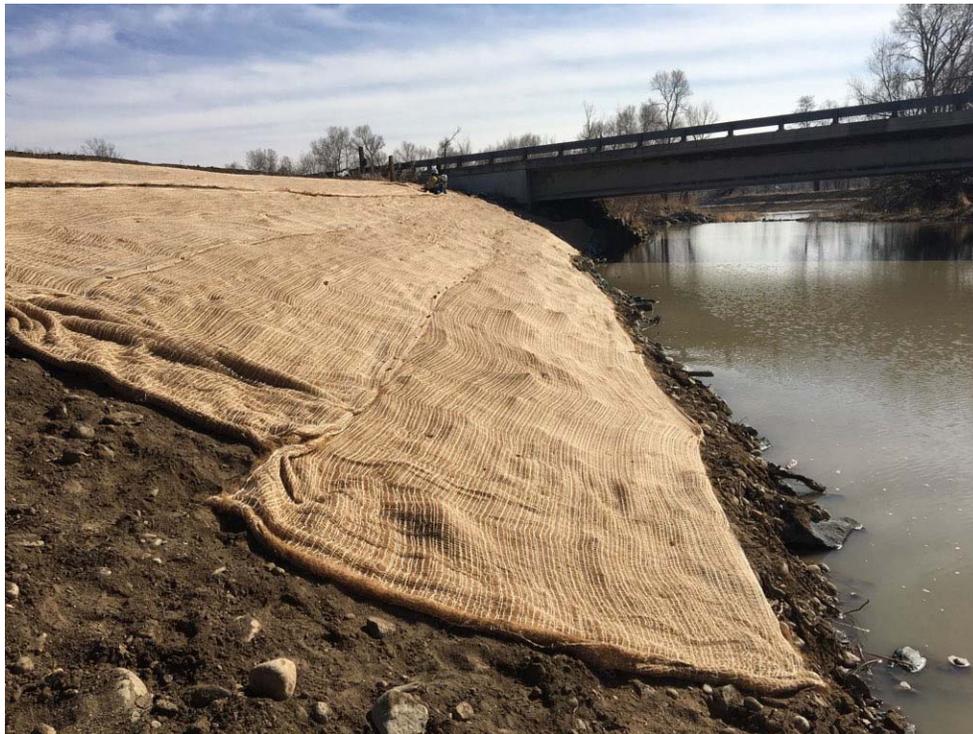
2-16-18: Amendment incorporation, lower and upper riparian seeding and erosion control blanket installation north of the Hygiene Rd. bridge.

1. Soil amendment, upper riparian and lower riparian seed installation, and erosion control blanket installation begun at Sta. 22+00 (just upstream of Hygiene Road bridge) on Friday 2-16-18, delayed both before and after due to adverse site conditions (wind, wet, and cold);

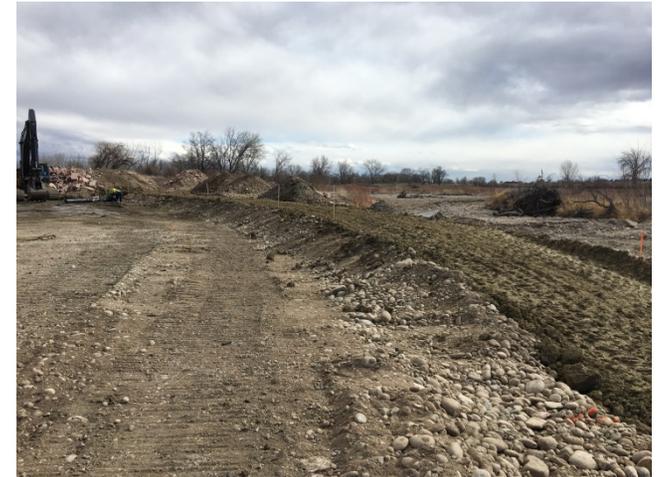
02-15-18 Breach 6 repair: clay core, view looking SE.

4. Breach 6 embankment repair: clay core installation one-half complete and Type H riprap placement along clay core ~ one-third complete;
5. Punch list review for in-stream and bank stabilization work between Sta. 28+00 and Sta. 34+60;

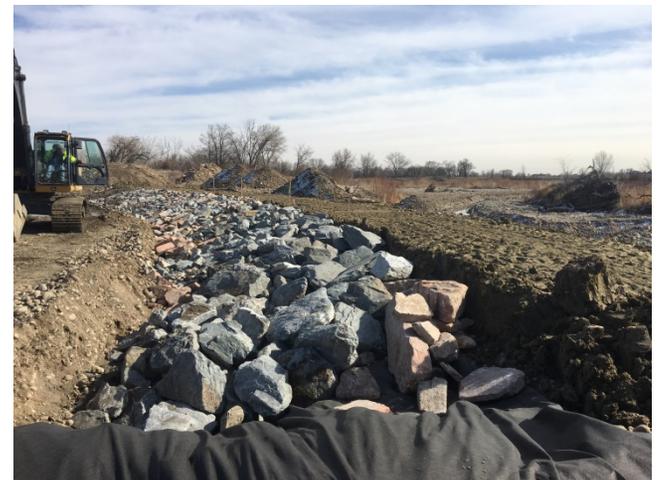
02-16-18 Breach 6 repair: geotextile and riprap installed along the clay core, view looking SE towards the Hygiene Rd. bridge.
