Boulder County

Plant Ecology

2021 Highlights

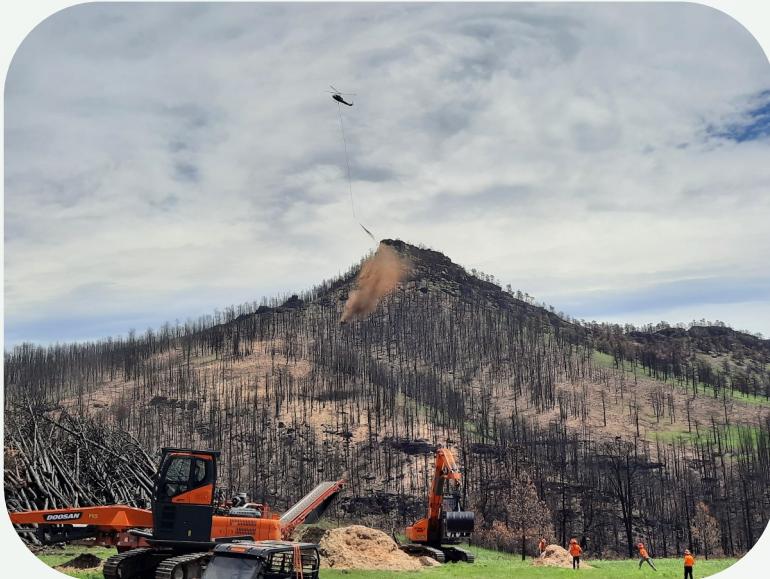
Aerial mulch drop on the Cal-Wood fire above the Mountain Ridge Subdivision..

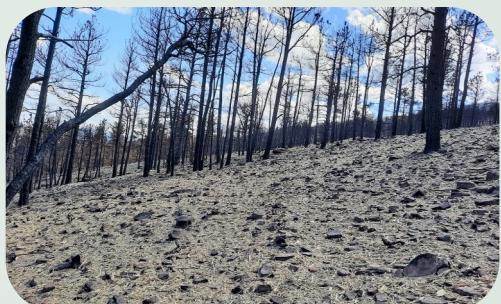
Consistent mulch coverage across severely burned slope.

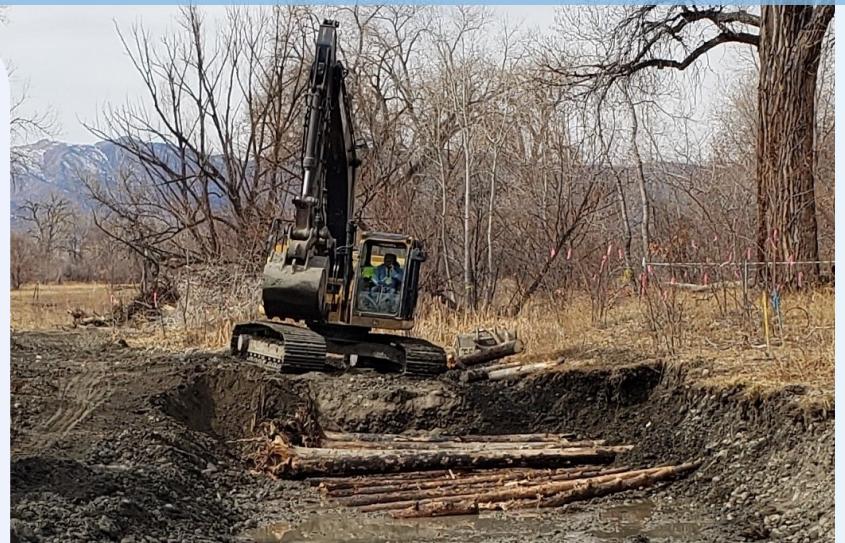
Above: An excavator carefully places logs at an outer bend of the St Vrain Creek as a part of the Niwot Ditch Diversion Project. The outer section of this row of logs will be covered with slash and fill material before being covered with riparian seed-laden soil lifts that will be supported with hundreds of willow stakes. This toe wood structure provides a strong natural barrier that protects the channel from erosion and provides fish habitat.

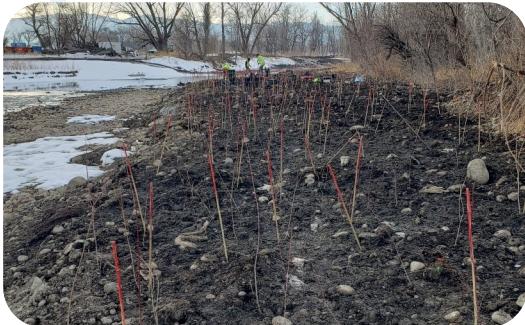
Container plantings installed in the Phase II section of the project. The red-painted bamboo poles will assist to locate plants for irrigation and to monitor survival.

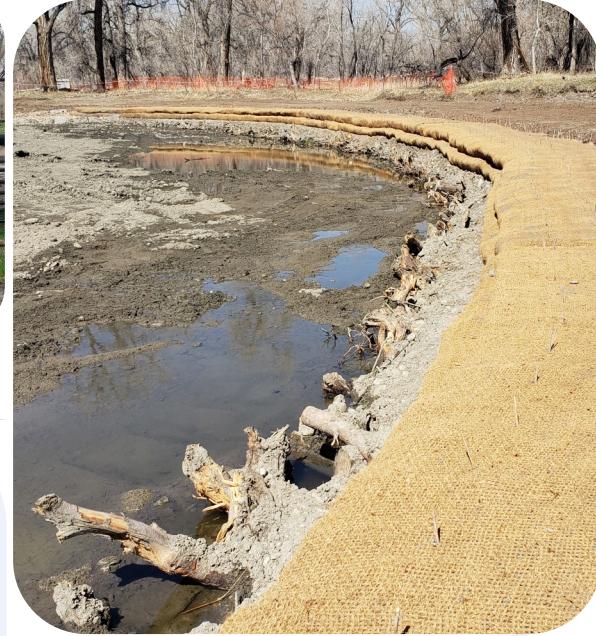
Above: toe wood structure #1, the same feature as pictured in the top photo, after construction is completed. Willow stakes are anchored into the two soil lifts and will soon take root and fortify the feature.

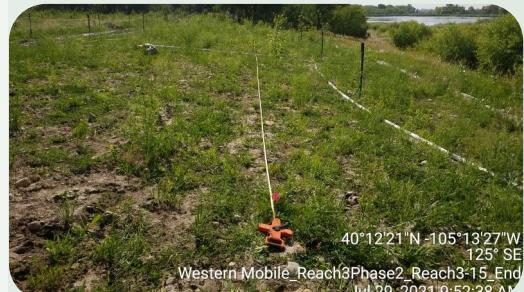
40°12'21"N 105°13'27"W
125° SE
Western Mobile_Reach3Phase2_Reach3-15_End
Jul 29, 2021 9:52:38 AM

Transect at Reach 3 Phase 2.

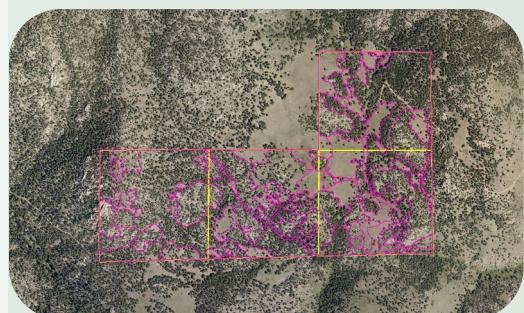
Vegetation mapped at the Billings property.

PE staff mapped 160 acres of vegetation at the Billings West property using the US National Vegetation Classification System (USNVC). PE staff continue to process the data collected in the field to determine the proper Alliances and Associations to which the vegetation communities belong. Multiple Significant Natural Communities and rare plant populations were identified. This information will assist in upcoming forest thinning projects as well as overall management of the property.

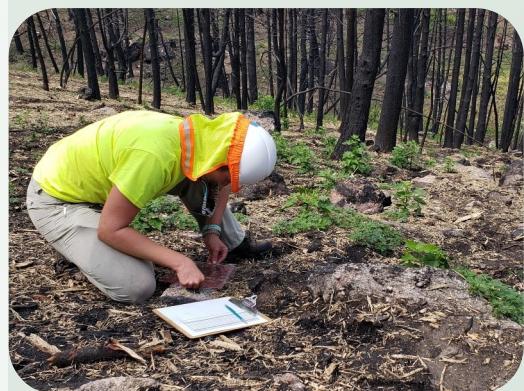
PE staff use a Wood Straw cover grid to assess mulch cover in the Cal-Wood Fire burn area.

To support the Cal-Wood Fire aerial mulching efforts, PE staff established and monitored 172 transects to assess whether mulch cover was acceptable. In all, this comprised 1,720 data plots that were analyzed. Plot data was collected utilizing a Wood Straw cover grid, and staff utilized randomly generated points within each mulch treatment unit as a transect start point.

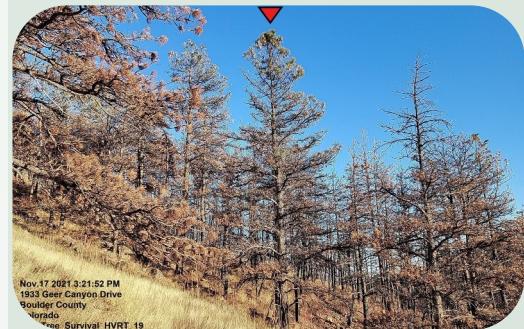
Nov.17 2021 3:21:52 PM
1933 Geer Canyon Drive
Boulder County
Colorado
Heil Tree Survival HVRT_19

Severely burned Ponderosa pine marked for monitoring.

During Cal-Wood Fire recovery efforts, certain trees along picnic sites, parking lots, and trails were marked to be left in case they end up surviving fire-related damage. PE staff identified Ponderosa pines at Heil Valley Ranch that lost a significant amount of leaves and will continue to monitor their recovery. A total of 30 trees were placed into three categories of live needle percentages: 0-10%, 11-20%, and 21-30% needle retention.
