30% DESIGN REPORT

# **St. Vrain Creek Restoration Highway 36 to Crane Hollow Road Boulder County, Colorado**

Project No. 110666

REVISED December 2016

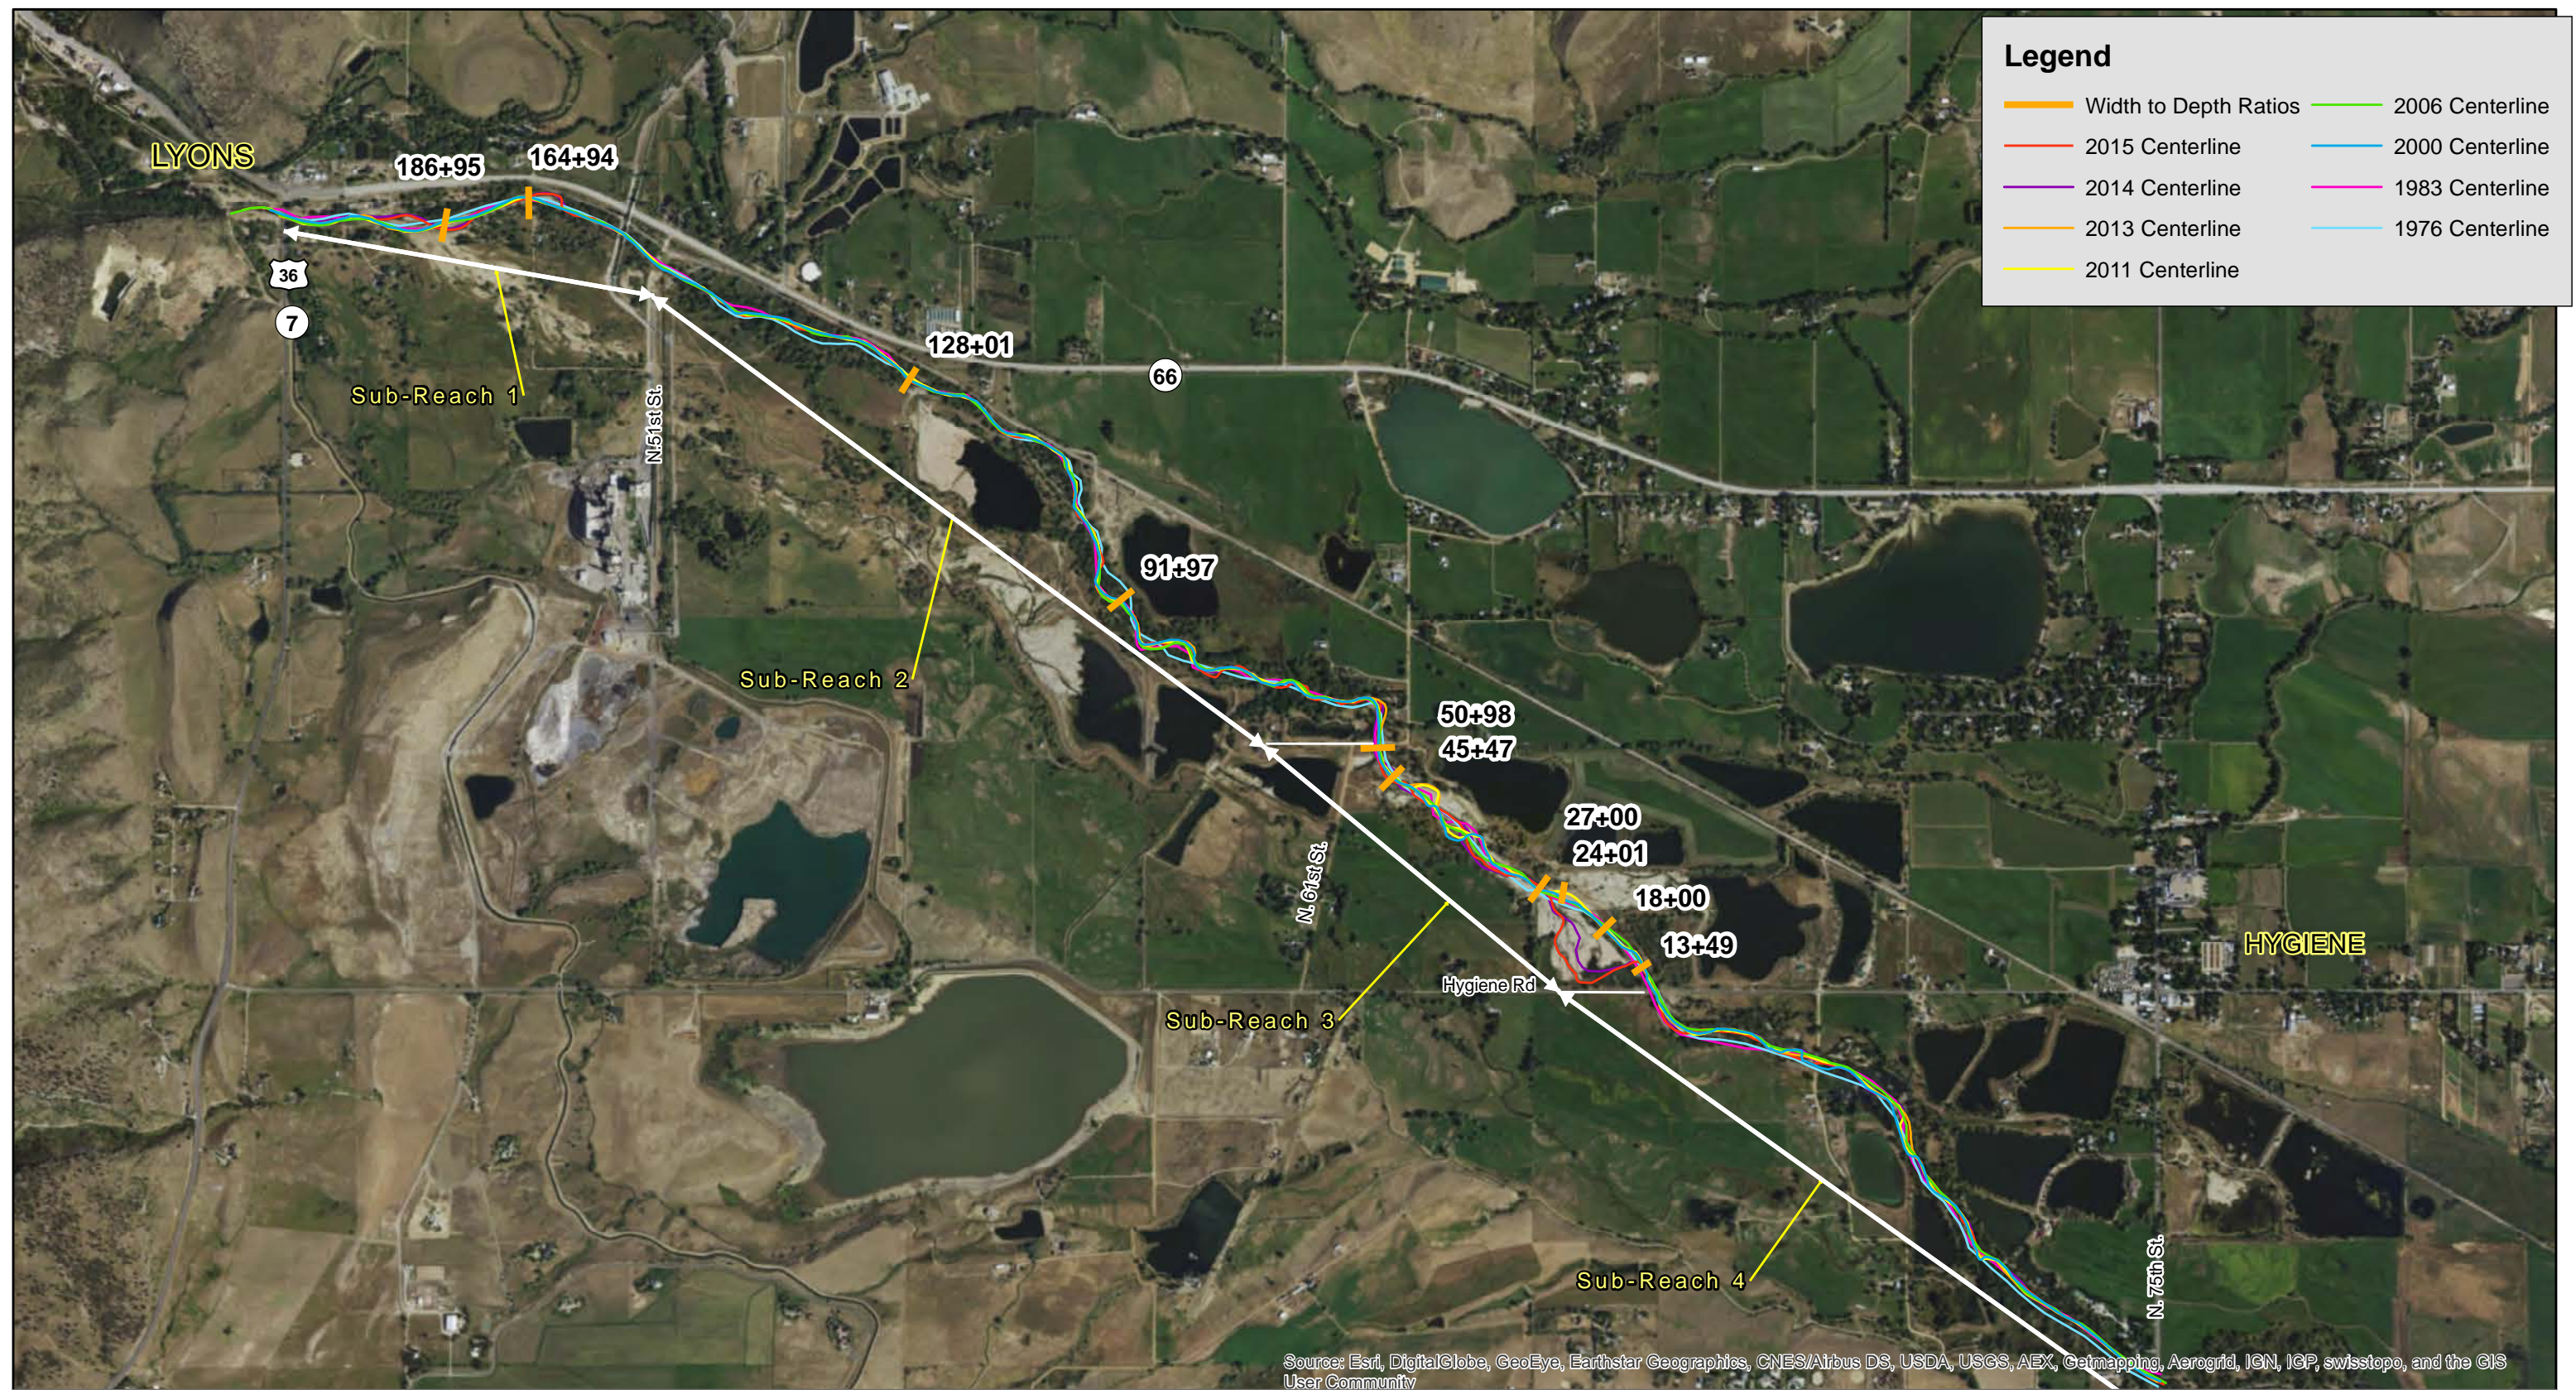
Figure 3  
Planform Comparison

This section presents an analysis of channel planform changes over time between the Highway 36 and 75<sup>th</sup> Street bridges. Sinuosity changes between 1976 and 2015 are presented on **Figure 3** and discussed in detail in the following paragraphs and figures. Sinuosity is the ratio of channel length to straight line valley length between crossings (Thorne, 1998). A completely straight channel will have a sinuosity of 1.0. Typically, sinuosity is an important factor in defining how a channel evolves over time. In some cases the past can serve as a footprint for the future. Meander Belt Width is the average width of the channel changes over time or is effectively the area of the valley characterized by recent channel changes. Such a concept is important in geomorphic thought since it allows one to address predictions of near term stability. Actions and development that takes place within the Meander Belt Width are clearly subject to modifications by the channel through either accretionary or avulsive processes.

Between 1976 and 2013, the average sinuosity of the St. Vrain Creek increased from approximately 1.06 to 1.10. During this time, St. Vrain Creek flowed freely through the Project Area in a semi-regular, fairly straight meander pattern. As noted in the St. Vrain Master Plan, St. Vrain Creek maintained a prominently stable planform from 1949 through the 2013 flood (Baker, 2014). After the flood in September 2013, the average channel sinuosity increased to 1.14 in 2015. The sub-reach with the highest post-flood sinuosity is Sub-Reach 3 which is between 61<sup>st</sup> Street and Hygiene Road. While the channel escaped its banks in numerous places during the 2013 flood, the only sub-reach where it remains in a different alignment is Sub-Reach 3. In this sub-reach, the creek captured an old aggregate pit (Hepp #1) and remains in this alignment currently. The old channel alignment was straighter, while the new alignment through the pit creates additional channel length and sinuosity. Significantly, Sub-reaches 1-3 are all exhibiting a post-flood increase in sinuosity trend. This is a reflection of a channel seeking to achieve a new geomorphic condition in a dynamic environment.

A Channel Migration Zone is the average width of the meandering channel as it changes over time. LA analyzed the meandering patterns of the St. Vrain Creek using the planform comparison presented in **Figure 3**. The average channel migration zone of the project area from 1976 to 2015 was able to be determined by calculating channel migration over the record of available historic aerial imagery (**Table 2.2b**). This nearly 40-year analysis

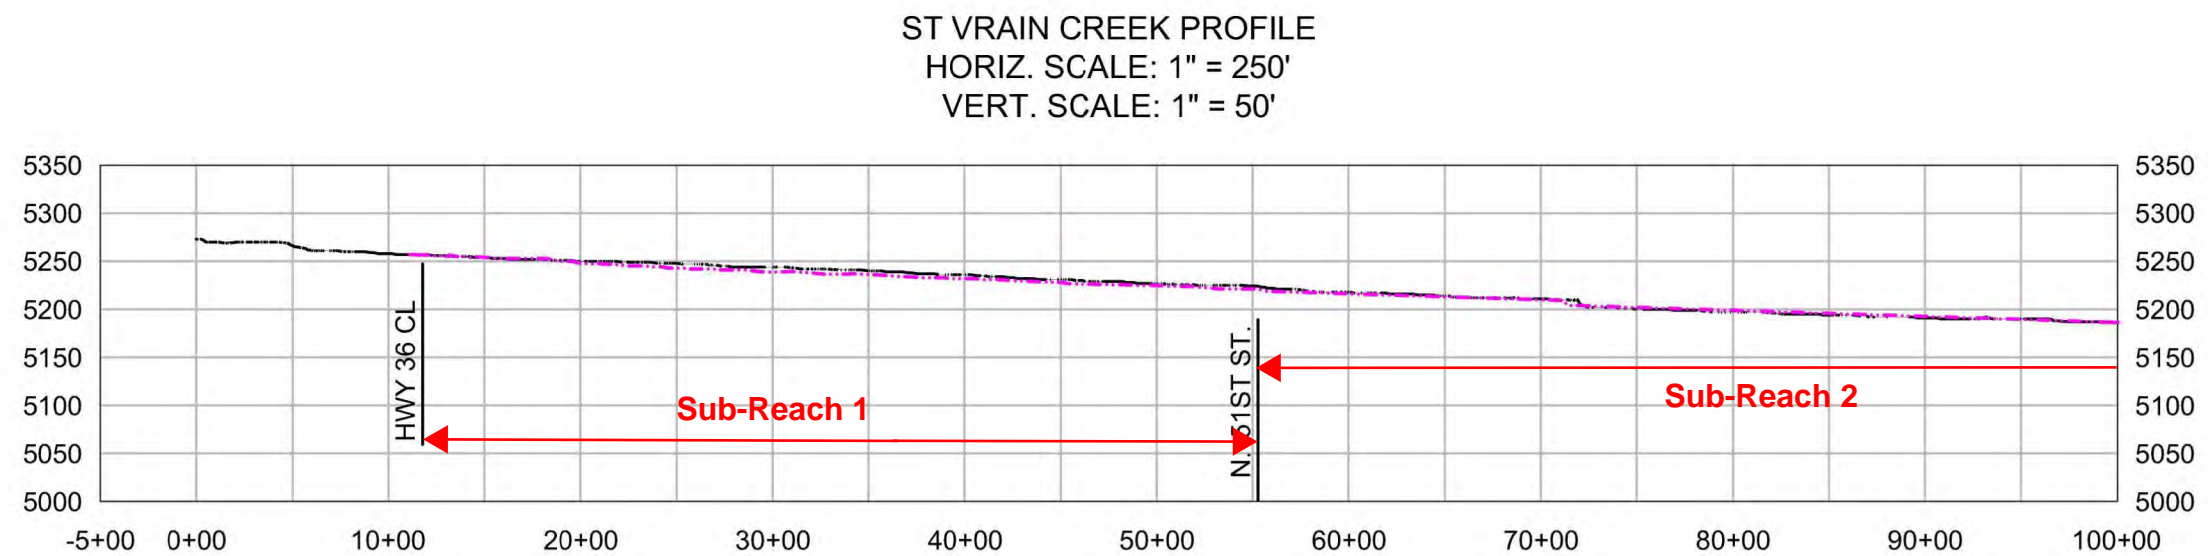
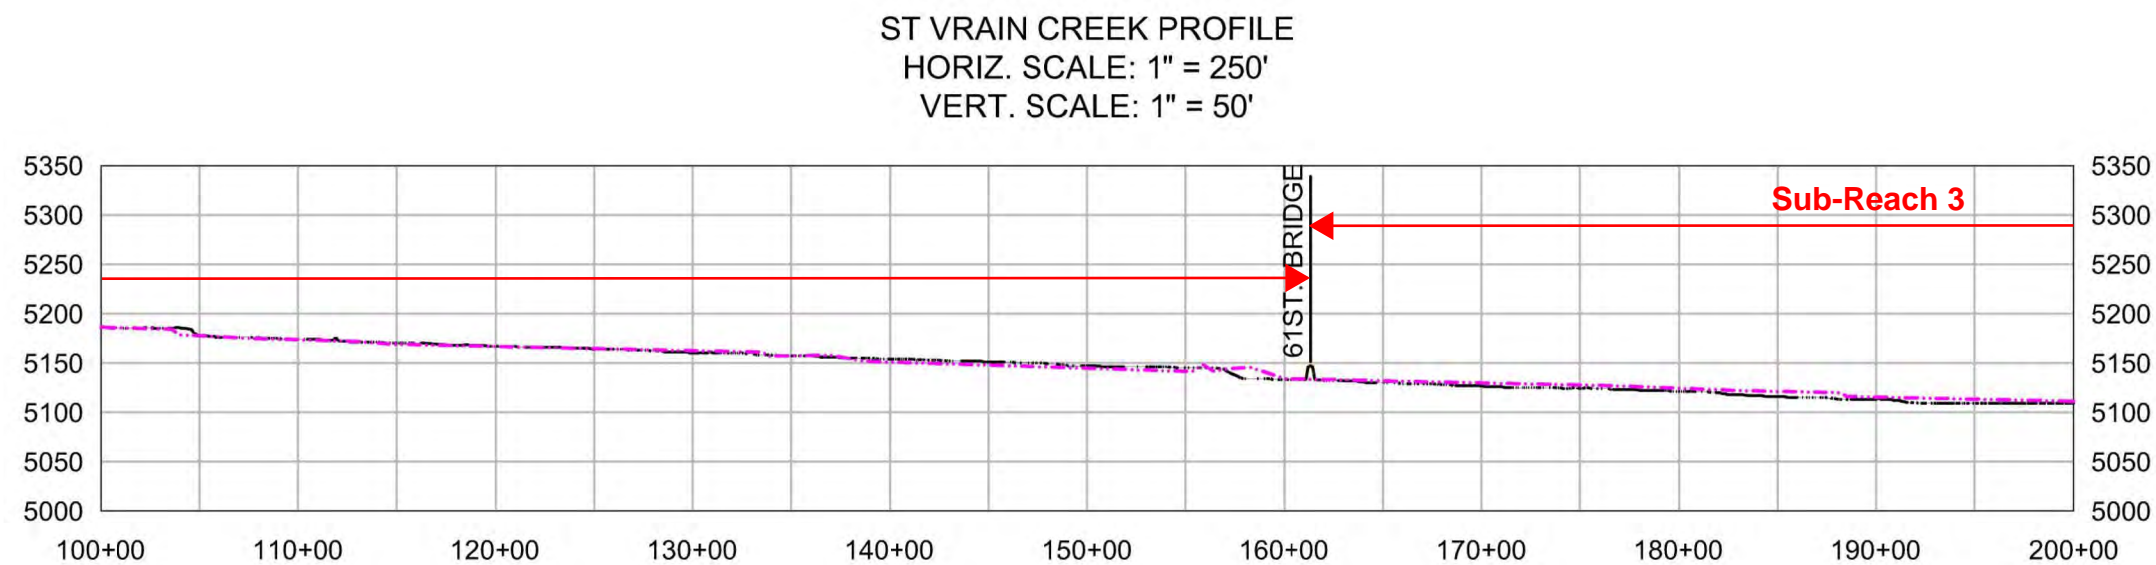
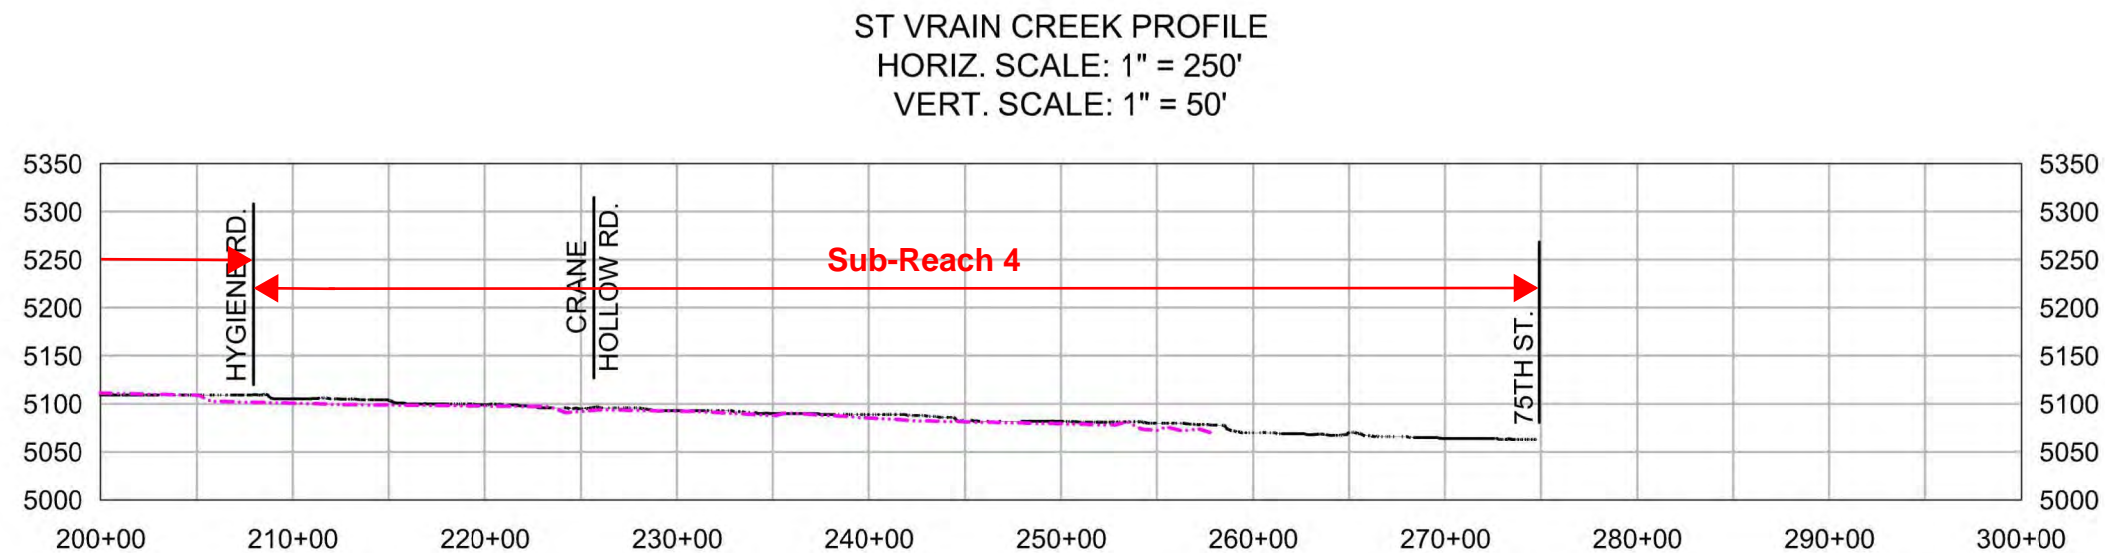
In an effort to evaluate historic bed changes throughout the project reach, inspection reports for the three main bridge crossings were obtained and analyzed: 61<sup>st</sup> Street, Hygiene Road, and 75<sup>th</sup> Street. Historical bridge inspection reports dating from 1988 to 2015 were obtained from Boulder County to observe vertical changes at specific locations measured from the low chord elevation of the bridge to the invert of the channel. Bridge inspection reports are included as **Appendix C**. LA also requested bridge inspection reports for the Highway 36 Bridge from CDOT; however, we were unable to acquire useful data on that structure. Based on the information obtained from Boulder County, the aggradational and degradational erosional processes at the three remaining bridges varied annually until the September 2013 flood. During this flood, the channel invert dropped 1.6 feet at the 61<sup>st</sup>

Street Bridge, just downstream of the Oligarchy Ditch diversion structure. This change was also observed at the 75<sup>th</sup> Street Bridge, which showed a similar channel invert lowering of approximately 1.5 feet. The Hygiene Road Bridge crossing was not affected as significantly, with only 0.5 feet of lowering of the channel at this location. However, there was lateral migration of the channel in this location. **Tables 2.4a, b and c** and **Figures 5, 6 and 7** present a summary of the bridge inspection data analysis.

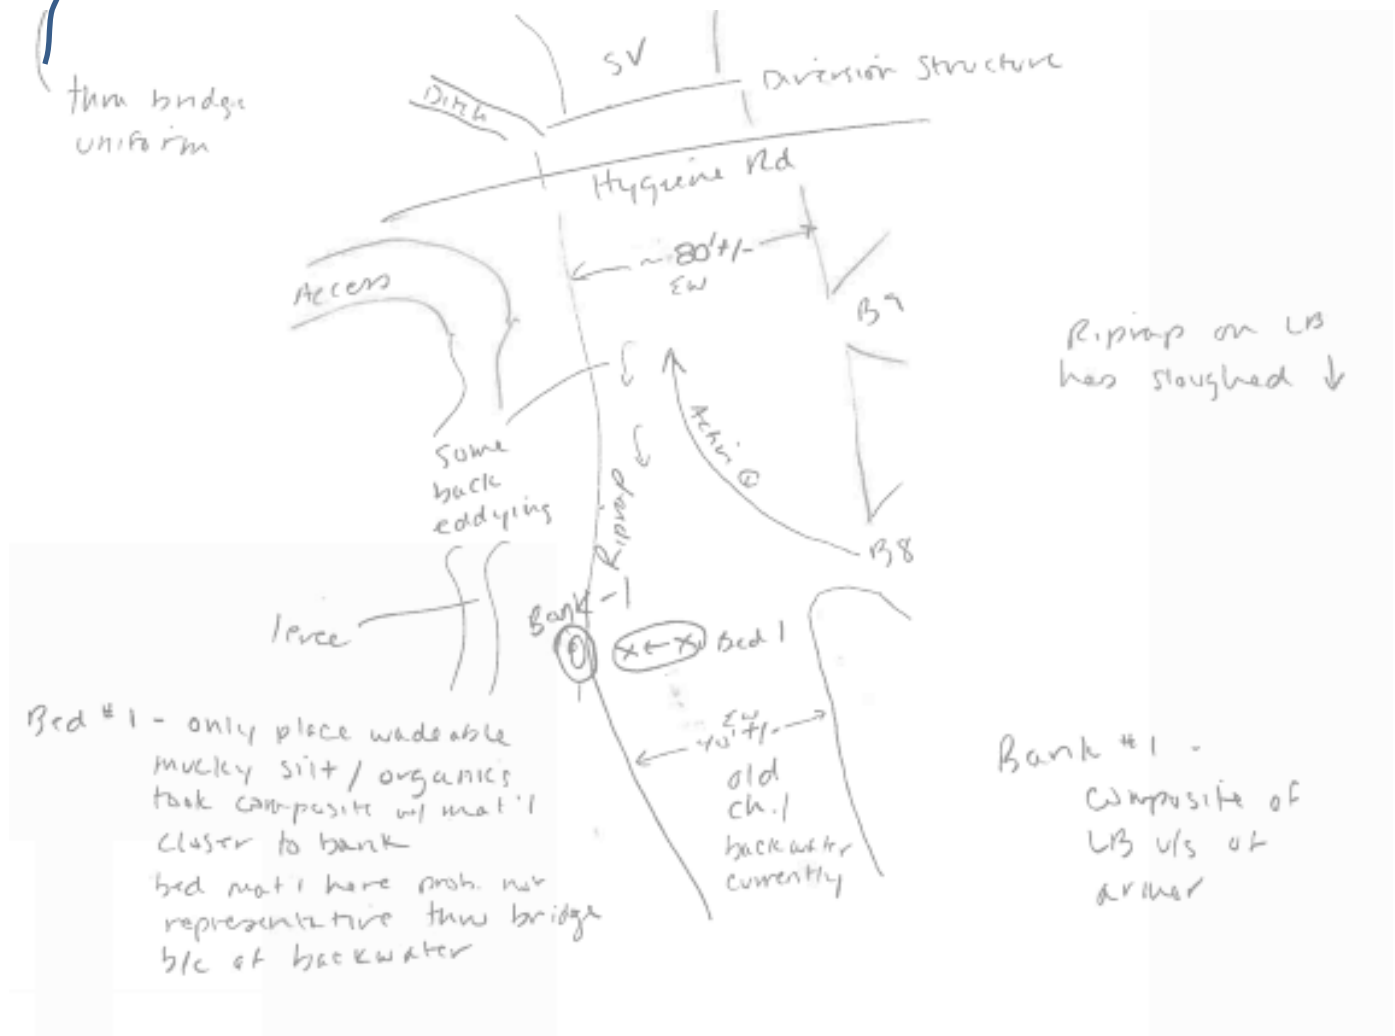
Bed	Left	Right
<b>Bank Height (ft.) (from EW)</b>		10'	5'
<b>Bank Angle (°)</b>		Upstream of armor- 48, 1:1 Armor- 3:1?	Upstream of armor- 3:1 Across from armor (LB)- 4:1
<b>Bank Stability</b>		Left bank has been armored. Toe erosion? Has sloughed down.	Stable/Veg/flatter slope
<b>Seepage Present</b>			
<b>Armoring</b>		Poorly graded sandstone, slabby	
<b>Bed/Bank Material</b>	At sample pt.-mucky backwater with organics and some cobbles	Cobbles in bank with sand and gravels	Cobbles in bank with sand and gravels
<b>Bed Form Meas.</b>			
<b>Agg./Deb. Length (ft.)</b>	Appears to have degraded some along reveted section, some toe erosion, no apparent degradation on right bank		
<b>Sediment Depth (ft.)</b>			
<b>Vegetation</b>		Grass, sparse willows	Grass, sparse willows
<b>O.B. Vegetation</b>		Sparse on levee, healthier willows behind	Some cottonwoods appear stressed
<b>Levee Vegetation</b>		Grass, weeds, cobbles

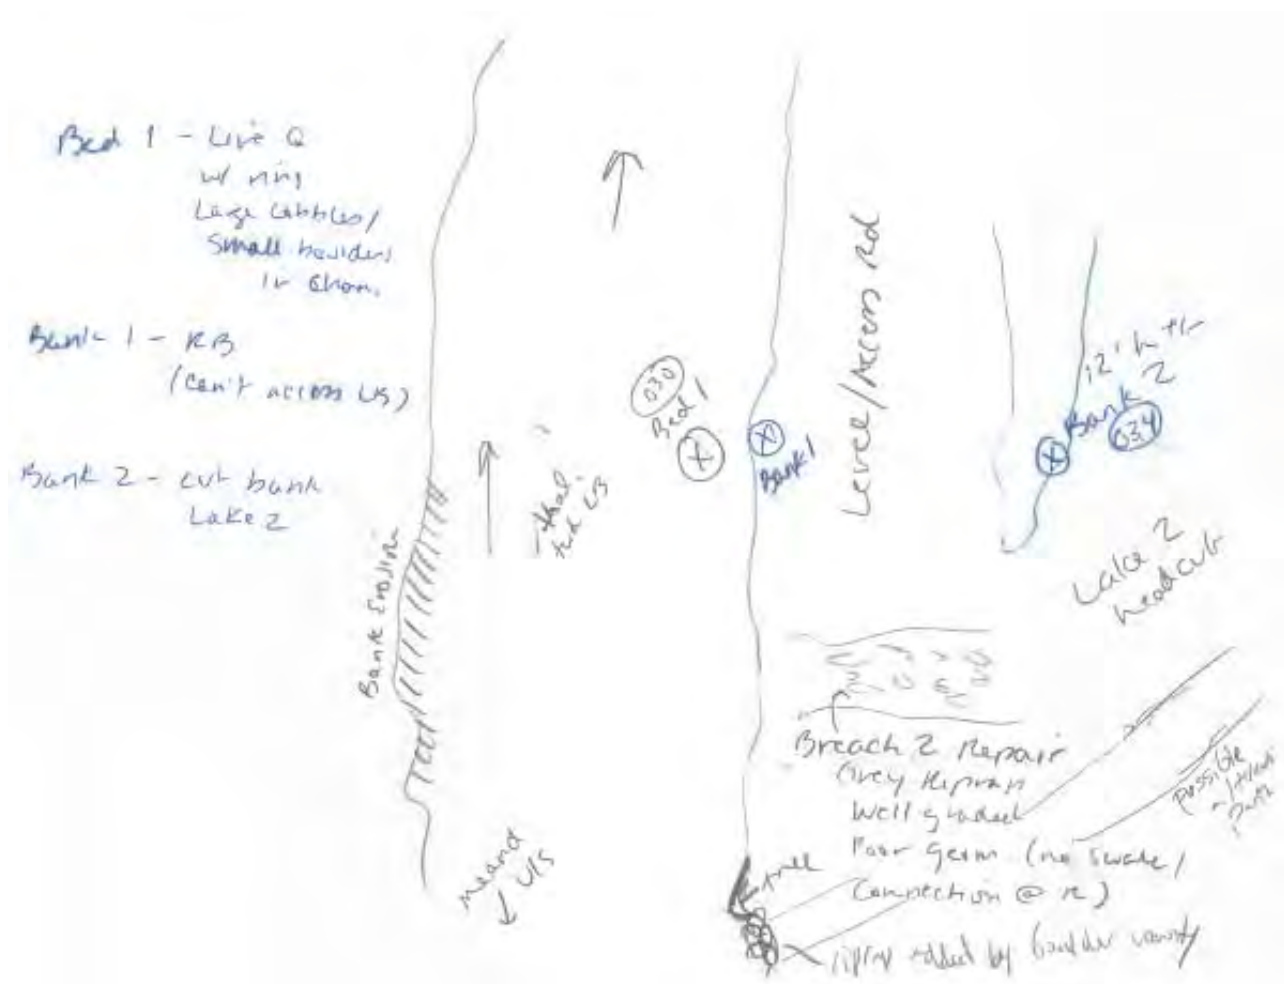
Bed	Left	Right
Bank Height (ft.)		3'	8'
Bank Angle (°)		Vertical cut	1.5:1 at B2 2:1 downstream
Bank Stability		erosion	Some toe erosion
Seepage Present			
Armoring	no		On right bank across from Breach 2
Bed/Bank Material		Silty/sand	
Bed Form Meas.			
Agg./Deb. Length (ft.)	Degradation through reach (through straight section)		
Sediment Depth (ft.)			
Vegetation		Sparse grass/weeds/cottonwoods	Cobbles
O.B. Vegetation		"	Sparse grass and weeds
Levee Vegetation			"
Levee Height (ft.)			8'
Levee Width (ft.)			45' +/-
Manning's "n"

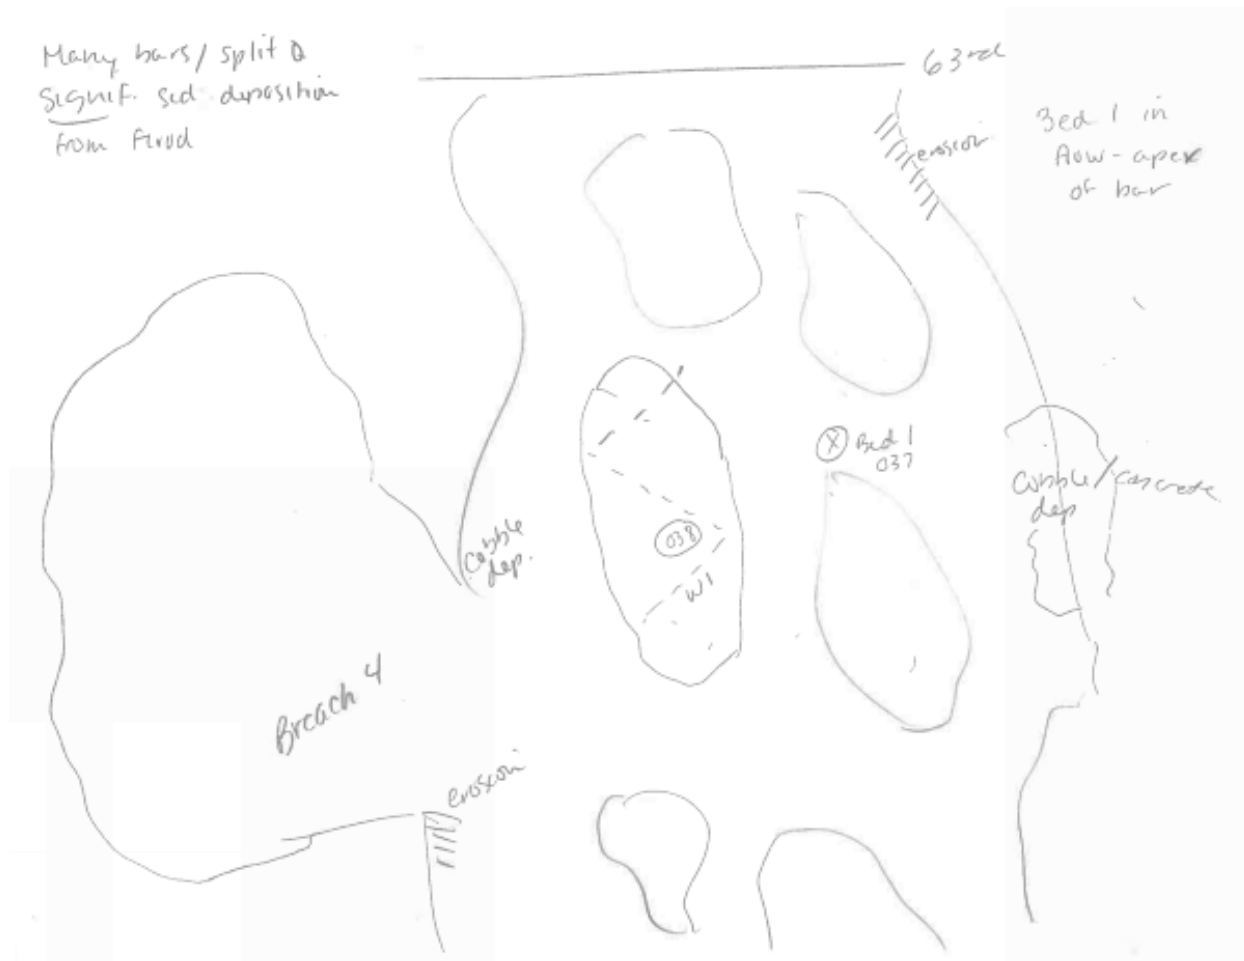
Bed	Left	Right
Bank Height (ft.)		Can't see native bank, all cobble deposition	“
Bank Angle (°)		Cobble deposition	“
Bank Stability		Erosion upstream below br.	Cobble deposition, bank erosion downstream B4
Seepage Present			
Armoring	Possibly same in places		
Bed/Bank Material	cobble	Banks gone cobble deposition	Bank gone cut into field
Bed Form Meas.			
Agg./Deb. Length (ft.)	Looks like aggregation originated after flood-now channel trying to braid, rechannelize		
Sediment Depth (ft.)			
Vegetation	None	none	None
O.B. Vegetation		Sparse cottonwoods	Sparse/stressed cottonwoods
Levee Vegetation			
Levee Height (ft.)			
Levee Width (ft.)			
Manning's "n"	Rougher than other locations

Notes concerning above:     Talked with Brian (BCPOS) and he said River here used to be single thread-a width of one of the splits (40' +/-), both banks gone, significant widening and flood debris and cobbles

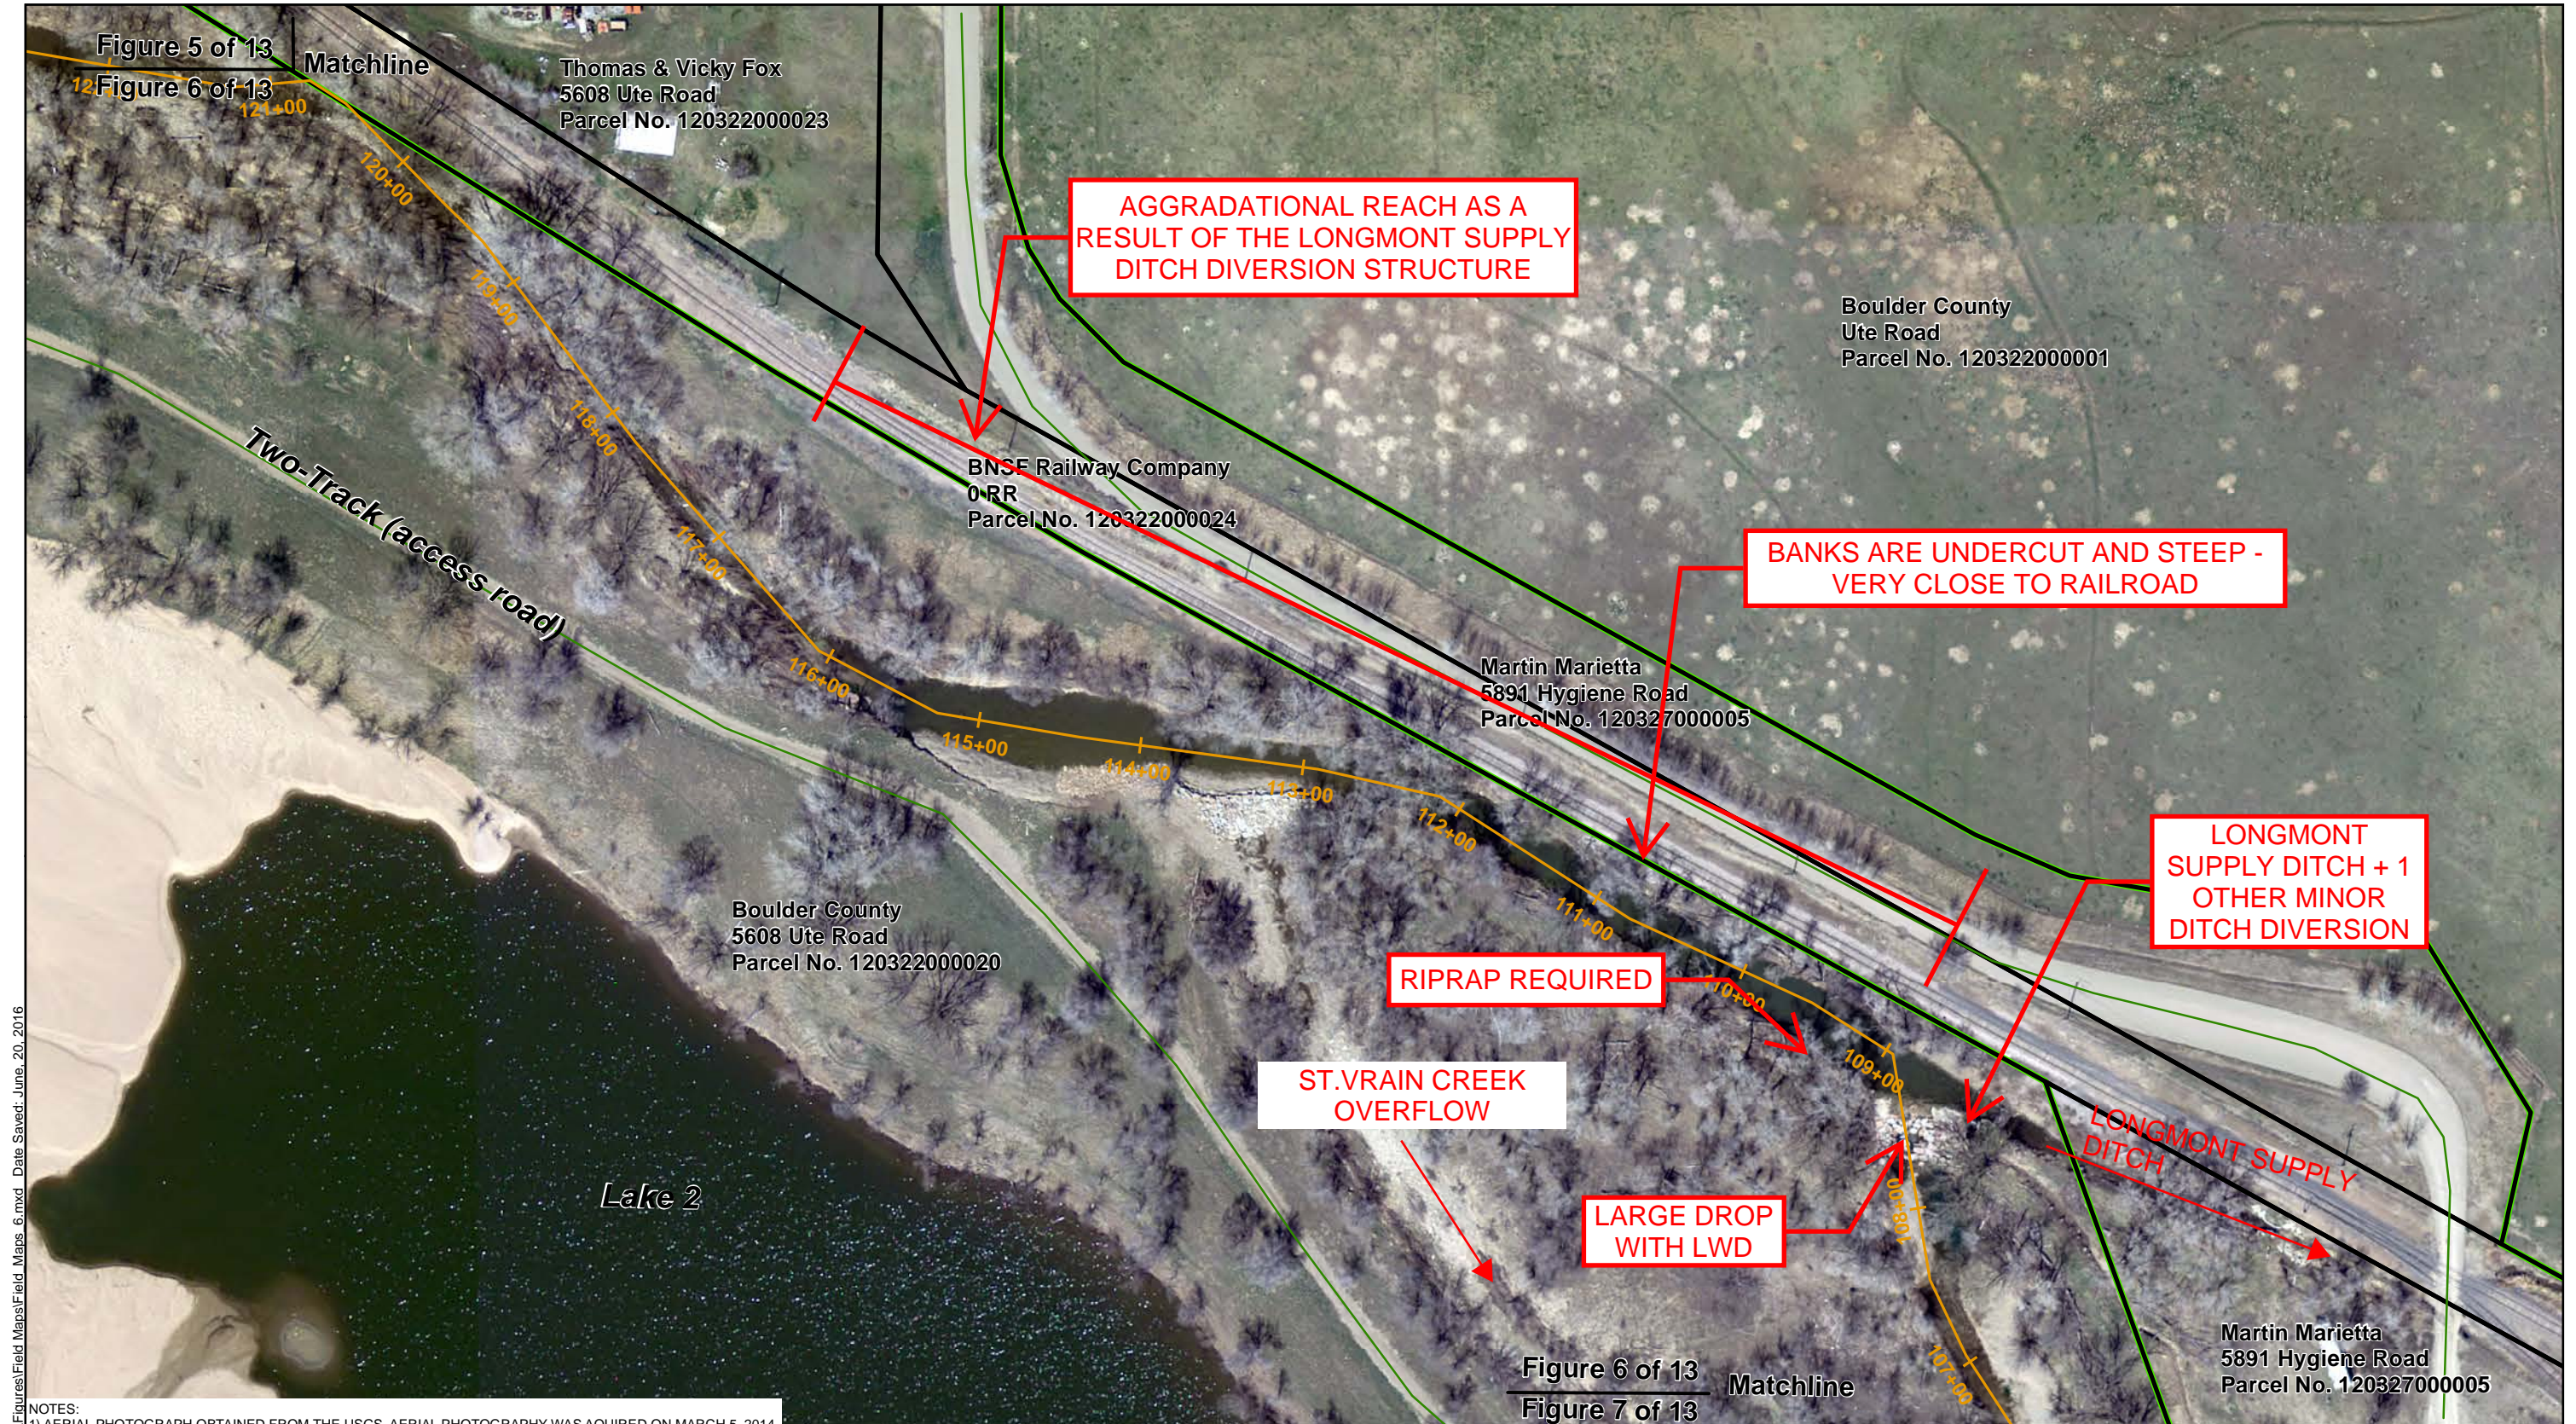
Date: June 2016	Project No.: 110666	Figure 6 of 13
-----------------	---------------------	----------------

**Response:** We assume you are referring to Figure 6 of 13, Appendix B of the LA report. This figure has been superseded by the alternatives analysis and will continue to be superseded as the 30% Design progresses to final design. The project team does not intend to propose riprap at any location. Our overall approach will be to continue to work with biotechnical slope protection, native plantings and toe slope protection where appropriate.
