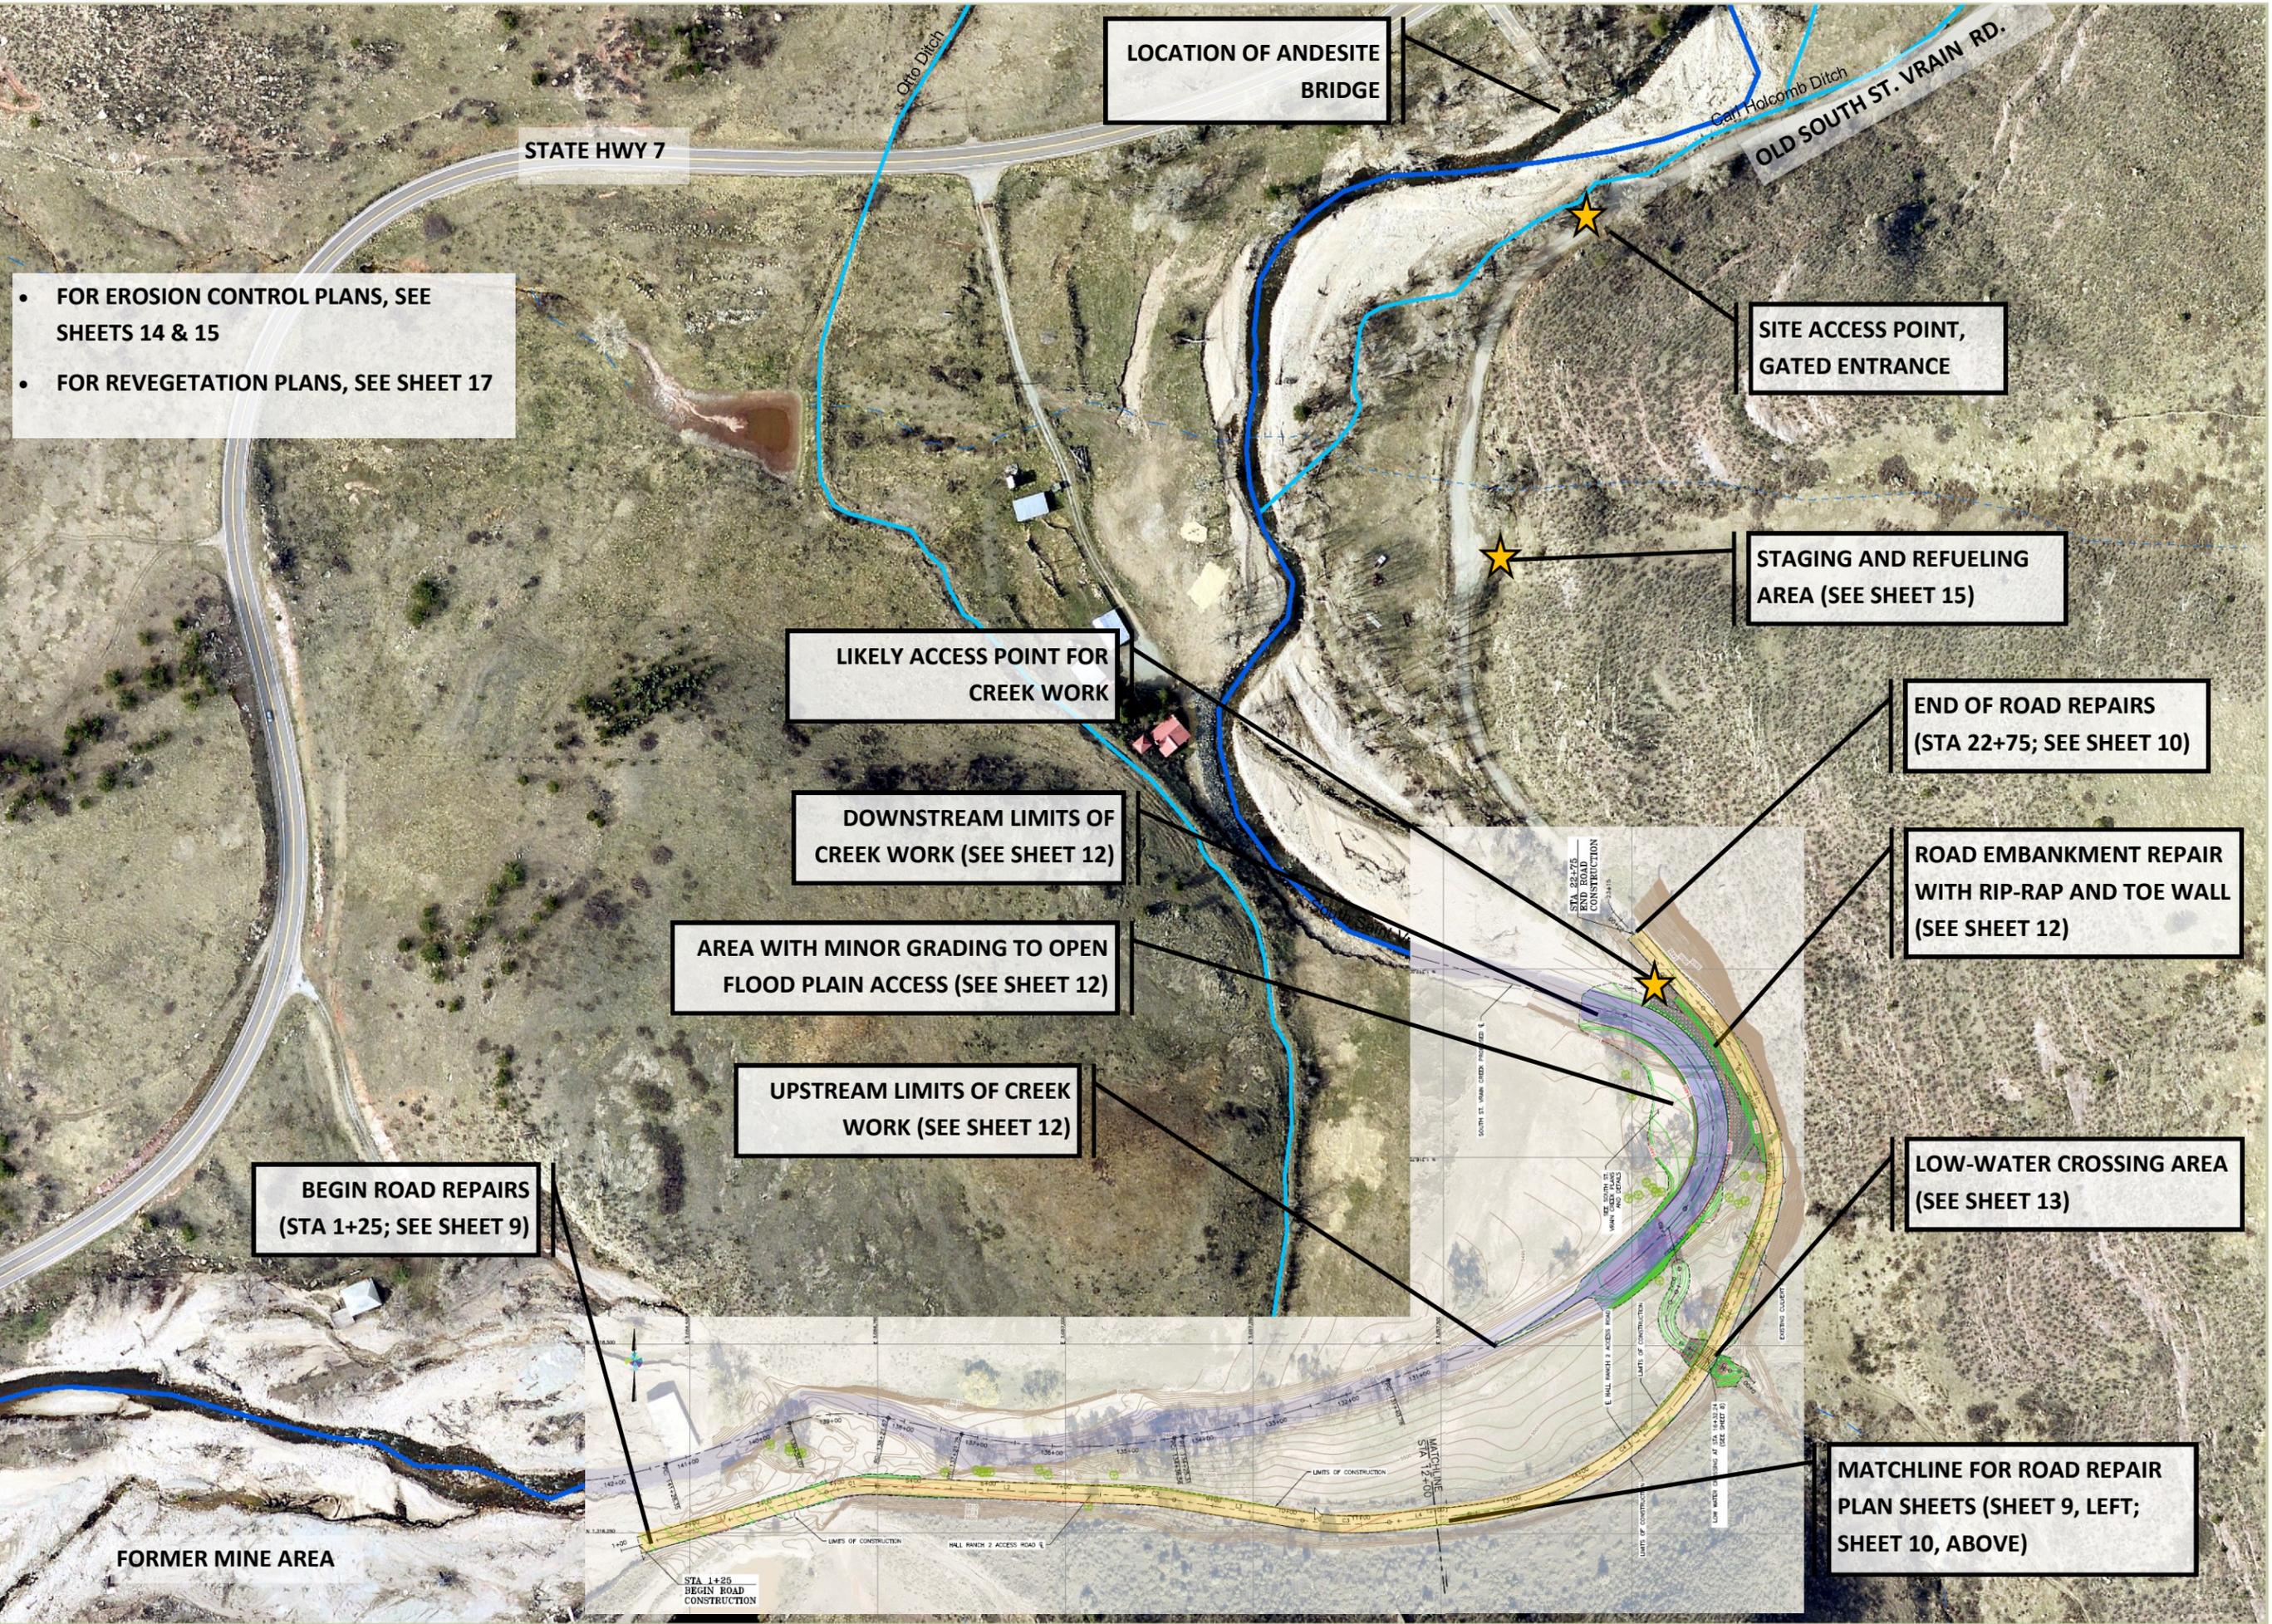
- FOR EROSION CONTROL PLANS, SEE SHEETS 14 & 15
- FOR REVEGETATION PLANS, SEE SHEET 17

SITE ACCESS POINT, GATED ENTRANCE

STAGING AND REFUELING AREA (SEE SHEET 15)

LIKELY ACCESS POINT FOR CREEK WORK

END OF ROAD REPAIRS (STA 22+75; SEE SHEET 10)

DOWNSTREAM LIMITS OF CREEK WORK (SEE SHEET 12)

ROAD EMBANKMENT REPAIR WITH RIP-RAP AND TOE WALL (SEE SHEET 12)

AREA WITH MINOR GRADING TO OPEN FLOOD PLAIN ACCESS (SEE SHEET 12)

UPSTREAM LIMITS OF CREEK WORK (SEE SHEET 12)

LOW-WATER CROSSING AREA (SEE SHEET 13)

BEGIN ROAD REPAIRS (STA 1+25; SEE SHEET 9)

MATCHLINE FOR ROAD REPAIR PLAN SHEETS (SHEET 9, LEFT; SHEET 10, ABOVE)
