Hall Ranch II Access Road Repair and Hazard Mitigation Weekly Construction updates

Date: 05/08/2018

By: Prashant KC

Location: South St. Vrain, West of Lyons, CO
Work in Progress/Completed

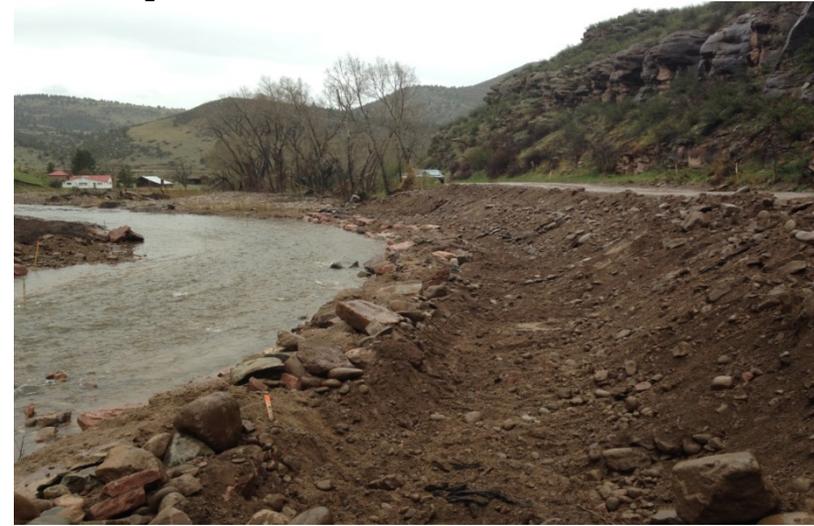
Looking Downstream: subgrade preparation for bankline construction.

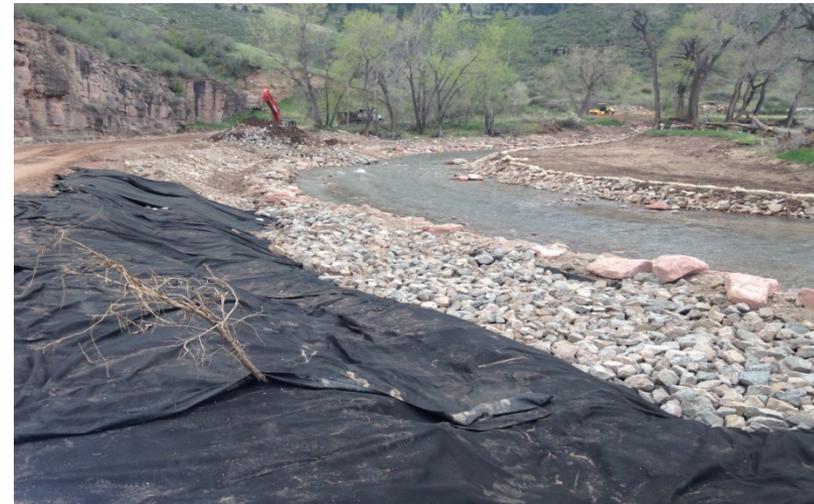
Looking Upstream: Installation of 9 inch rip rap behind boulder toe and above separation geotextile.

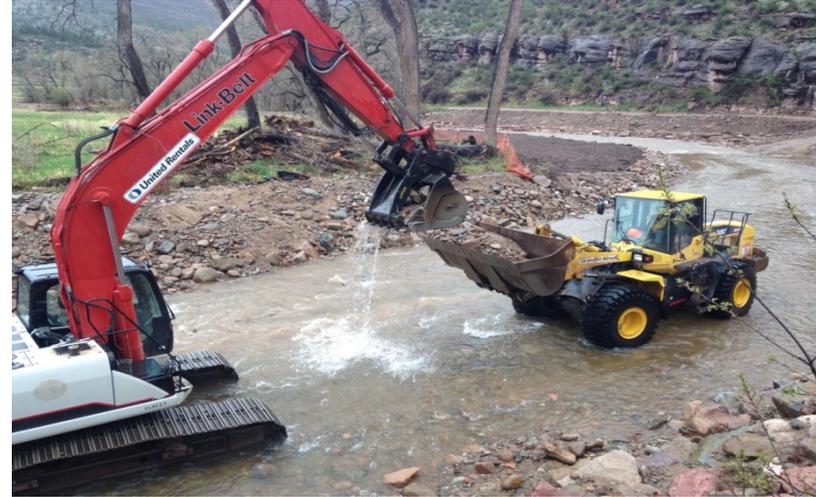
Looking downstream: Completing construction of low flow channel and hauling excess material for processing.

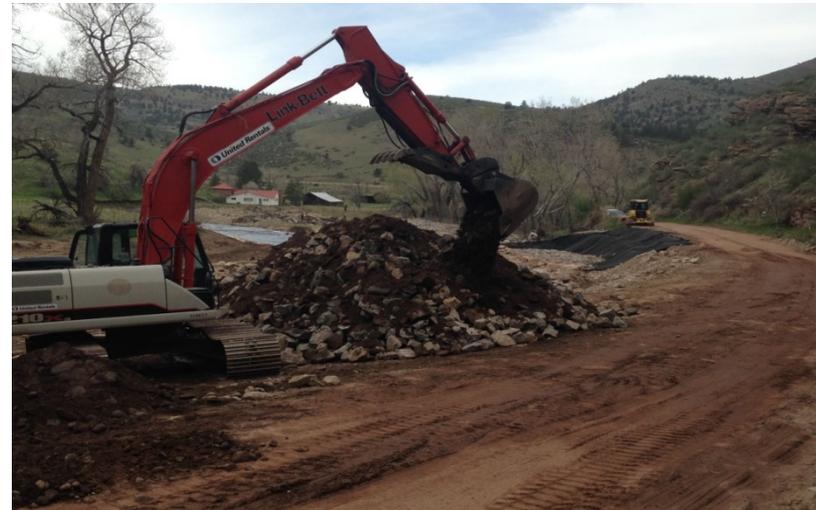
Batching Soil riprap mix (65-35) for bank stabilization.
