Hall Ranch II Access Road Repair and Hazard Mitigation Weekly Construction updates

Date: 06/06/2018

Location: South St. Vrain, West of Lyons, CO

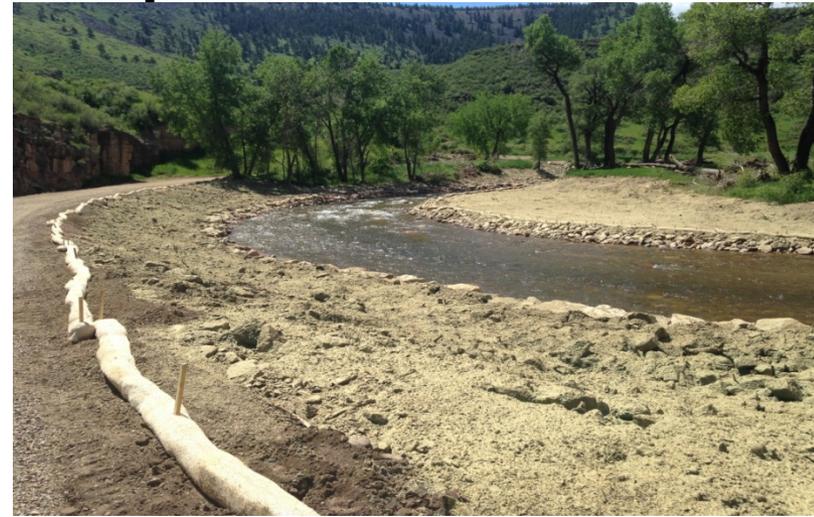
Looking upstream: Seed and Hydromulch above soil riprap in road embankment slope and floodplain.

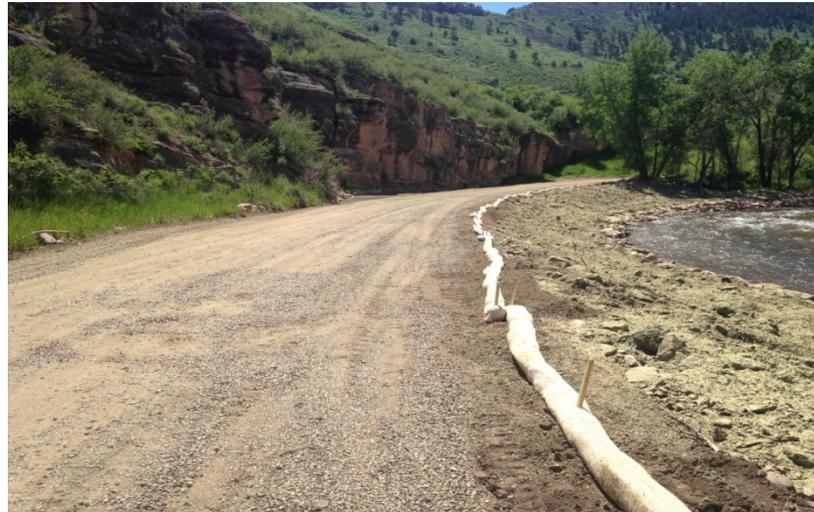
Looking upstream: new aggregate base course road at washout reach.

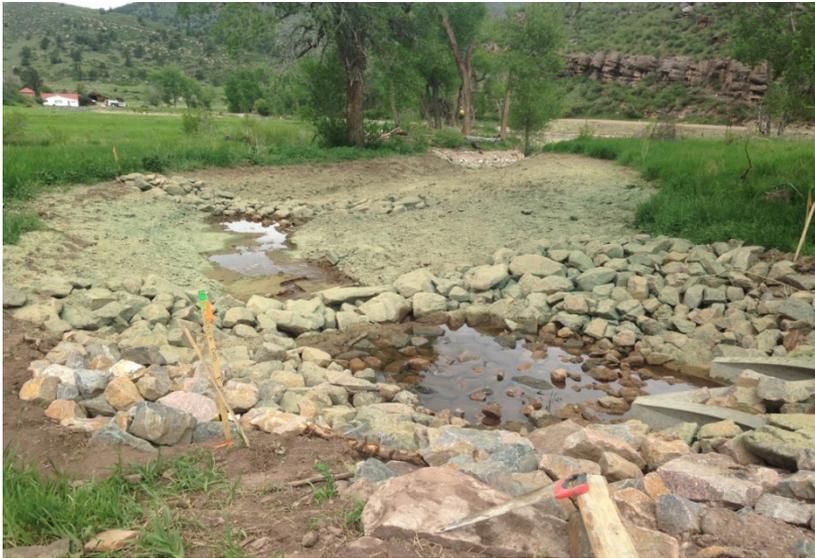
Looking downstream: Low water crossing ditch and outfall

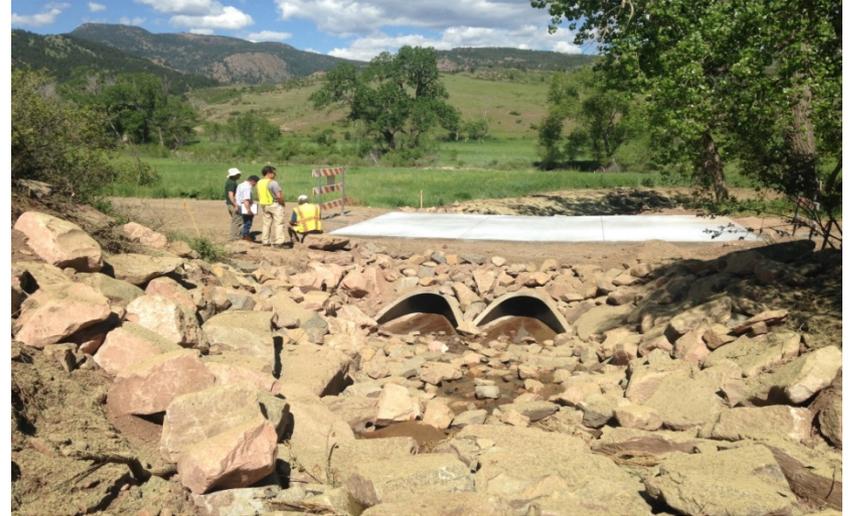
Looking downstream: Concrete Low water crossing

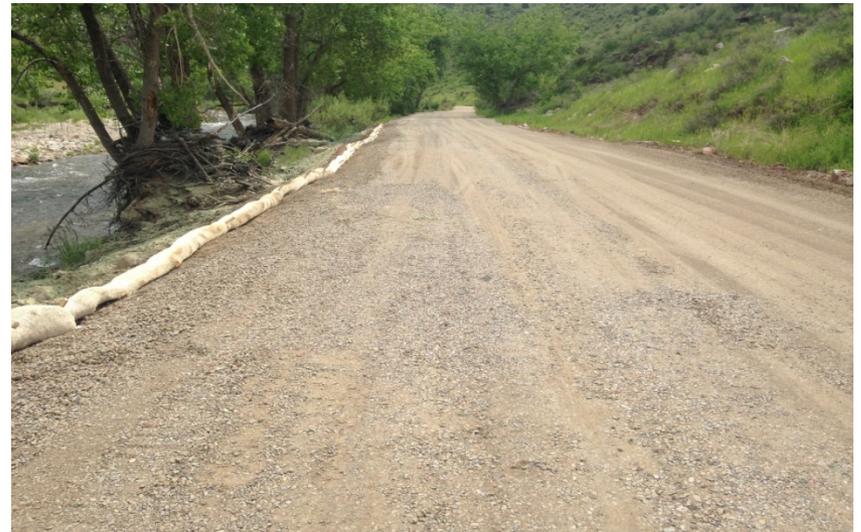
Re-surfaced Aggregate base course road
